EFFECTIVENESS MONITORING OF  
SOUTH FORK NOOKSACK INSTREAM HABITAT PROJECTS,

SUMMER 2011

Nooksack Indian Tribe  
Natural Resources Department

July 11, 2012

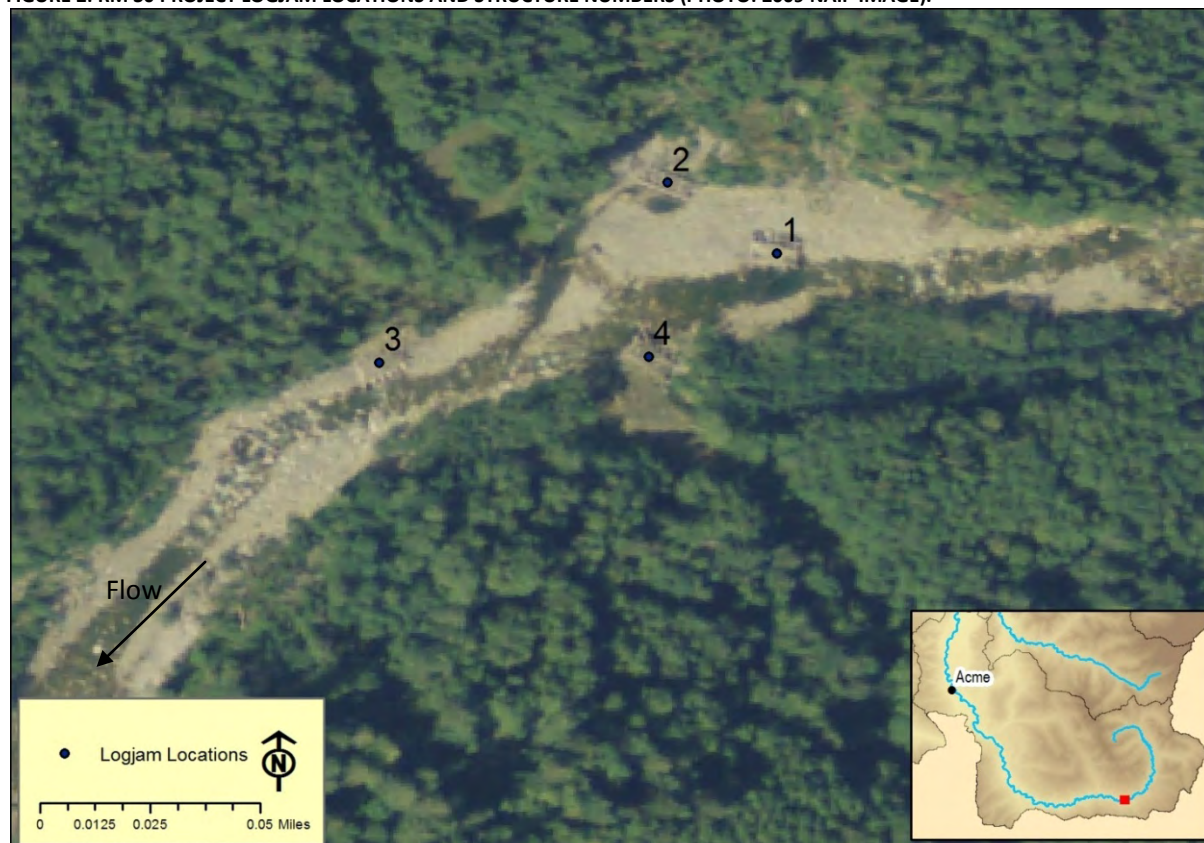
FIGURE 2: RM 30 PROJECT LOGJAM LOCATIONS AND STRUCTURE NUMBERS (PHOTO: 2009 NAIP IMAGE).

Of the four structures built, one (#1) formed a primary pool (Table 2). This structure was placed in the middle of the active channel with the intent of splitting the majority of the flow away from the landslide now protected by Structure #2, which was being actively undermined by the channel at the time of construction, and toward Structure #4. The logjam has formed one of the deeper pools (maximum depth= 2.8m) of all of the projects in the South Fork, in spite of the large boulder-dominated substrate. The structure is deeply undercut and provides nearly 78m<sup>2</sup> of woody cover. The scour has led to the settling of the structure, and the cracking of at least one of the log pieces, although it is still cabled into the structure. The logjam has lost some gravel ballast that has been washed through the structure during high flow. Very little wood debris has racked onto the structure. The logjam has sorted sediment, and has developed a bar of suitable spawning sized gravel (~2-10 cm) in the lee that could provide spawning, although it was exposed at the time of the survey.

Logjam #2 was designed to protect the toe of an unstable slope from erosion by the river, and form a pool with complex wood cover. The hillslope immediately above the structure was revegetating with young alder trees, although the landslide is continuing to fail around the logjam. The logjam itself is beginning to be buried by the slide material. At the time of the survey, a small side channel led around Logjam #1 to #2. A secondary pool was formed in the side channel and the structure was providing a small amount of cover. The structure has no racked material aside from the small amount that has been contributed by the landslide.

This project appears to be functioning well. There are no recommendations for improvement.

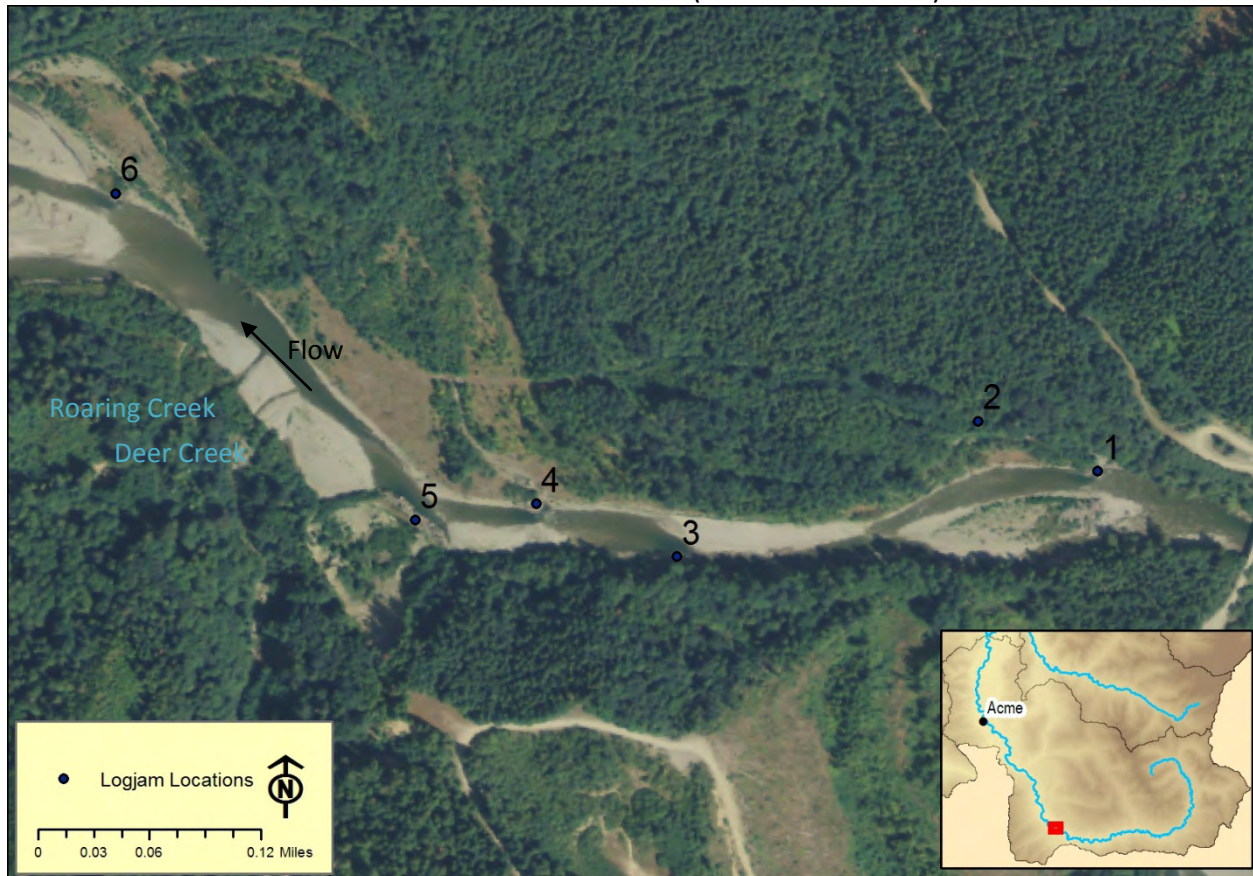
FIGURE 3: LARSON'S BRIDGE PROJECT STRUCTURE NUMBERS AND LOCATION (PHOTO: 2009 NAIP IMAGE).

The objective of the first structure was to form a pool, provide cover, and split flow toward the north into an existing low-flow side channel and toward Logjam #2, which was to split flow into a floodplain channel. As the primary pool developed along the southern side of the logjam, the changed bed elevation likely contributed to deposition in the mouth of the side channel and abandonment of this

habitat (Table 3). Currently the structure splits bank-full flow into the side channel. The structure does not appear to have racked much woody debris beyond what was originally placed as a part of construction. Some of the ballast has eroded away, exposing several of the key pieces at the front of the log jam.

Logjam #3 was designed to scour a pool, provide cover and protect a streamside slope failure. This structure has scoured the deepest pool (maximum depth = 4.2m) of any structure in the South Fork Nooksack. The pool is scoured through the shallow alluvium and into the underlying glacio-lacustrine deposits. It is possible that the glacial deposit limits scour depth, or slows the development of the pool, but observed depth indicates that it does not form a significant barrier to pool development. The upslope area has not continued to fail and help bury the structure as anticipated. The pool formed by the structure has resulted in a broad gravel tail-out that appears suitable for spawning. The logjam is deeply undercut for over half of its width and has lost most of its gravel ballast. The structure appears to have lost several of its key pieces, but appears to still be stable, with young alders growing on the remaining ballast. The structure has not racked much more material beyond what was originally placed.

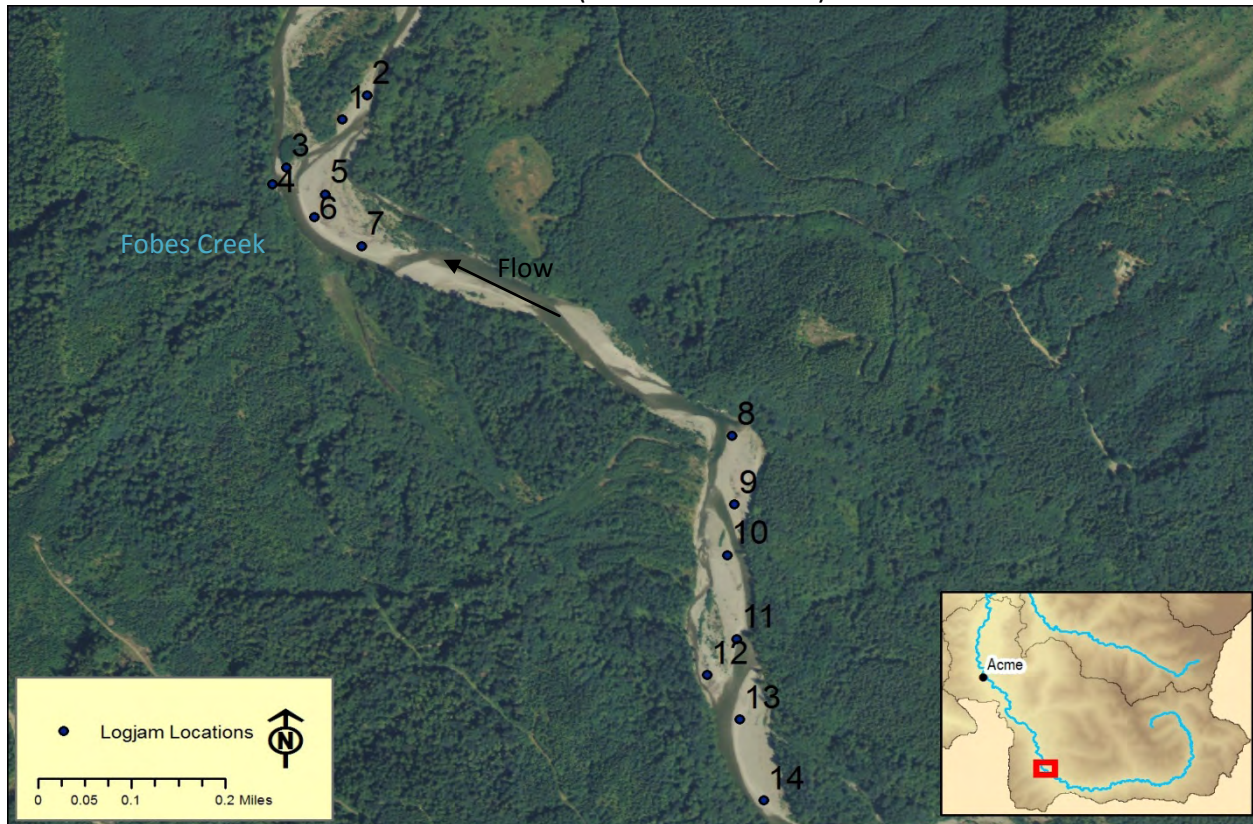
FIGURE 4: FOBES PROJECT STRUTURE NUMBERS AND LOCATION (PHOTO: 2009 NAIP IMAGE).

Logjam #1 and #2 are located on a lateral bar where they had scoured small secondary pools at the edge of the low flow channel. The upstream structure (#1) had racked ~4m of wood on the upstream side. Both of these structures appear to be splitting the high flow channel and #2 showed signs of sediment sorting on the upstream side (Table 4).

Logjam #3 is located at the upstream end of a forested island with a low flow channel split. The structure has formed a medial bar, and is providing cover in a riffle in the left bank channel and a secondary backwater pool in the right bank channel.

Logjam #7 is located at the upstream end of the same lateral bar that #5 and #6 are built on. This structure has formed a small secondary pool at the margin of the main channel and has racked wood over 10m laterally on the upstream end of the structure. An additional deposit of wood that is 10m long is loosely associated with the structure. This deposit is racked across a high flow channel and appears to be deflecting high flow toward the left bank.

Logjams #11 and #12 are also located on the same lateral bar as #10. Both of these structures have formed small secondary pools. The pool associated with logjam #12 was the deepest observed in the project (0.65m). Logjam #11 has ~2.5m of freshly racked wood and has formed an arcuate bar upstream of the structure. Logjam #12 has racked ~9m of material on the upstream side. The racked material has grown upstream along the outside of a bend and is currently deflecting the high flow channel toward the right bank. Logjam #12 also splits high flow into disconnected side channel area that appears to be connected through the majority of the year.

This project also appears to be functioning well. Five of the structures show signs of damage (lost ballast), but all continue to function. Adding ballast to several of the structures could be explored. The original design for this reach included additional structures, and continuing with another phase (particularly upstream of the bridge) could be warranted here. Additional structures downstream of logjam #6 should also be considered to improve in-stream cover in proximity to spawning and to encourage stabilization and riparian re-colonization of large mid-channel and lateral bars.

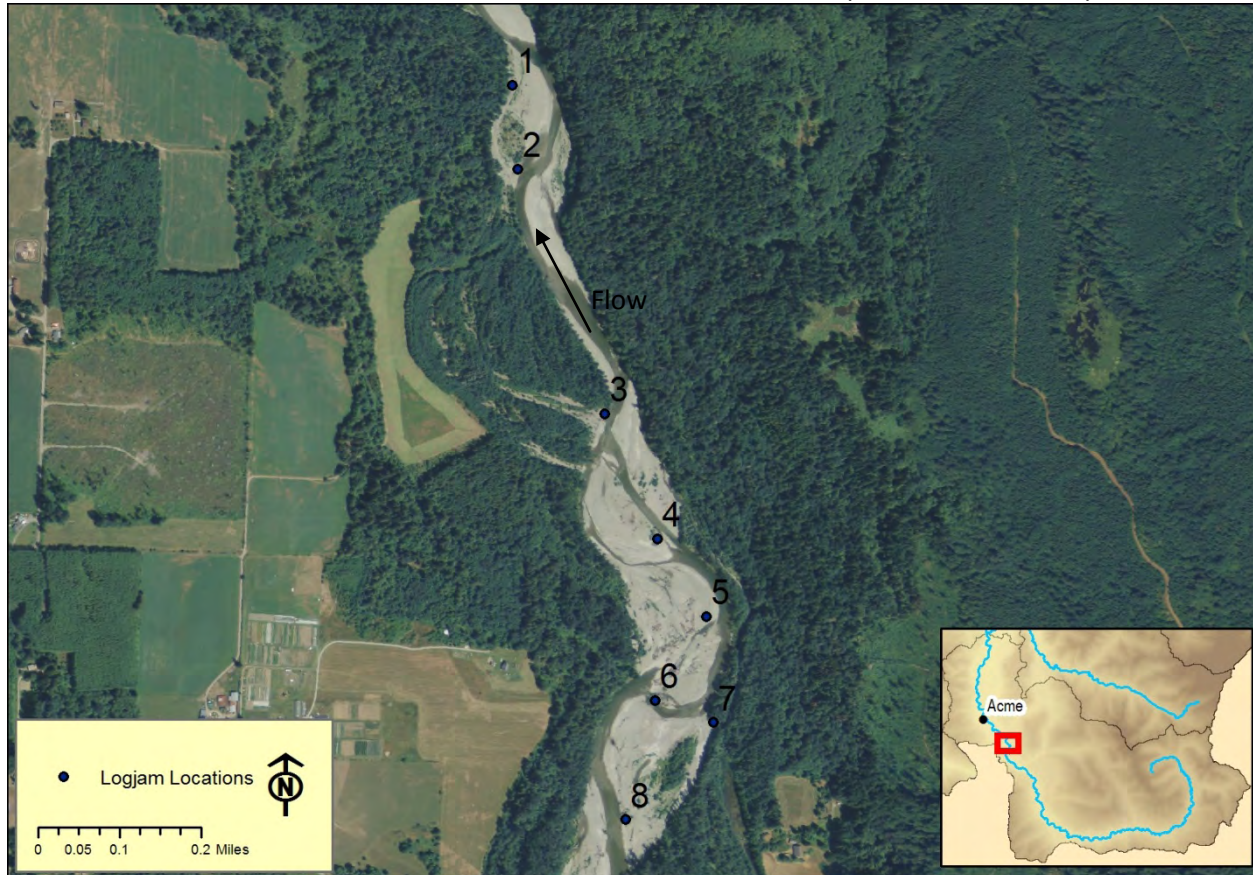
FIGURE 6: NESSET'S PROJECT REACH SHOWING STABILIZATION SITE LOCATIONS AND NUMBER (PHOTO: 2009 NAIP IMAGE).

Logjam #1 is located at the edge of the active channel area, where an ephemeral side channel enters the mainstem of the South Fork Nooksack. This structure forms a pool in the side channel, which was isolated from the main channel at the time of the survey (Table 6).

Sites #2 and #3 were both washed-out at the time of the survey. In both cases, downstream migration of a meander undermined the sites and washed the large placed wood and pilings away.

Three of the eight structures in this project reach have been washed-out by the river and one structure has lost several of its pilings. The remaining structures have provided habitat when the channel was interacting with them, but at the time of the surveys none of the remaining five structures were creating primary pools. Given the length of the reach and the few stable structures, it is unlikely that the remaining structures will provide adequate habitat to meet the recovery objectives. We recommend development and implementation of a new reach-scale design that will have high certainty of achieving habitat targets within the reach.

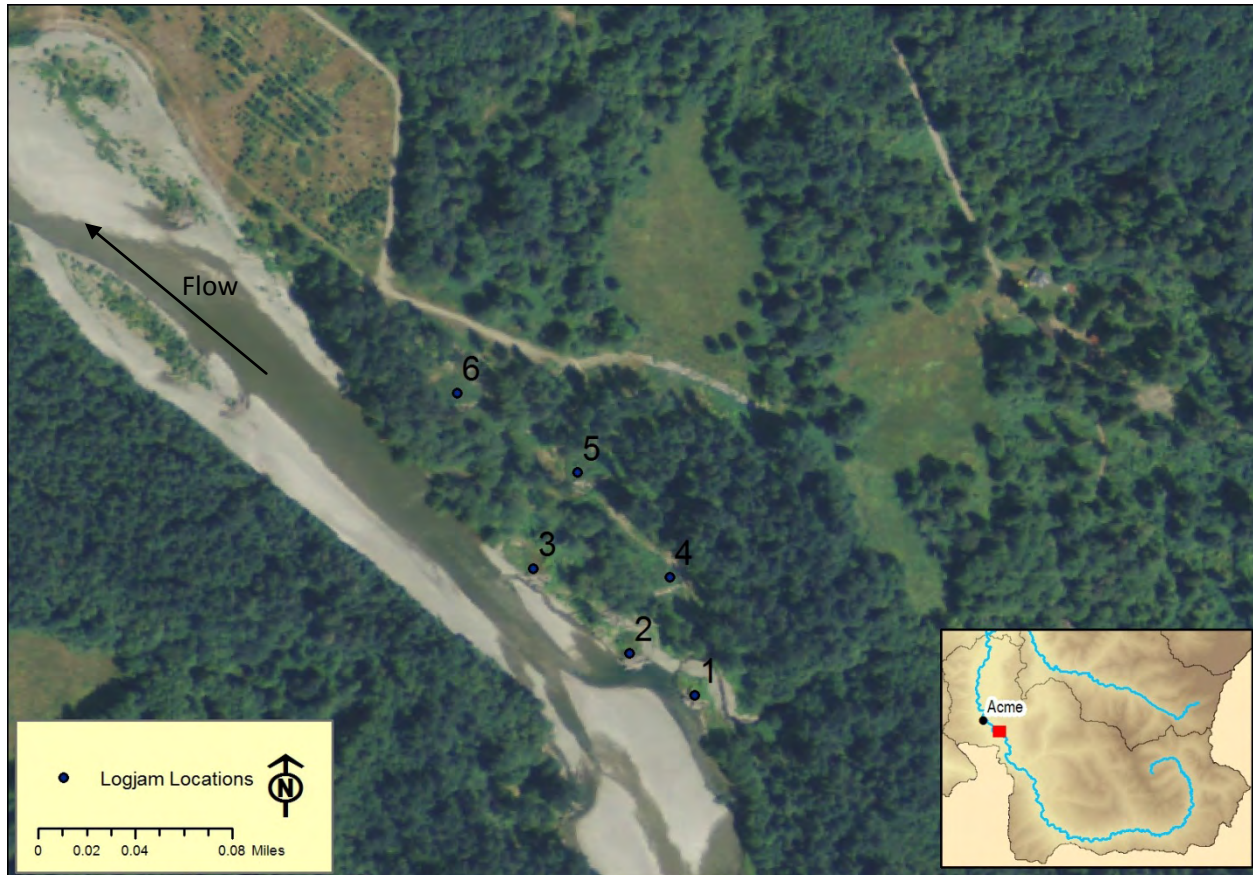
**FIGURE 7: LOWER HUTCHINSON PROJECT SHOWING THE STRUCTURE LOCATIONS AND NUMBERS.**

Logjam #1 is located in a riffle in a braided channel of the South Fork Nooksack. The logjam has loosely racked material for a length of ~10m along the bank upstream, although this appears to be temporary. Some of this material appears racked on submerged rock left over from the eroding remnant of levee

upstream of the logjam. The logjam has no local scour associated with it, although it is providing cover and slowing the velocity in the riffle (Table 7: Lower Hutchinson Project habitat functions (1= function observed, 0=not observed)). The remnant of riprap upstream of Logjam #1 is likely slowing migration of the channel toward the north and limiting the engagement of the logjam with the channel.

Logjam #2 is located at the confluence with Hutchinson Creek. The structure forms a primary pool (max= 2.9m) and is deeply undercut providing complex wood cover. Hutchinson Creek flows into the scour pool to provide a cool water source to the channel. The structure has accumulated several meters of material on upstream side of the structure. Wood and sediment deposition on the right bank side of the structure has obstructed the old channel of Hutchinson Creek that was associated with the back side of the removed levee. The structure still appears to split the bank-full flow of the river.

Logjam #3 forms a secondary pool in a flat water section of the South Fork Nooksack. There is some evidence that the structure split high flow (sand deposition around the structure), although the area is thoroughly vegetated. The logjam has not accumulated any additional wood since construction.

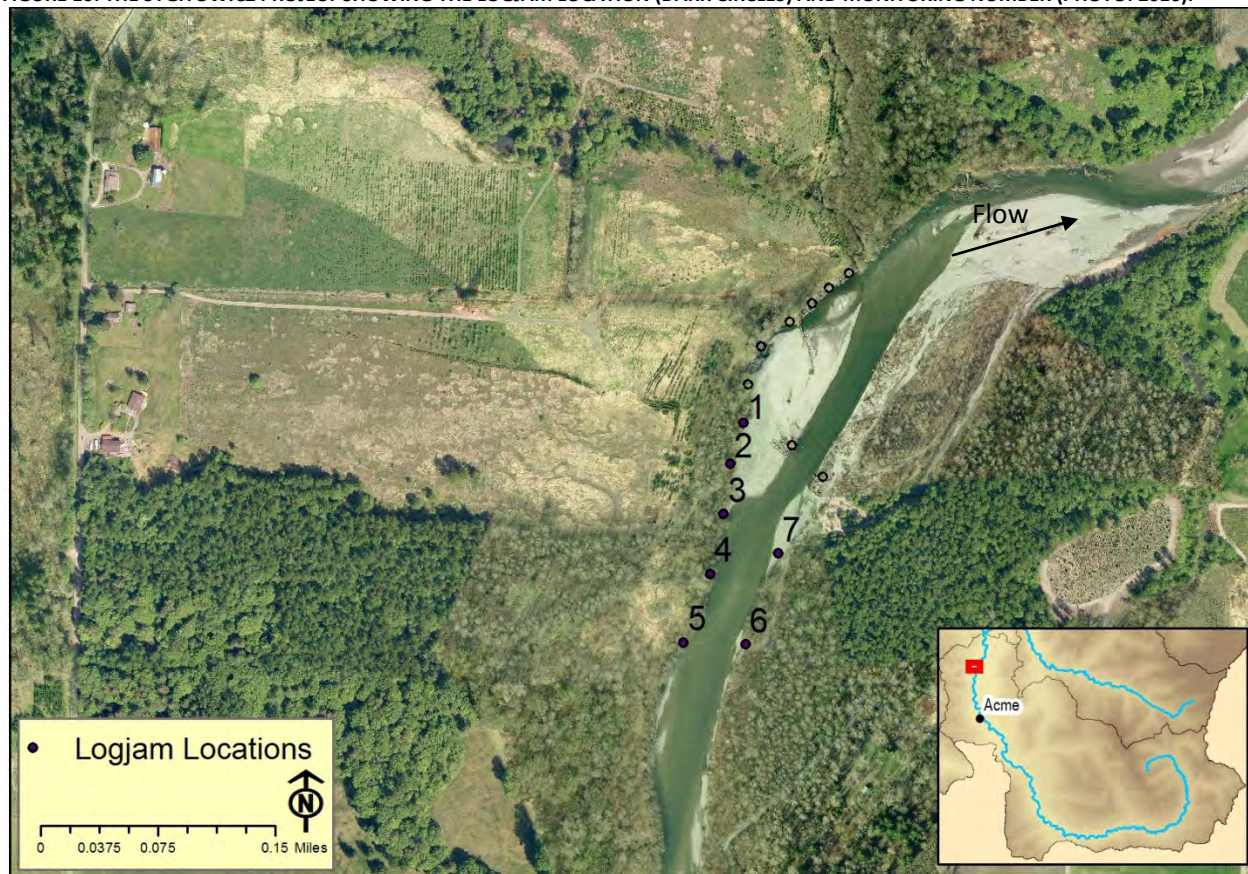
FIGURE 10: THE SYGITOWICZ PROJECT SHOWING THE LOGJAM LOCATION (DARK CIRCLES) AND MONITORING NUMBER (PHOTO: 2010).

Logjams #1 and #2 are located along a high bank on a lateral bar. These two structures are intended to encourage the main channel flow across the bar and reestablish a low flow channel along the bank, although they are currently only functioning during high flow. Logjam #3 is also located in the bank at the upstream extent of this bar and it is also only functioning at high flow. A small high flow channel

runs along the bank from Logjam #3 to the downstream Todd Project. None of these structures are currently providing any other habitat functions aside from protecting the bank from erosion (Table 10).

Logjam #4 forms a secondary pool in a long run habitat unit in the South Fork. The pool is being formed by the log that was added to the structure in 2011, and this was the only part of the structure that was providing cover. The log had accumulated some small brush, but the rest of the structure was isolated from the channel and providing no functions aside from protecting the bank. Logjam #5 also lies along the edge of the same run habitat in the South Fork. The additional log added to this structure is providing some woody cover, but no pool scour was observed at the site. Pool scour may have been limited in the first year by remnant riprap boulders in the channel, but subsequent removal may improve conditions.

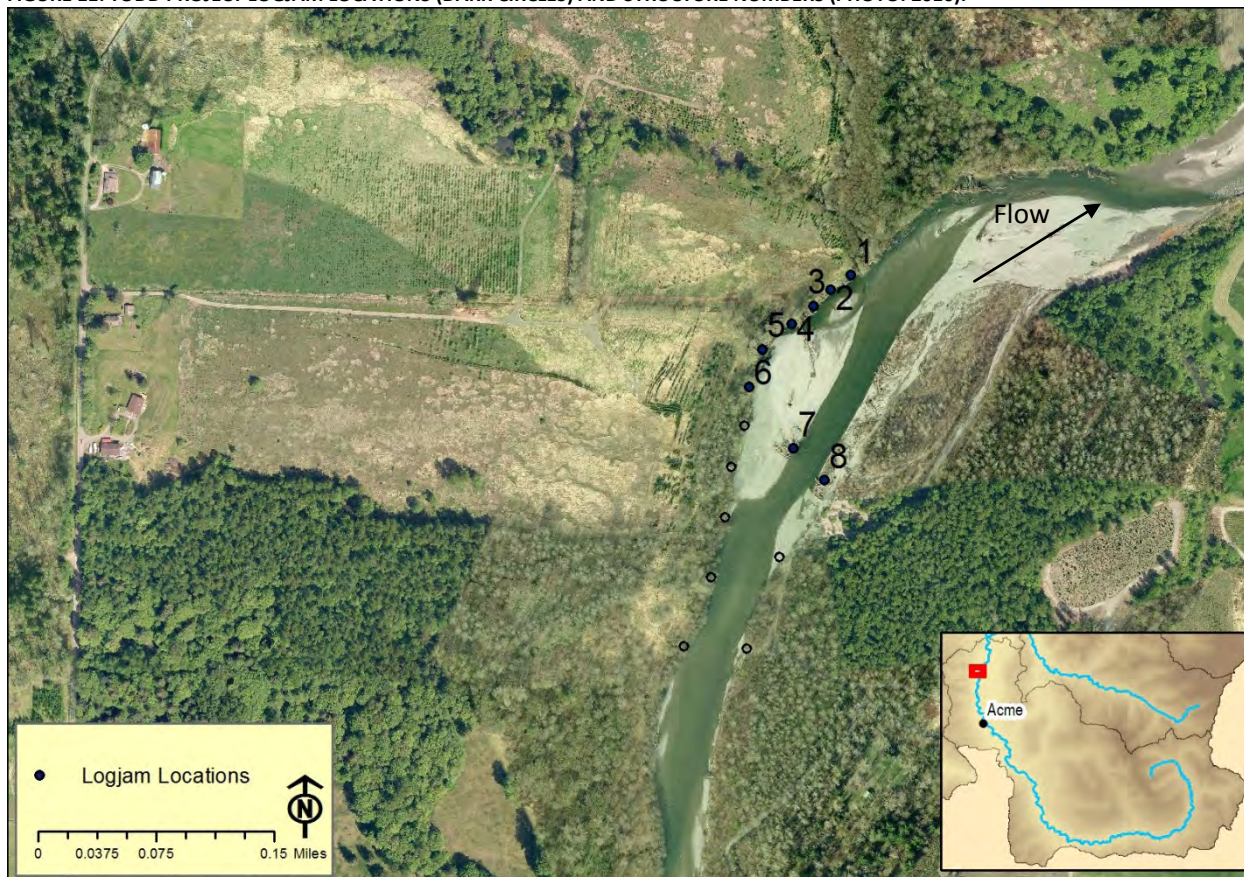
FIGURE 11: TODD PROJECT LOGJAM LOCATIONS (DARK CIRCLES) AND STRUCTURE NUMBERS (PHOTO: 2010).

Logjam #1 was built into the Todd Creek alluvial fan, which is above the modeled 100-year flood surface. The structure forms a deep pool in a disconnected side channel (Table 11). It appears that the side channel is connected at the downstream end for most of the year, and at the upstream end during high flow events. This side channel bar area was the main channel when the project was constructed, but the main channel moved to the east of Logjam #7, leaving this area as a high flow channel. The structure is providing some woody cover for the abundant juveniles present in the isolated pool. Logjam #2 is also built into the alluvial fan deposit upstream of Logjam #1 and forms another isolated pool. There is a subtle tail-out between this pool and the pool associated with Logjam #1, but they are essentially the same feature. The pool has filled substantially in the last year, with fresh gravel bars narrowing the backwater area. As with Logjam #1, this structure protects the bank from erosion.

Logjams #3 and #4 are also built into the high bank of the alluvial fan deposit. Both of these logjams form isolated pools in the side channel. The maximum depth at Logjam #3 is 2.1m, making it one of the deeper pools created for the South Fork projects. There is a subtle tail-out between the two isolated pools, but they are both the same feature. These two structures have each accumulated ~1m of woody material since they were constructed. These structures also protect the high bank from erosion.

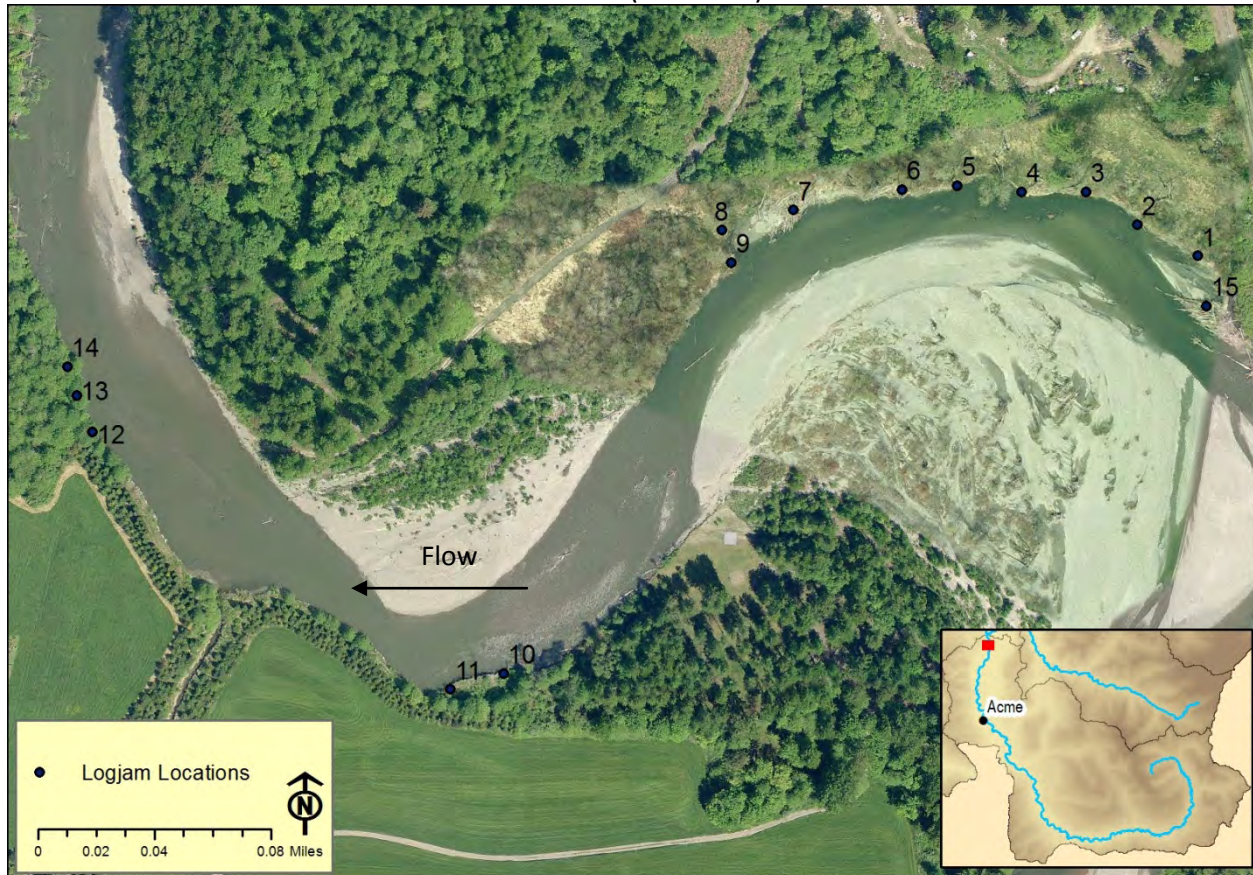
FIGURE 12: VAN ZANDT PROJECT LOGJAM LOCATIONS AND NUMBERS (PHOTO: 2010).

Logjams #3, #4, and #5 are all located along the high bank of landslide material at the outside of the meander bend. Logjam #3 forms a secondary pool with a subtle tail-out leading into the primary pool associated with Logjam #4. Since construction, the bank has retreated between the logjams and exposed more of the structures to the force of the river and resulted in some wood accumulation on them. The primary pool formed at Logjam #4 is aided by additional scour from a large rock that has eroded from the landslide deposit. Logjam #5 is located in the tail-out of the pool formed by Logjam #4. All three of these structures locally protect the floodplain and are tall enough to split the flood flow when it crests the bank to the north.

Logjam #6 forms a primary pool that is one of the deepest (max = 3.1m) found during the surveys. The pool is formed in the clay, silt and fine sand that makes up the deposit of a large deep-seated landslide and begins immediately downstream of the tail-out from the pool formed near Logjams #3, #4, and #5. The structure locally protects the bank, although erosion between the structures has exposed more of the logjams to flow and encouraged deep pool formation. As with the other structures, Logjam #6 splits the flow when it is high enough to top the bank.

Logjams #8 and #9 form a primary pool, with only a subtle tail-out between the two structures. The maximum depth is one of the deeper (max = 2.8m) found in the monitoring effort. The structures are built along a resistant bank, which is also contributing to the pool formation. The structures are both providing bank protection.

Logjams #10 and #11 are both located on a small patch of low floodplain at the foot of a higher floodplain surface. At the time of construction, both of these logjams were isolated from the channel, but subsequent channel migration has exposed Logjam #11. This structure forms the deepest secondary pool found (max depth = 2.1m) in the surveys in a flat water section of the South Fork. The logjam is deeply undercut and providing excellent cover. Both of these structures are providing protection to the higher floodplain surface behind them.

Logjam #15 is racked on a large cottonwood tree that was stabilized with pilings. The log has racked woody material upstream along the bank of the river for a length of approximately 40 meters, which is forming a secondary pool in the mainstem run habitat. The stability of the racked material is questionable, but any lost will likely be replaced by new recruitment. A deeper pool is associated with a natural logjam just upstream of the racked material, and it is possible that continued growth of the logjam could join these two accumulations together. Logjam #15 deflects the low flow channel and has a sand bar deposited in the lee of structure- between the logjam and high bank behind it. This accumulation has contributed to the isolation Logjams #1 and #2.
