# Railroad Grade Beach Nourishment Study

Megan Dethier, University of Washington  
Jason Toft, University of Washington  
Hannah Faulkner, Washington Department of Fish and Wildlife  
Frank Leonetti, Snohomish County  
Elisa Dawson, Snohomish County

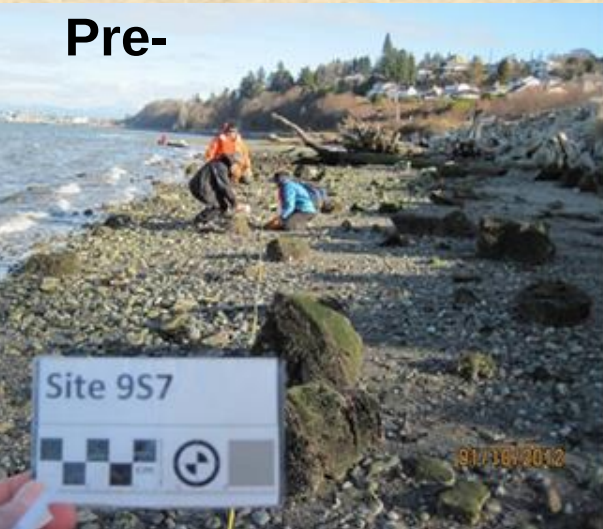
Pre-

# Site 9 – ~310 feet/ 4500 cy
