# **SALMONID HABITAT LIMITING FACTORS WATER RESOURCE INVENTORY AREAS 15 (WEST), KITSAP BASIN AND 14 (NORTH), KENNEDY-GOLDSBOROUGH BASIN**

**FINAL REPORT  
JUNE 2003**

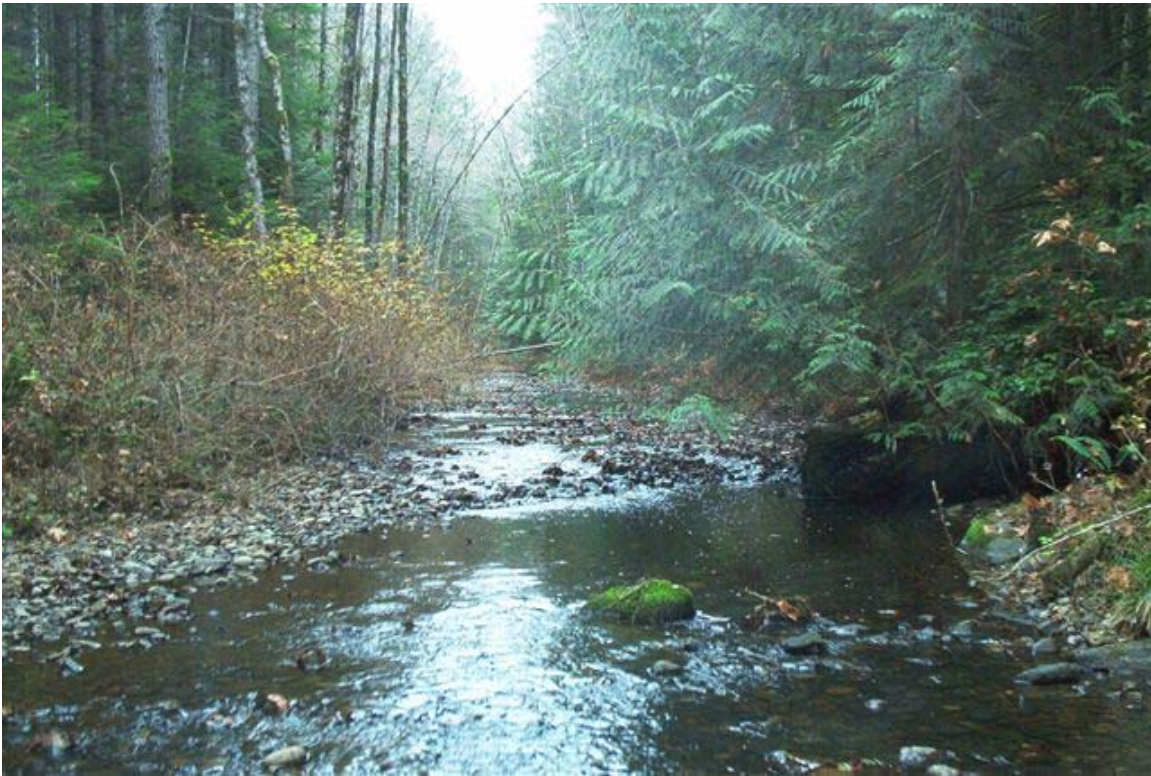
Figure 6. Upper Tahuya River downstream from Tahuya Lake, early December 2002. Shrubs and trees in the riparian zone stabilize streambanks. Photo courtesy of Marty Ereth, Skokomish Tribe.

Natural streambank stability maintains the integrity of riverine processes. The root masses of riparian vegetation and large woody debris stabilize streambanks (Figure 6). Riparian zones can maintain or repair themselves if they are located on a stable bank. Vegetation has a difficult time recovering from flood damages or other disturbances if it is continually undermined by a failing bank (Naiman *et al.* 2001). Stable streambanks also ensure an adequate channel depth. A given volume of water is deeper in a narrow channel than in a wide channel. Depth maintains the cool temperatures and hiding cover needed by salmonids. Rapidly eroding banks tend to lead to development of overly wide and shallow channels (Platts 1991). Eroding streambanks can contribute large amounts of fine sediment to the water column as well as large amounts of coarse sediment that is deposited in the stream channel (aggraded), thus leading to subsurface flows (Hicks *et al.* 1991, Ziemer and Lisle 2001). Fine sediment appears to have little negative effect on adult salmonids (unless levels are chronically high), but it smothers developing juvenile salmonids buried in the streambed and fills interstices between gravels, cobbles, and boulders that provide important winter cover (Bjornn and Reiser 1991) (See [Fine Sediment](#)).

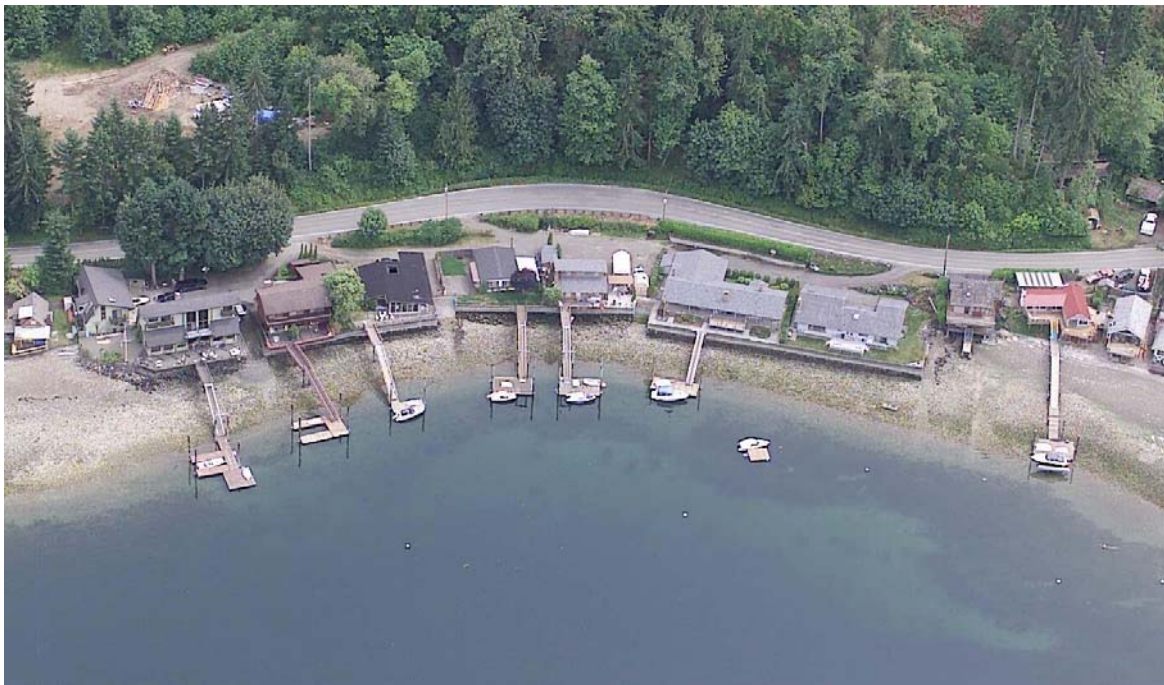
Figure 11. Each residence along Hood Canal often has its own pier and dock. These homes are along SR 106 on the east arm of Hood Canal. Photo number 010626-151838 (Washington Department of Ecology 2000b).

The shoreline of Hood Canal is a popular site for residential development. In particular, the north and south shores of the east arm of the canal have been extensively developed for residential use (Yoshinaka and Ellifrit 1973, Brody 1991, Washington Department of Ecology 2000b). Docks limit, or eliminate eelgrass beds through shading and the physical structures of the docks themselves. They can also alter juvenile salmonid behavior, forcing fish from the shallows into deeper water where they are more vulnerable to predation (Simenstad 2000). Many of the docks on lower Hood Canal are large, exceeding 400 square-feet, to compensate for small residential lot size (Small 2003, Personal communication). Naturally, docks and piers are often accompanied by boats. Propeller scour from boats can damage benthic communities and remove eelgrass (Simenstad 2000). Individual residences frequently have a private pier and/or dock. In many cases the water craft in use at these docks are small enough to store on land and trailer to a public boat launch (TAG 2003). See Figure 11.
