# MIDDLE PILCHUCK RIVER ASSESSMENT

## Habitat Report

Prepared for  
Washington State Salmon Recovery Funding Board

Prepared by  
Snohomish County Surface Water Management

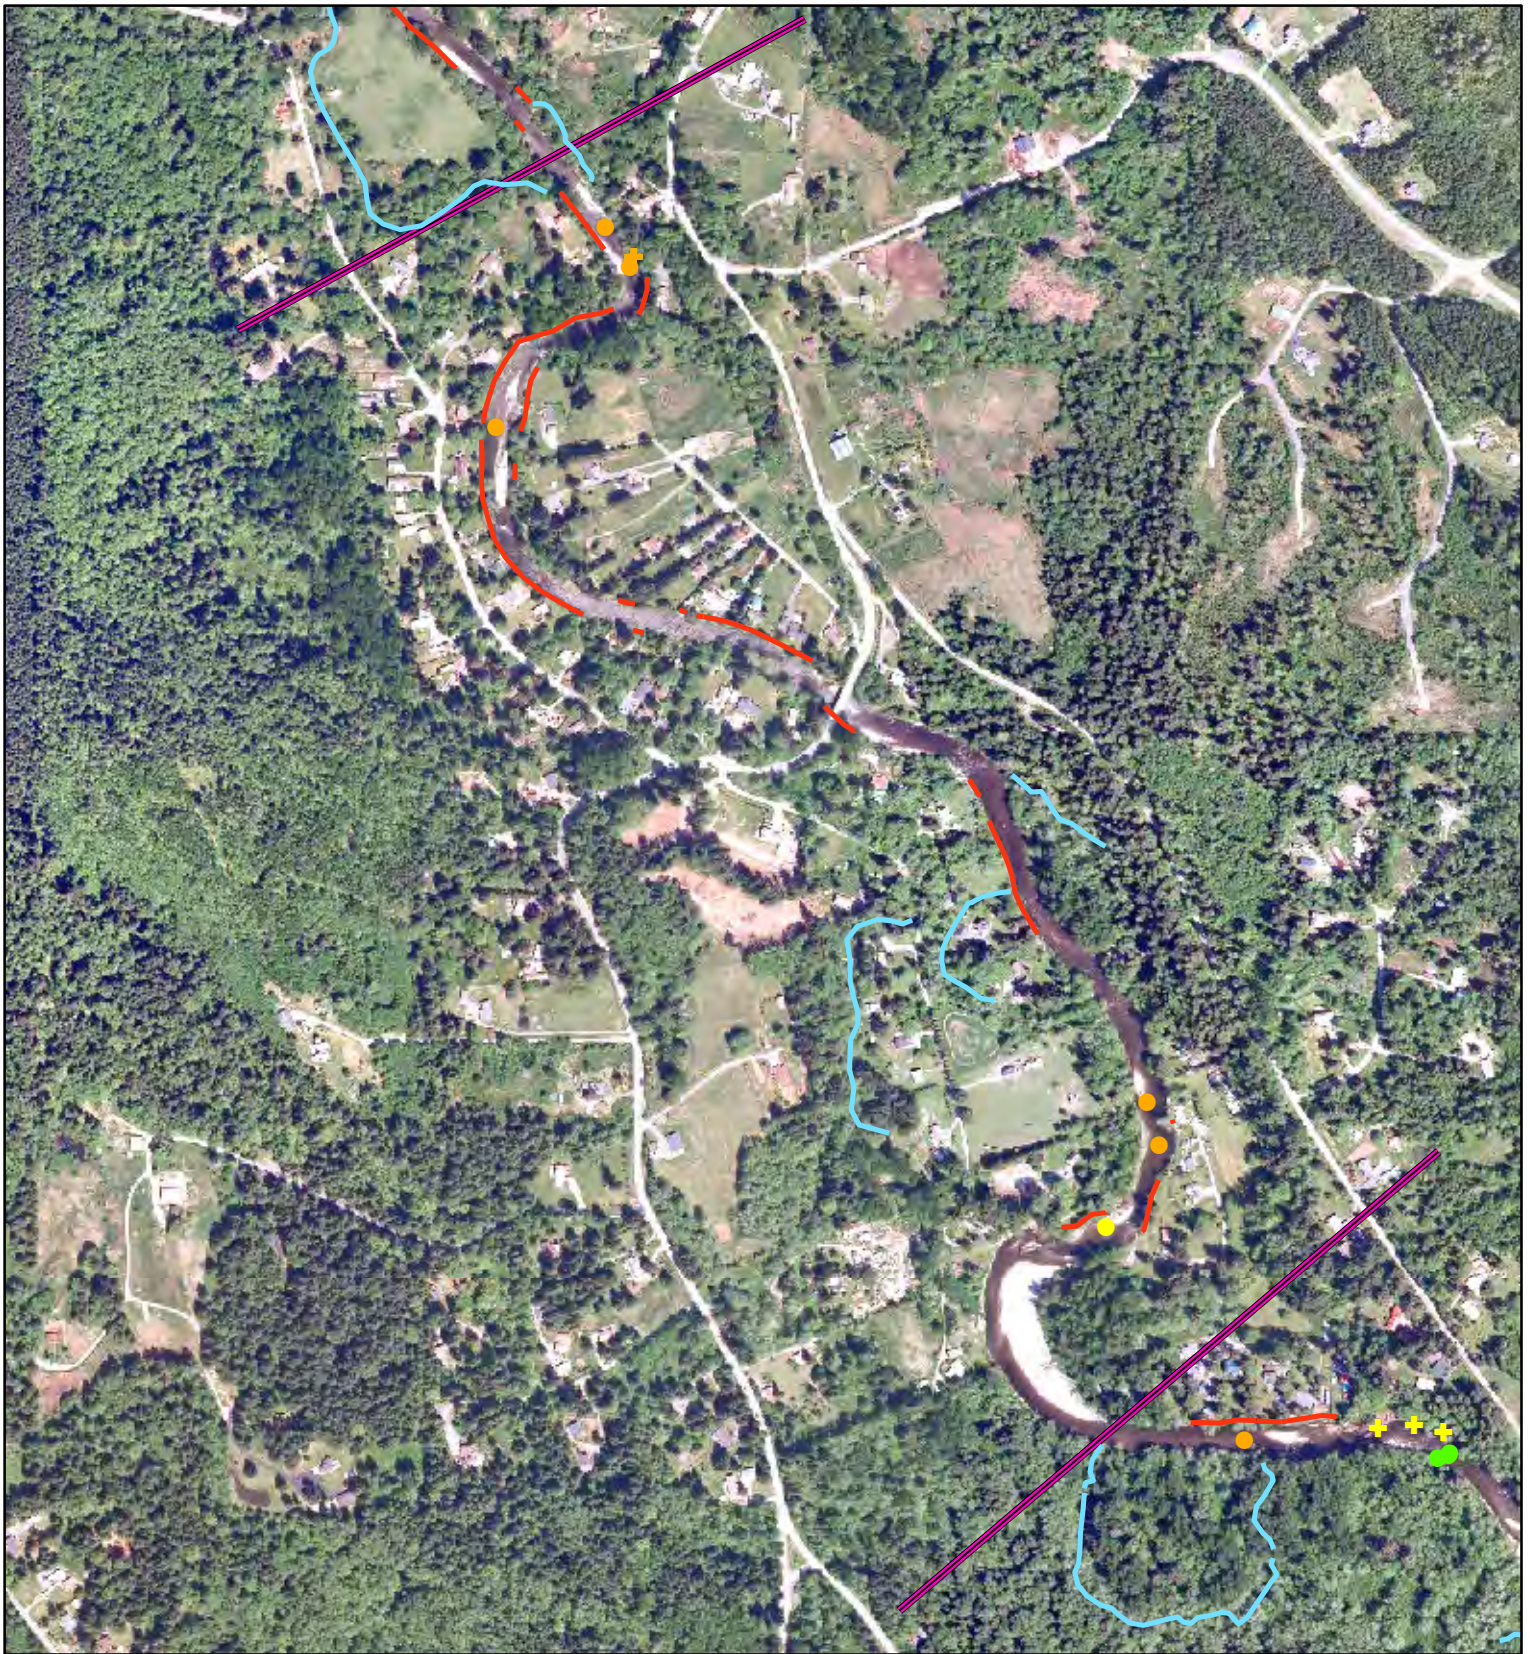
Figure 3-21. Habitat Conditions Map - Reach 6

- Salmon Spawning Locations
- Side Channels
- Armored Bank
- Assessment Reach Boundaries
