# Fisher Slough Tidal Marsh Restoration Baseline Monitoring Report

**The Nature Conservancy**  
410 North 4th Street  
Mount Vernon, WA 98273

The Nature Conservancy. 2011.  
Fisher Slough Tidal Marsh Restoration  
Baseline Monitoring Report.

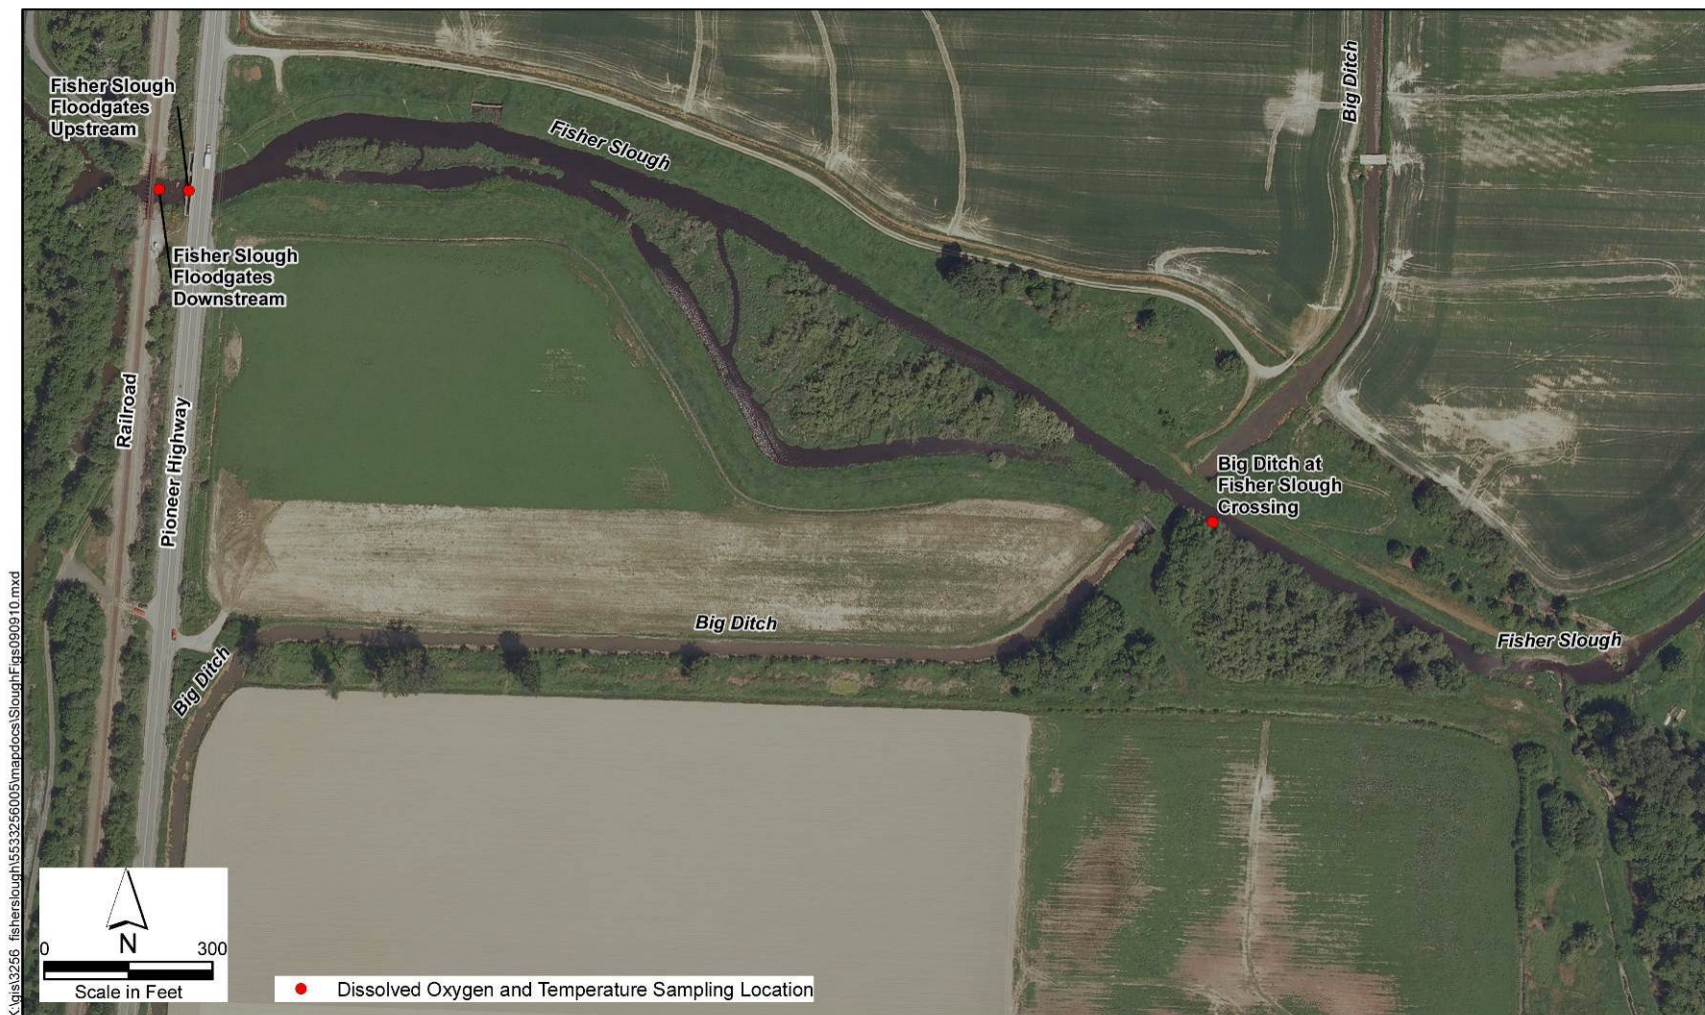
Figure 2-1 Water Quality Sampling Locations

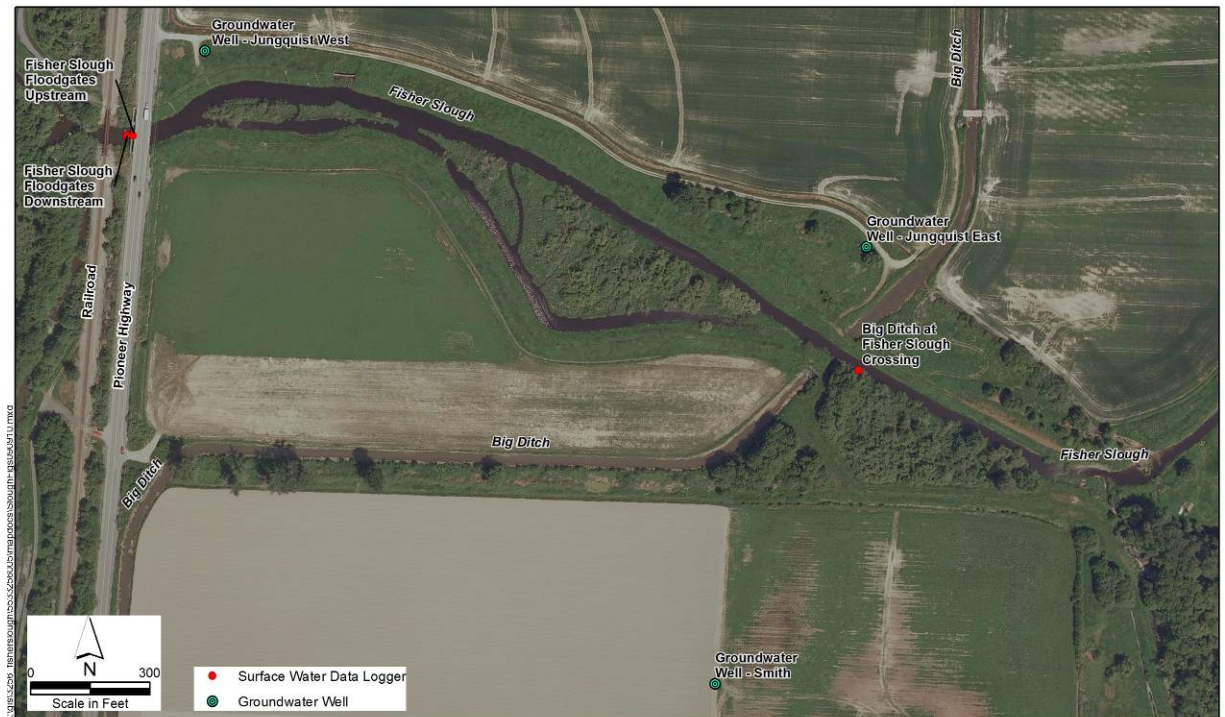
Figure A-1. Surface Water and Groundwater Sampling

Appendix A presents groundwater data collected from January 2, 2009 to September 30, 2009 at three locations (GW-Smith, GW-Jungquist East, and GW-Jungquist West). The following charts display groundwater elevations collected at 15-minute intervals during this data collections period by month. Tables A-2 through A-4 show monthly averages, maximums, and minimums at each well location.

See Figure A-1 for Surface Water Sampling locations. Appendix B presents surface water data collected from September 29, 2008 to September 30, 2009 at two locations (Fisher Slough Downstream and Big Ditch Crossing). The following charts display surface water elevations collected at 15-minute intervals, October of 2008 through August 2009 by month. The data from September of 2008 are not included because of limited sampling. Tables B-1 through B-2 show monthly averages, maximums, and minimums at both sampling locations.

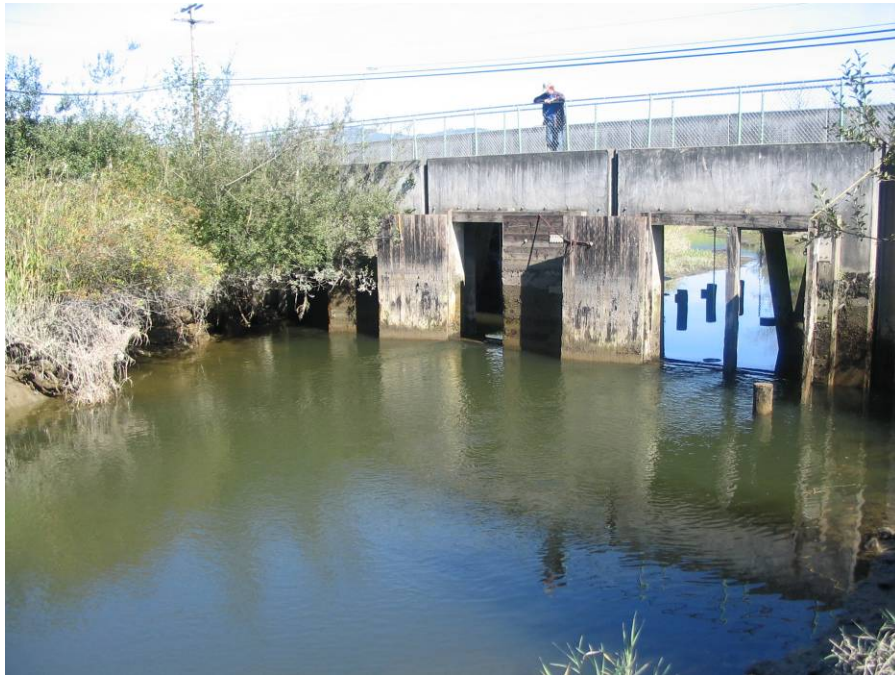
**FS01-Photograph 1: Taken from the south bank of Fisher Slough at the railroad bridge looking at the downstream side of floodgates. (Photo taken September 21, 2009)**

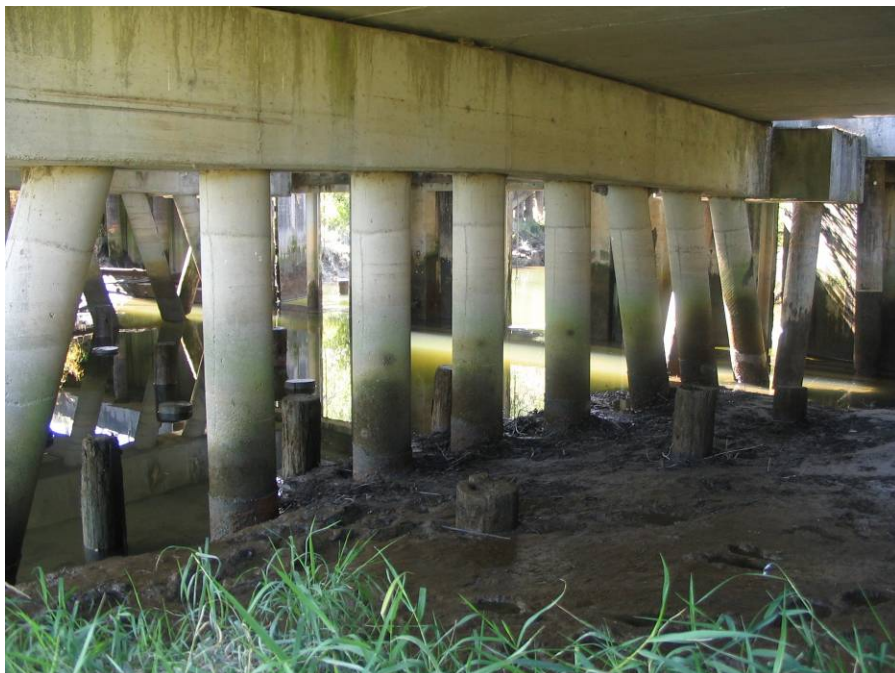
**FS02-Photograph 1: Taken from the north bank of Fisher Slough at the highway bridge looking at the upstream side of floodgates. (Photo taken September 21, 2009)**

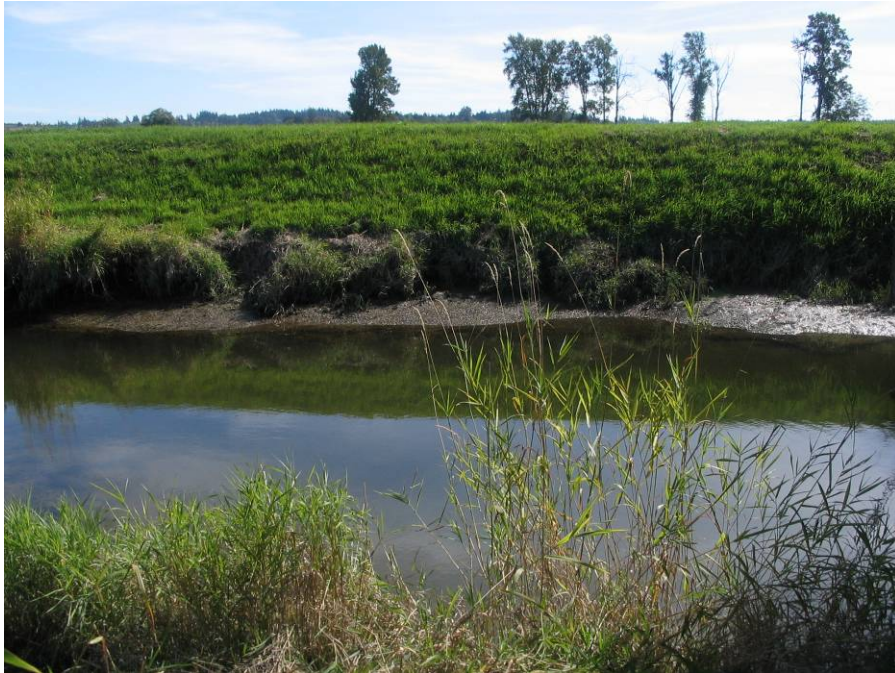
**FS02-Photograph 2: Taken from the north bank of Fisher Slough at the highway bridge looking at the new crossing for Big Ditch at water level. (Photo taken September 21, 2009)**

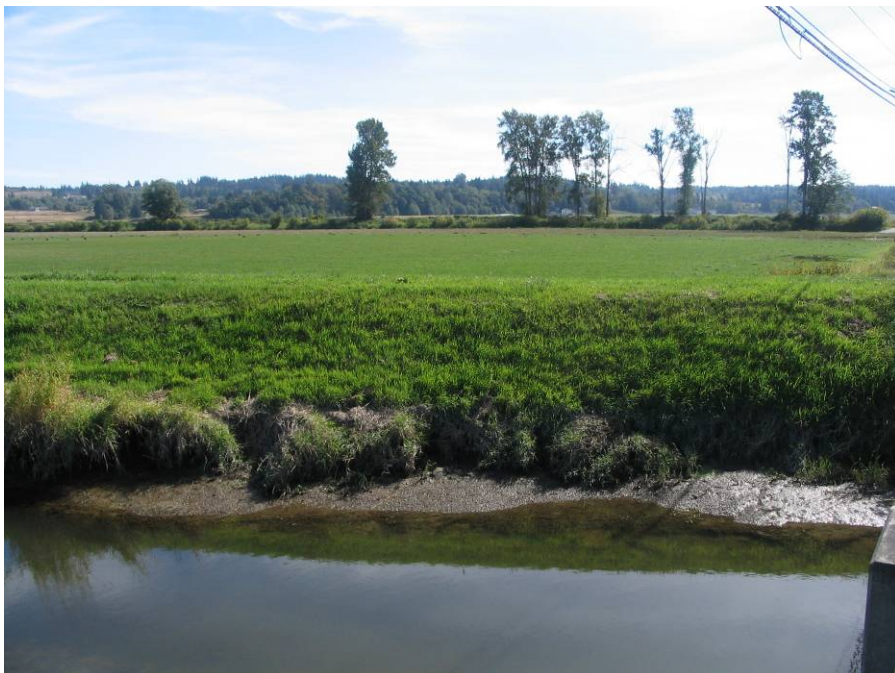
**FS02-Photograph 3: Taken from the highway bridge looking at the new crossing for Big Ditch, the new south levee, and Smith A. (Photo taken September 21, 2009)**

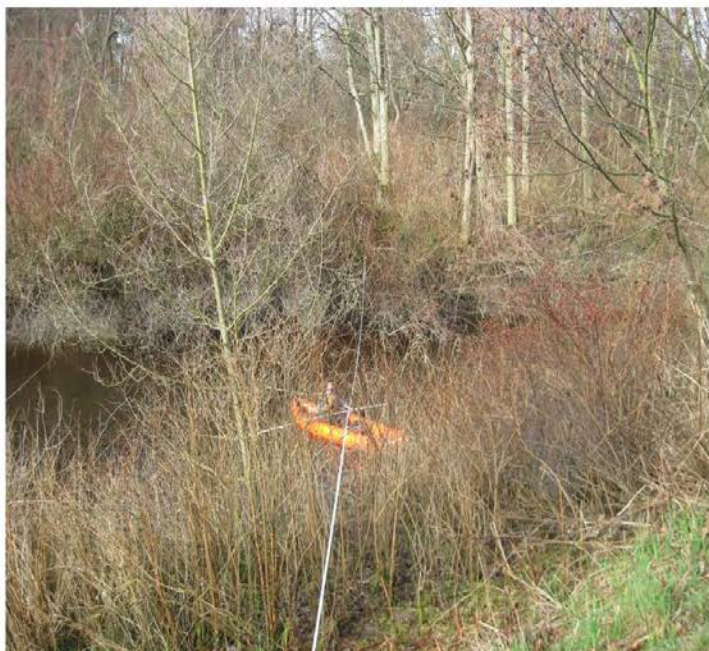
**Figure 6. Looking towards right bank (west) FS-1**

The rock protection observed along the reach extends approximately 50ft upstream of FS-3 and 50ft downstream of FS-2 and is roughly in the locations without willows or tree vegetation along the railroad embankment. The rock size appears to be a D50 of 3ft. During the surveys it was noted that the rock extends out towards the center of the channel, beyond the toe. It is not apparent if this is by design, a relic of construction placement, or from previous loss and launching of material. Overall the embankment is heavily protected by large rock.
