Agricultural Waterway Buffer Study  
Whatcom County, Washington  
2012

## Summary

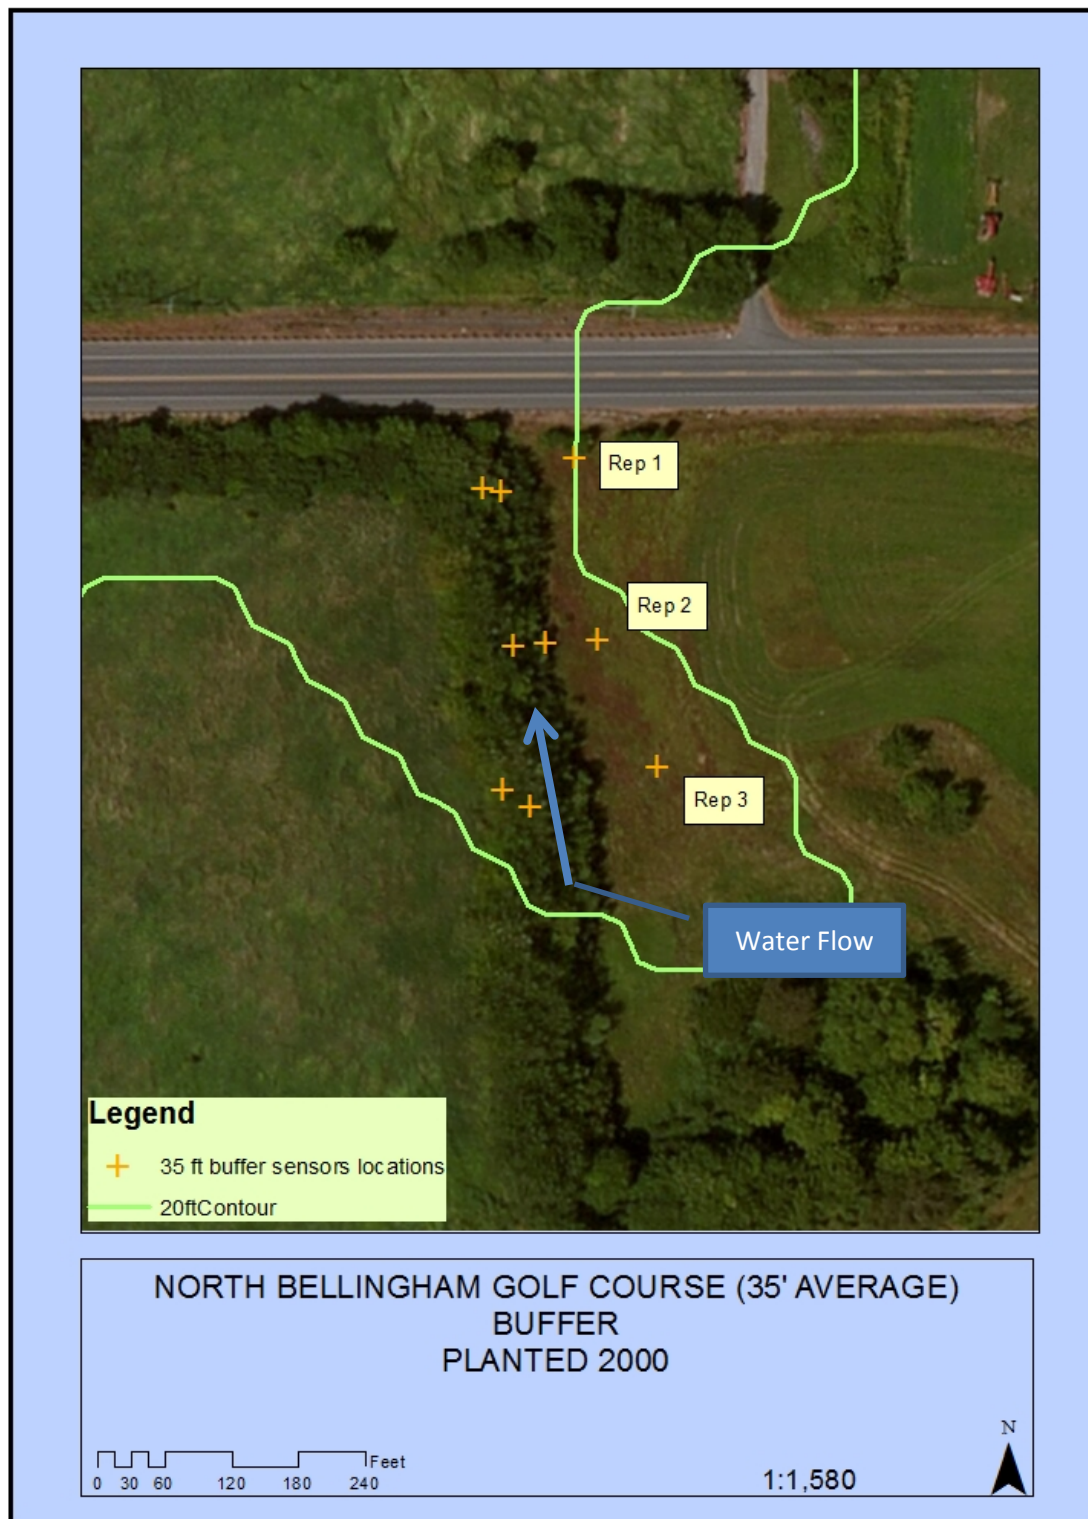
**Appendix 3.** Location of temperature sensors at North Bellingham Golf Course where 35' buffer was located.

the 0' section, and share similar aspects and channel bank steepness. Channel width ranges within each buffer were: 0' buffer (2-5'), 5' buffer (3-6'), 15' buffer (4-8'), 35' buffer (5-12'), 180' buffer (5-13'). All study sites except for the 35' buffer were adjacent to active farm fields. The 0', 5', 15' buffers had either/both silage corn/hayland adjacent. The 35' buffer was adjacent to a golf course, but surrounding vegetation had not been managed in 1-3 years. It should also be noted that all sites with the exception of the 35' buffer had relatively little change in elevation in the surrounding landscape. Just east of the 35' was a 20' increase in elevation ([Appendix 3](#)) which could have impacted air flow.

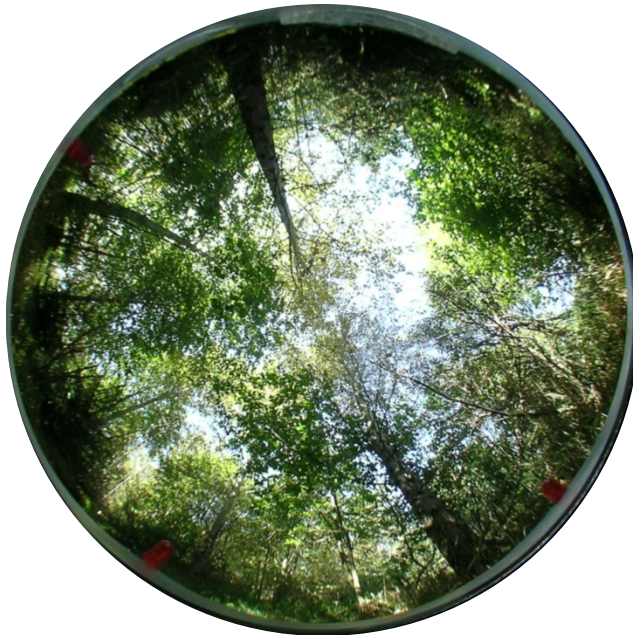
**Appendix 23.** Sample hemispherical Photo from 180' buffer, calculated effective shade of 79%.

Effective shade was calculated by analyzing hemispherical photographs using HemiView<sup>®</sup> software. Photographs were taken on two dates in September and results are included in [Table 8](#). Values were combined across dates. The no (0') buffer had the lowest effective shade percentages ranging from 3-22%. The remaining buffers all had effective shade percentages above 72% and ranked in numerical order (mean percentage): 76% (35' buffer), 80% (180 buffer), 87% (5' buffer), and 88% (15' buffer). Box and whiskers plots (mean, quartiles, and min/max) are included in the appendix ([Appendix 21](#)). Examples of hemispherical photos can be found in [Appendix 22-26](#).

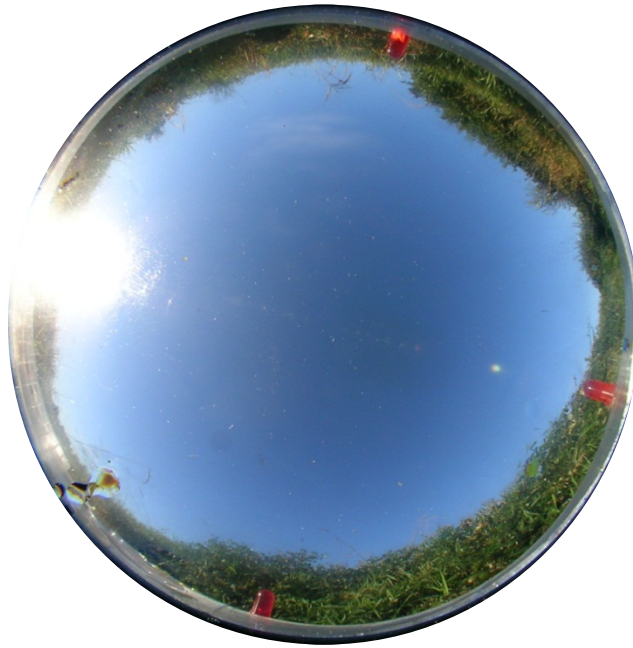
**Appendix 26.** Sample hemispherical Photo from 0' buffer, calculated effective shade of 3%.

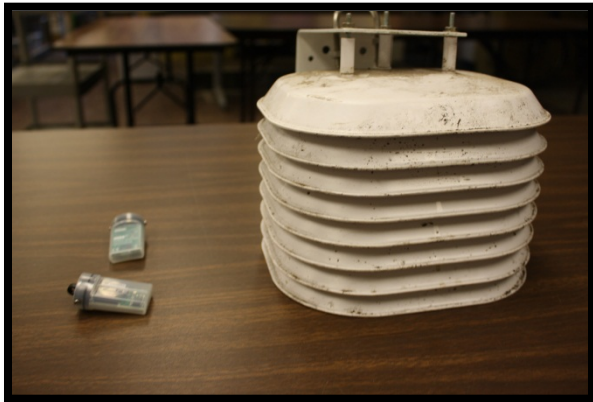
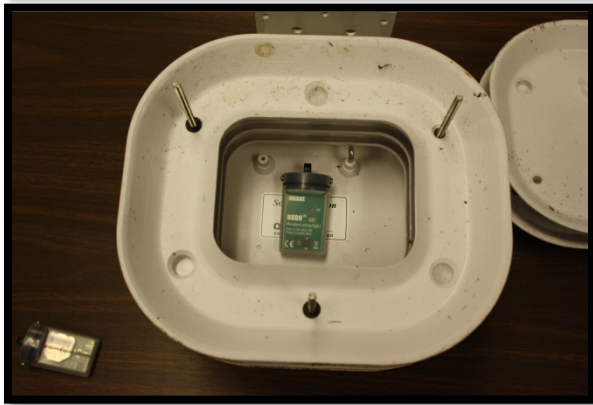
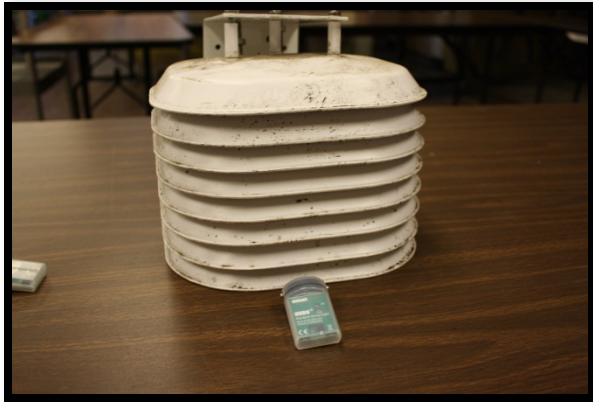
**Appendix 27.** Photographs of sensor and sensor housing.

In this study only air temperature was recorded, water temperature was not included because of available resources. Temperature logging stations were set up by 10 July 2012 and ended on 27 September 2012 for all sites. Temperature data was collected along three transects at each buffer site consisting of three logging stations. Each logging station consisted of one Hobo

Pendant ([Onset® Computer Corporation, Pocasset, MA](#)) temperature logger suspended within a solar radiation shield ([Appendix 27](#)). The stations were staked into the ground on posts three feet above the ground. For each transect; one logging station was placed outside the buffer in an un-shaded area, a second was placed mid-way between the furthest edge of the buffer and the center of the channel, and a third was suspended over the water channel. Data was recorded in 5-minute intervals, uploaded from the data loggers at 30-day intervals, and checked for battery longevity once a month. To evaluate the impact of buffer width on air temperature, data from sensors was compared between (sensor) location within a given buffer width across the replications (5' buffer: outside vs. mid-way vs. overwater). Daily maximum, minimum, and average temperature was calculated and then compared using PROC GLM (SAS, 2002) within each buffer but across sensor location. Before applying the model exploratory data analysis tools were used to describe data variability (e.g. portray data to identify outliers, extreme values, mode, correlation, and test for normal distribution and equal variance).
