# **Stillaguamish Estuary Monitoring Report Summary**

**September 2013 – July 2014**

Field monitoring of biophysical conditions

Western Washington University

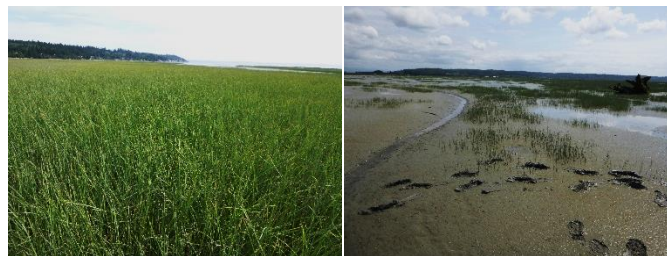
**Figure 13.** Examples of threesquare bulrush marsh. The left is dense, middle elevation (~1.8-2.7m) marsh with an average height exceeding 100cm. The right is the extreme low elevation (~1.1-1.5m) marsh that rarely reaches 50cm and grows very sparsely.

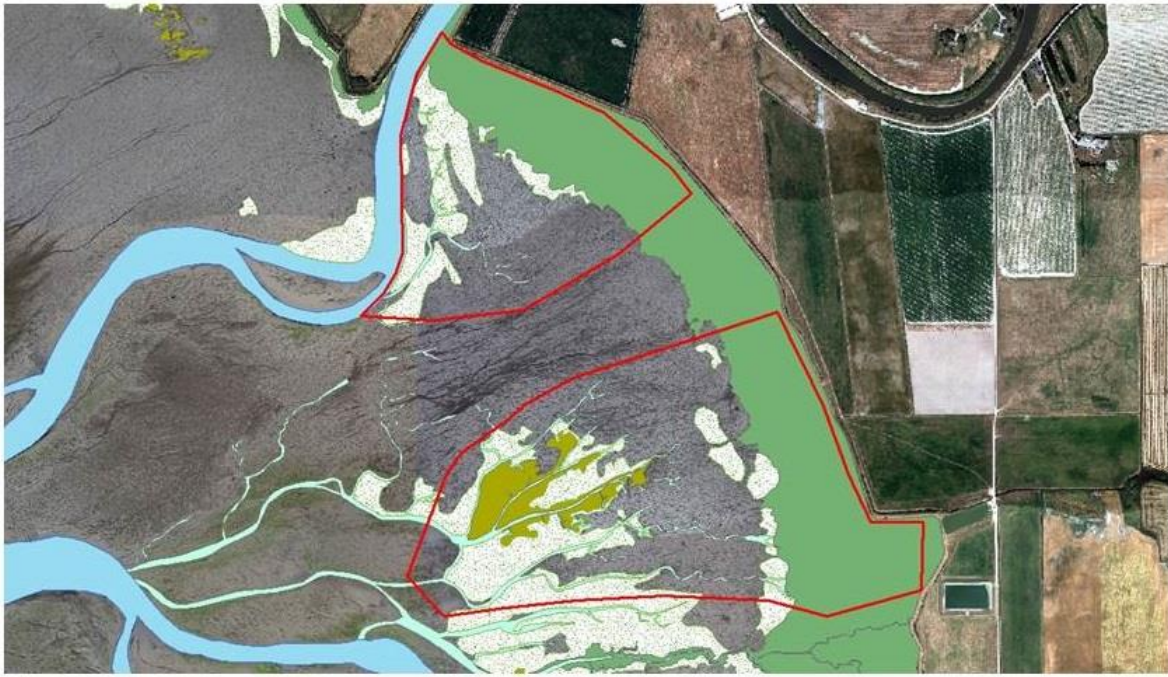
**Figure 13.** In the northern estuary, the low elevation, low density marsh (stippled white polygons) are separated from the higher elevation continuous marsh (green polygons) by bare tide flat. This is the 2013 habitat delineation.

Zone 4 decreased slightly until 1933 but then grew very rapidly through 1990 at an average annual rate of 20m/year. Since 1990 most of the growth was reversed and marsh width declined at an average rate of 40m/year. It should be noted that these numbers are for the continuous marsh category. Some of the lost continuous marsh in zone 4 was undetectable in the 2011 aerial but was detected in the 2013 aerial as low density marsh (Figure 13 and Figure 2) which is not represented in this analysis.

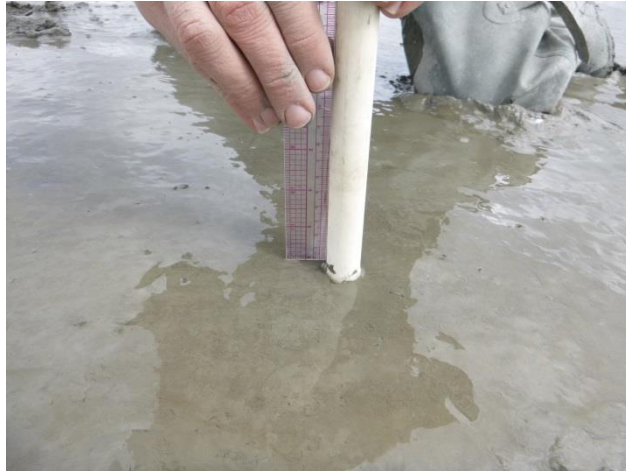
**Figure 1.** Position of the ruler next to the stake, so that any scour or compression of the sediment surface next to the stake is avoided during measurement.
