# Assessing bulkhead removal and shoreline restoration using boat-based lidar

Hannah Drummond, Heather M. Weiner, George M. Kaminsky, Diana McCandless, and Amanda Hacking  
Washington State Department of Ecology

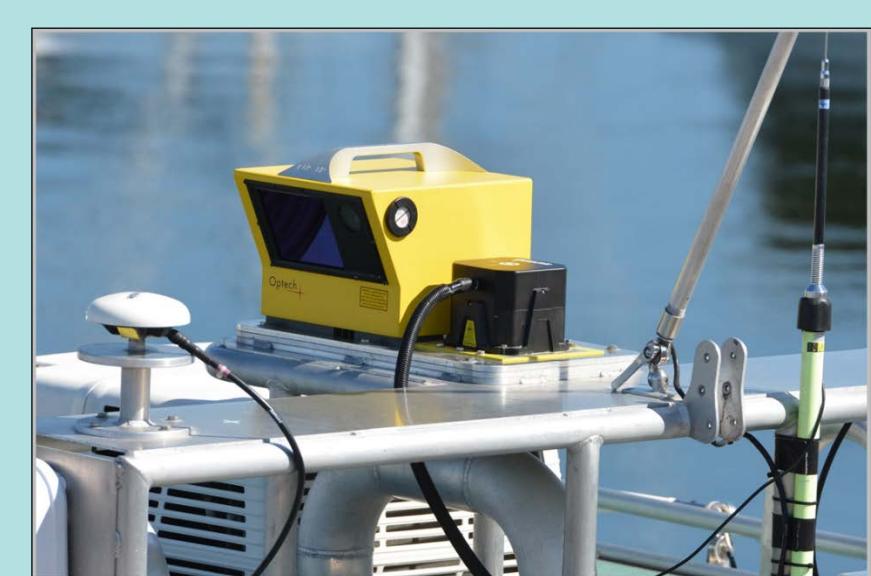
Boat-based topographic lidar surveys were conducted in Sept. 2015, about a year before removal of the shoreline armor, and June 2017, almost eight months following removal. Each survey involved the collection of boat-based lidar along 5 km of shoreline using Real Time Kinematic (RTK) corrections. Surveyors on foot set up lidar targets for ground truthing and collected photos for digital grain-size analysis. High-resolution shoreline photos were also taken during each shoreline scan to aid with point cloud cleaning.

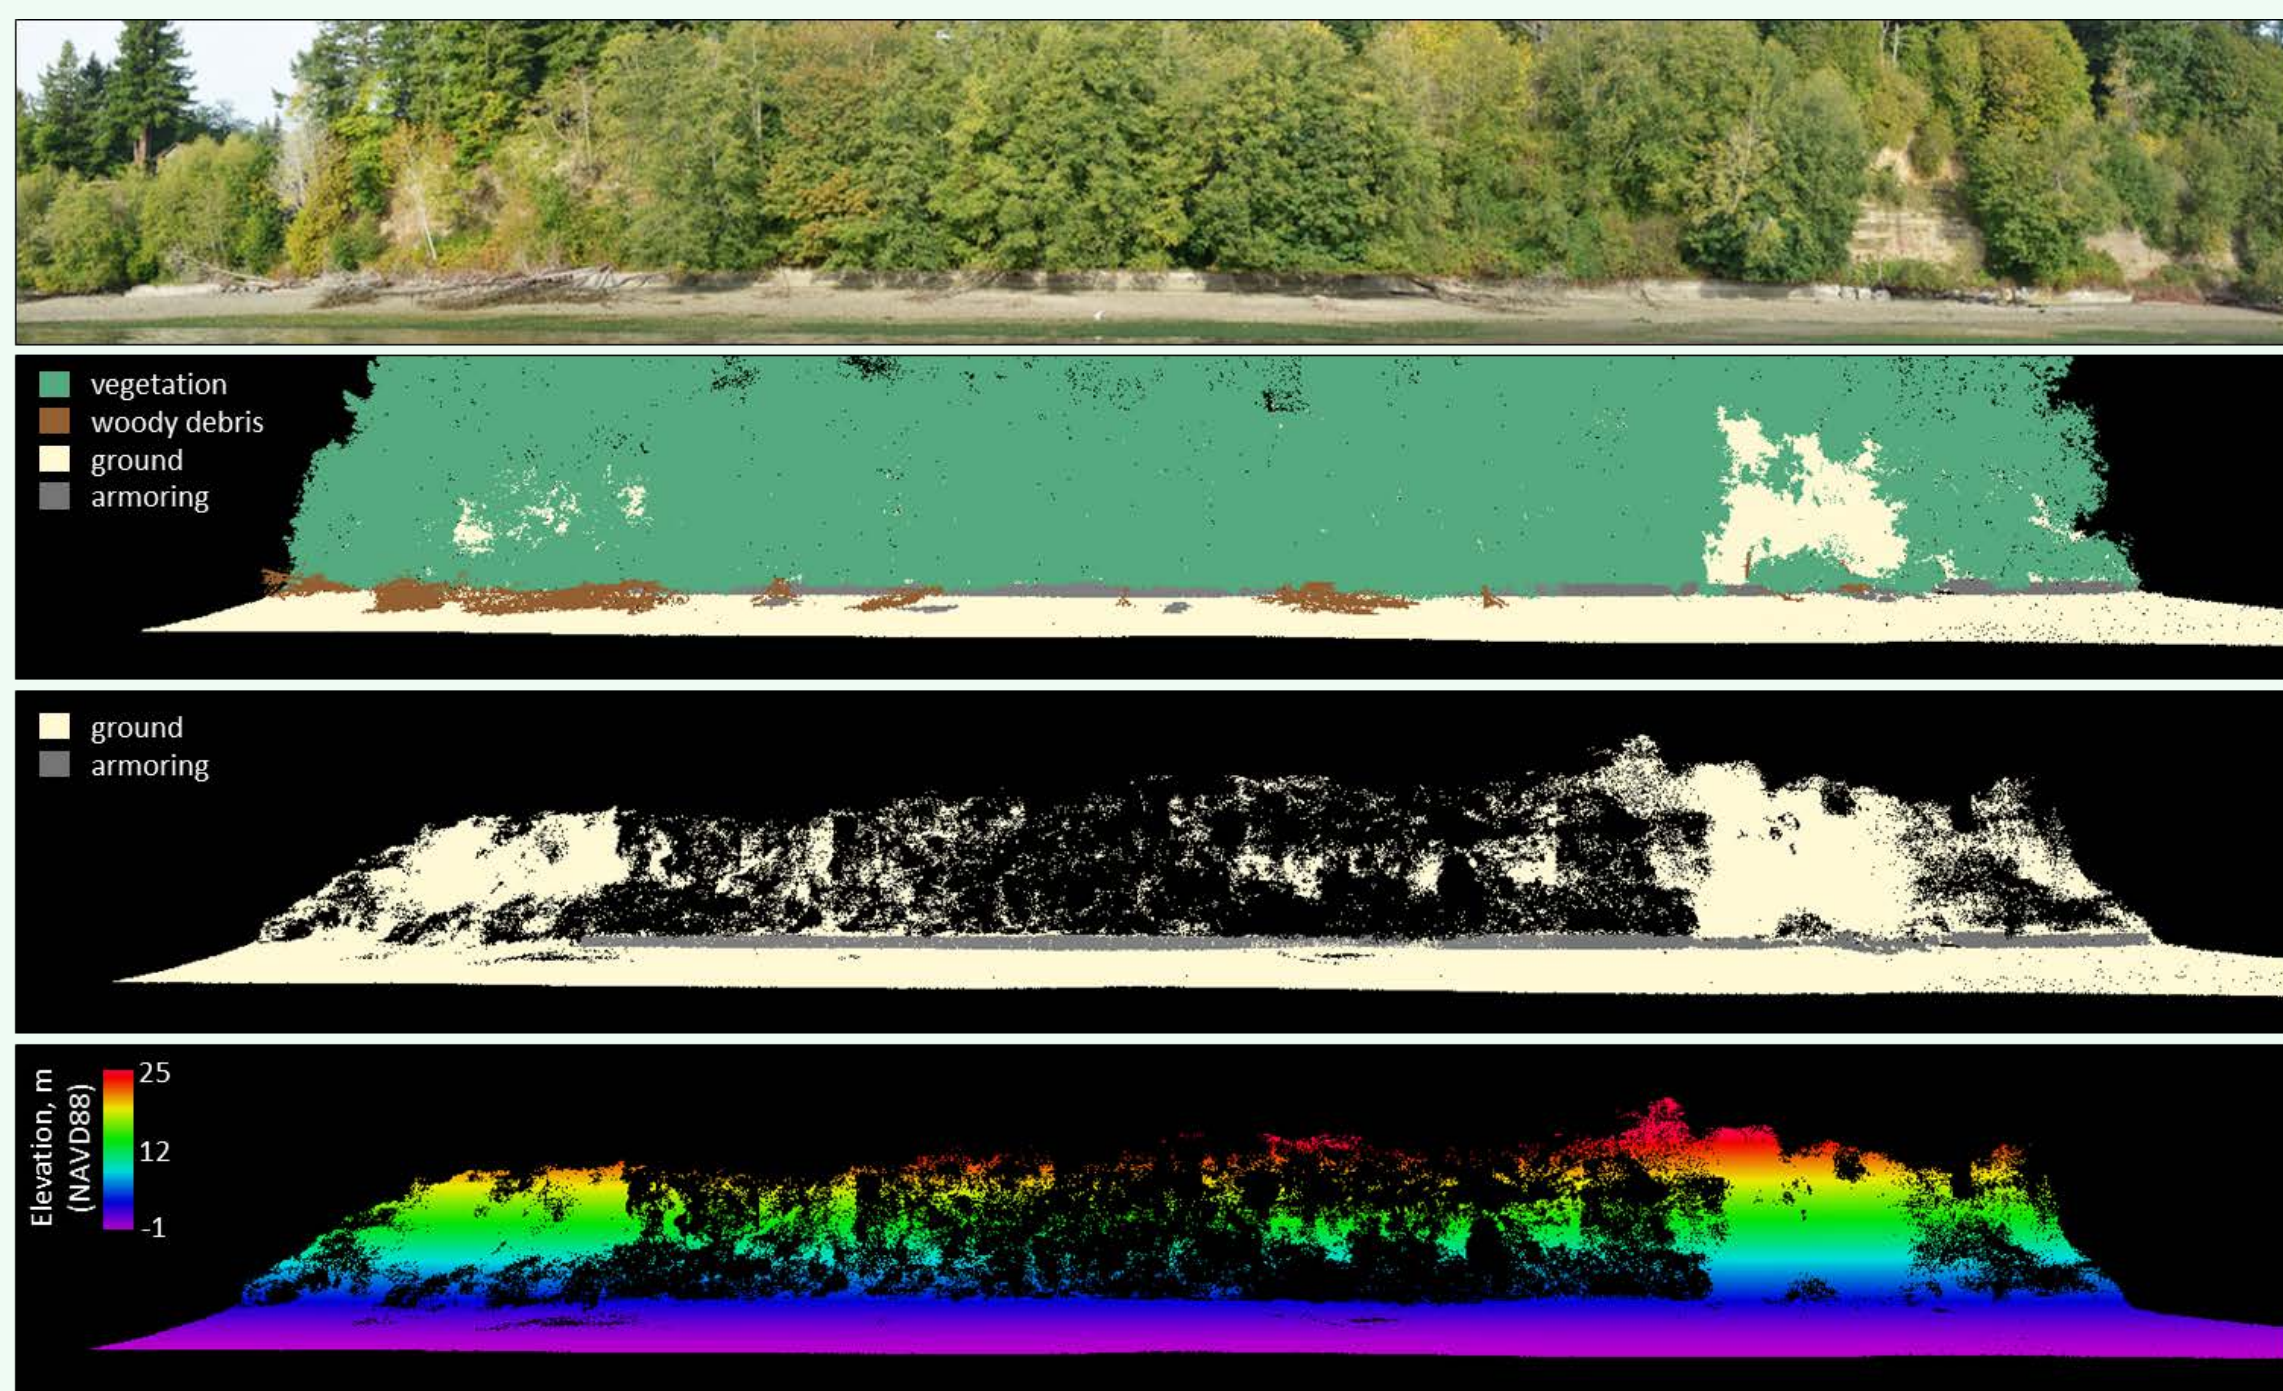
Pre-restoration (2015):

## Lidar Point Cloud

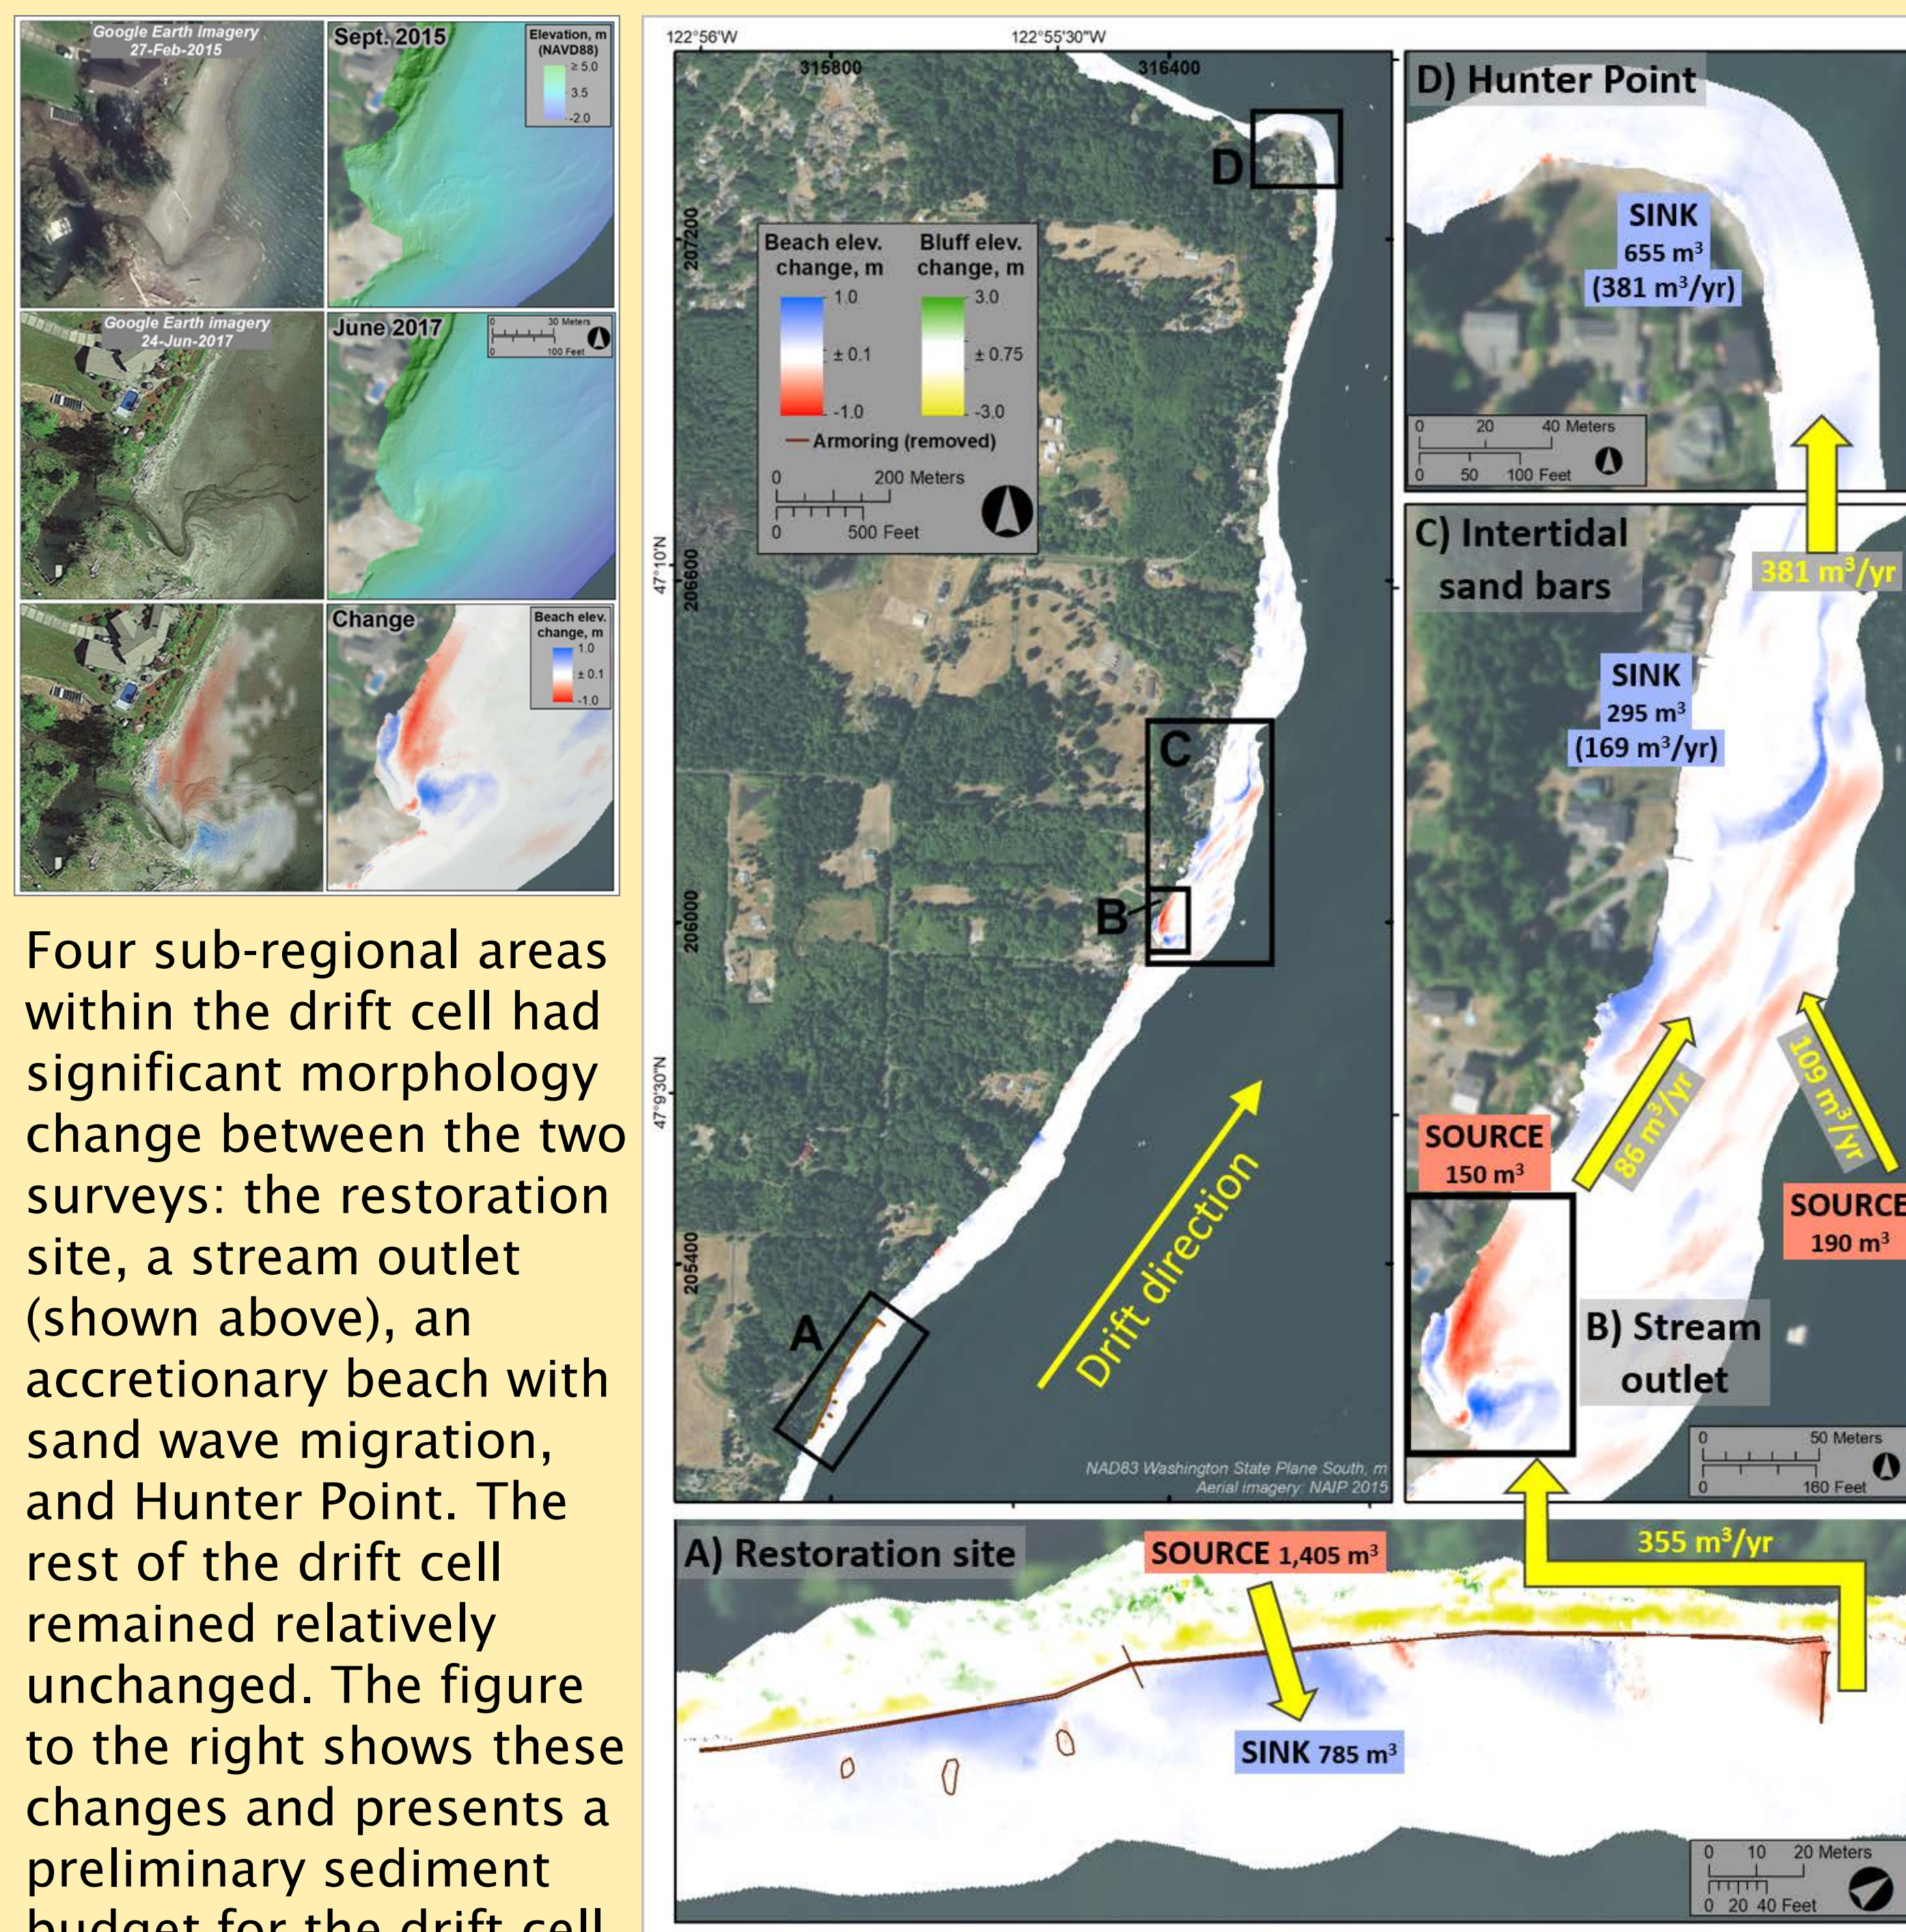
A difference surface is created by subtracting the digital elevation model (DEM) of the post-restoration survey from the baseline survey DEM, and is used to quantify morphology changes on the beach and bluff.

Four sub-regional areas within the drift cell had significant morphology change between the two surveys: the restoration site, a stream outlet (shown above), an accretionary beach with sand wave migration, and Hunter Point. The rest of the drift cell remained relatively unchanged. The figure to the right shows these changes and presents a preliminary sediment budget for the drift cell. The feeder bluff restoration accounts for 65% of the downdrift sediment accumulation, while the stream mouth and nearshore contribute 15% and 20%, respectively.

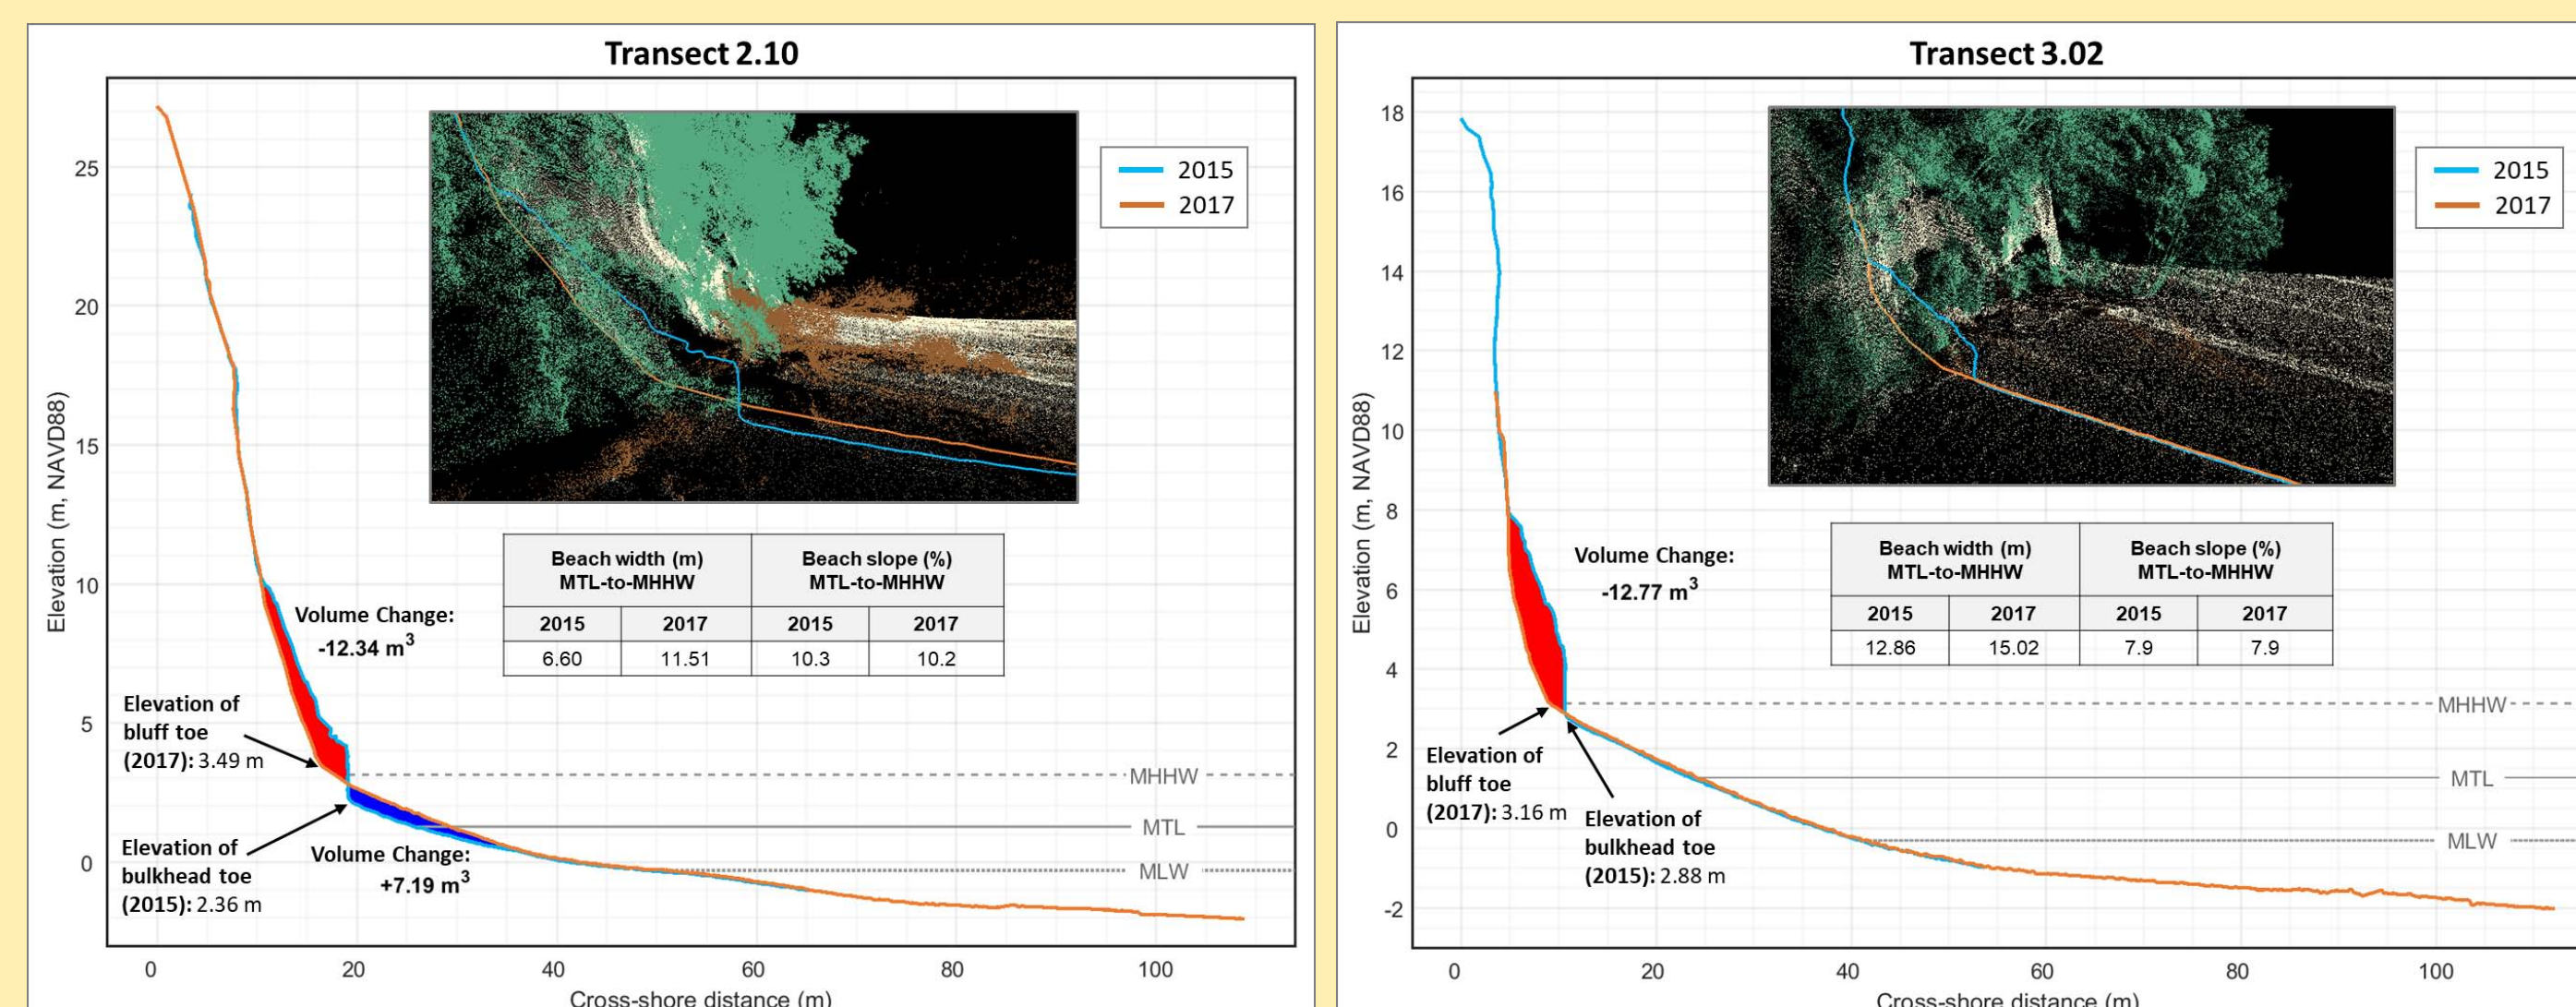
Profiles were extracted from the pre- and post-survey lidar point clouds and plotted together to show morphology and volume change.

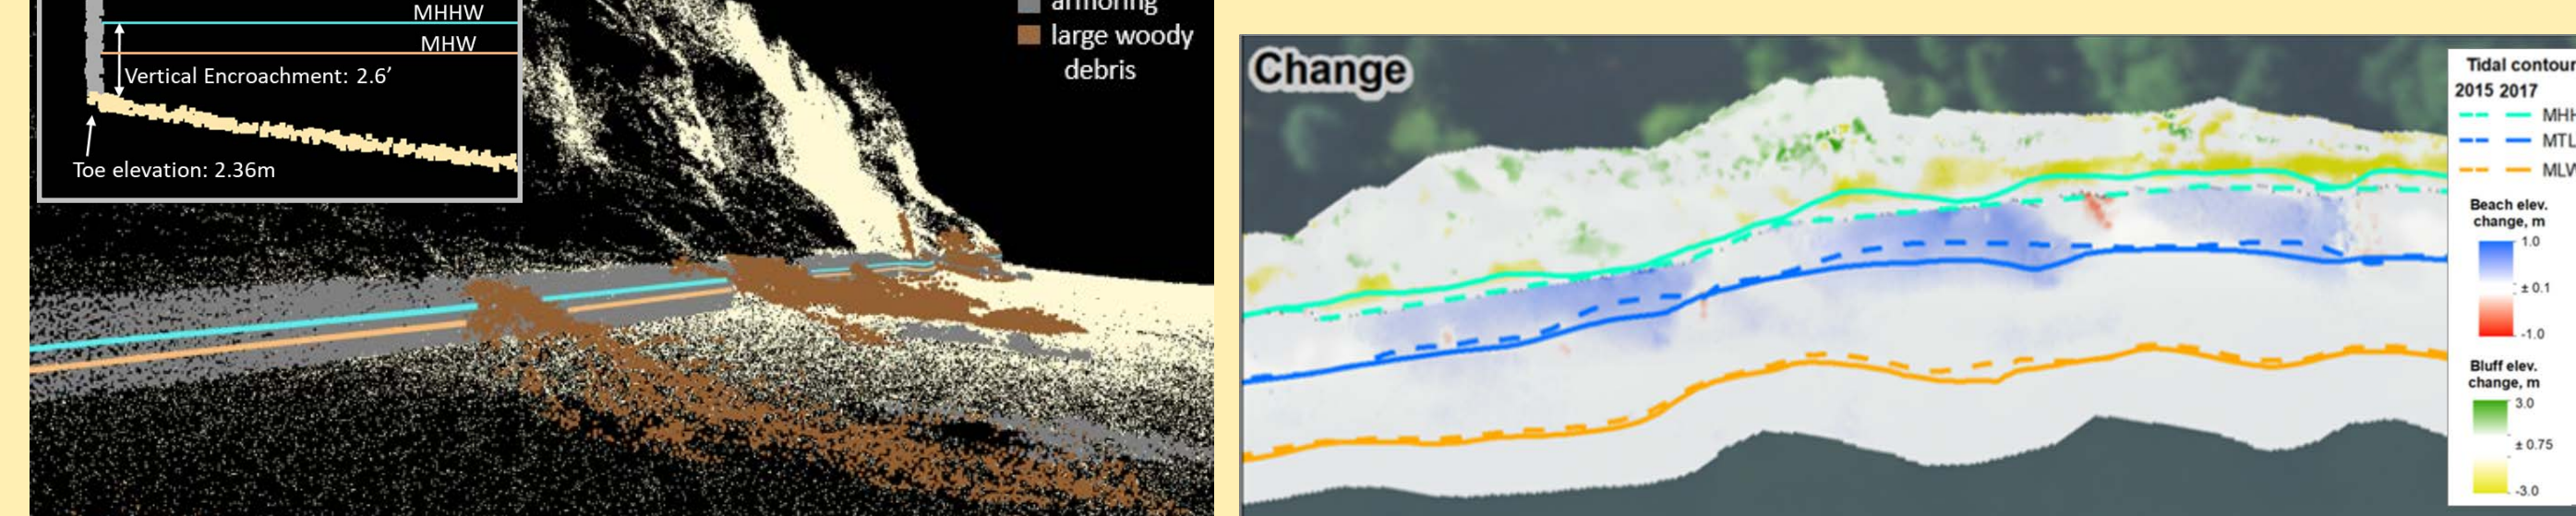
Below, the water levels plotted on the bulkhead face in the point cloud show how it had encroached on the upper beach (bulkhead toe averaged 2.0 ft below MHHW over the length of the armoring). The upper beach width increased by 3.6 m, on average, as shown on the difference surface (right).

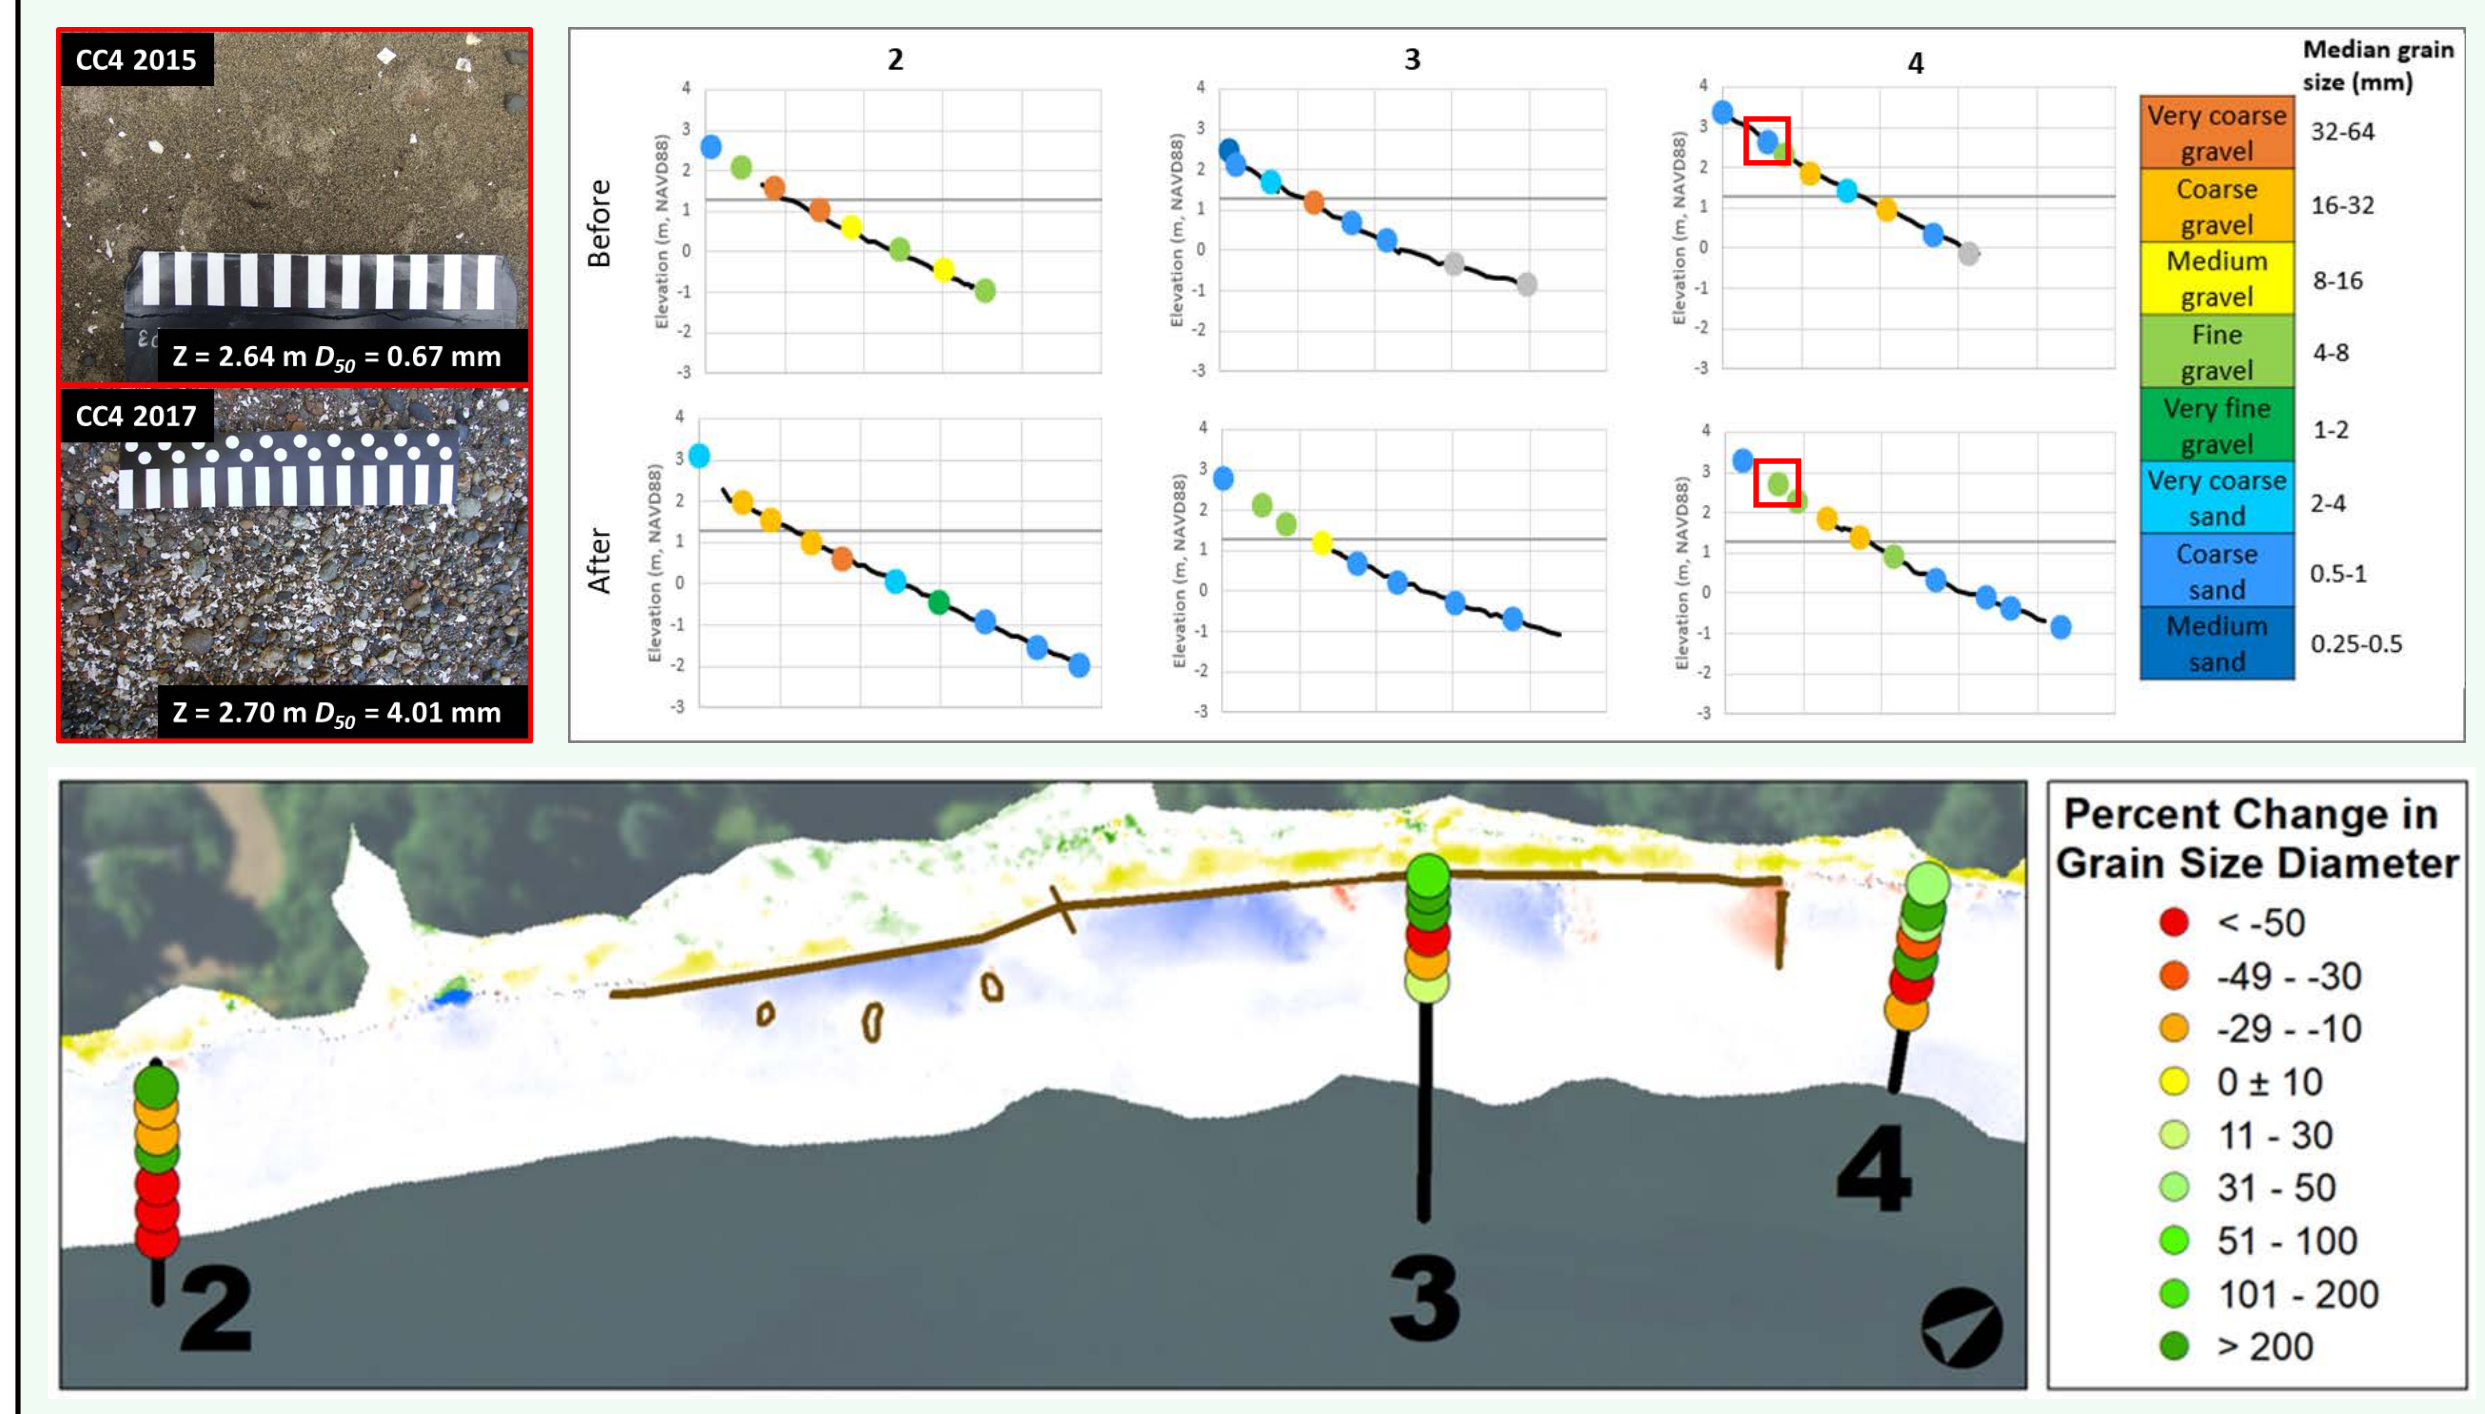
A digital grain-size analysis tool known as “cobble cam” was used to collect sediment grain-size data at 0.5-m elevation intervals along 5 transects in and adjacent to the restoration site. Cobble cam photos from Transect 4, down drift from the restoration, and changes in grain size for Transects 2-4 are displayed below:

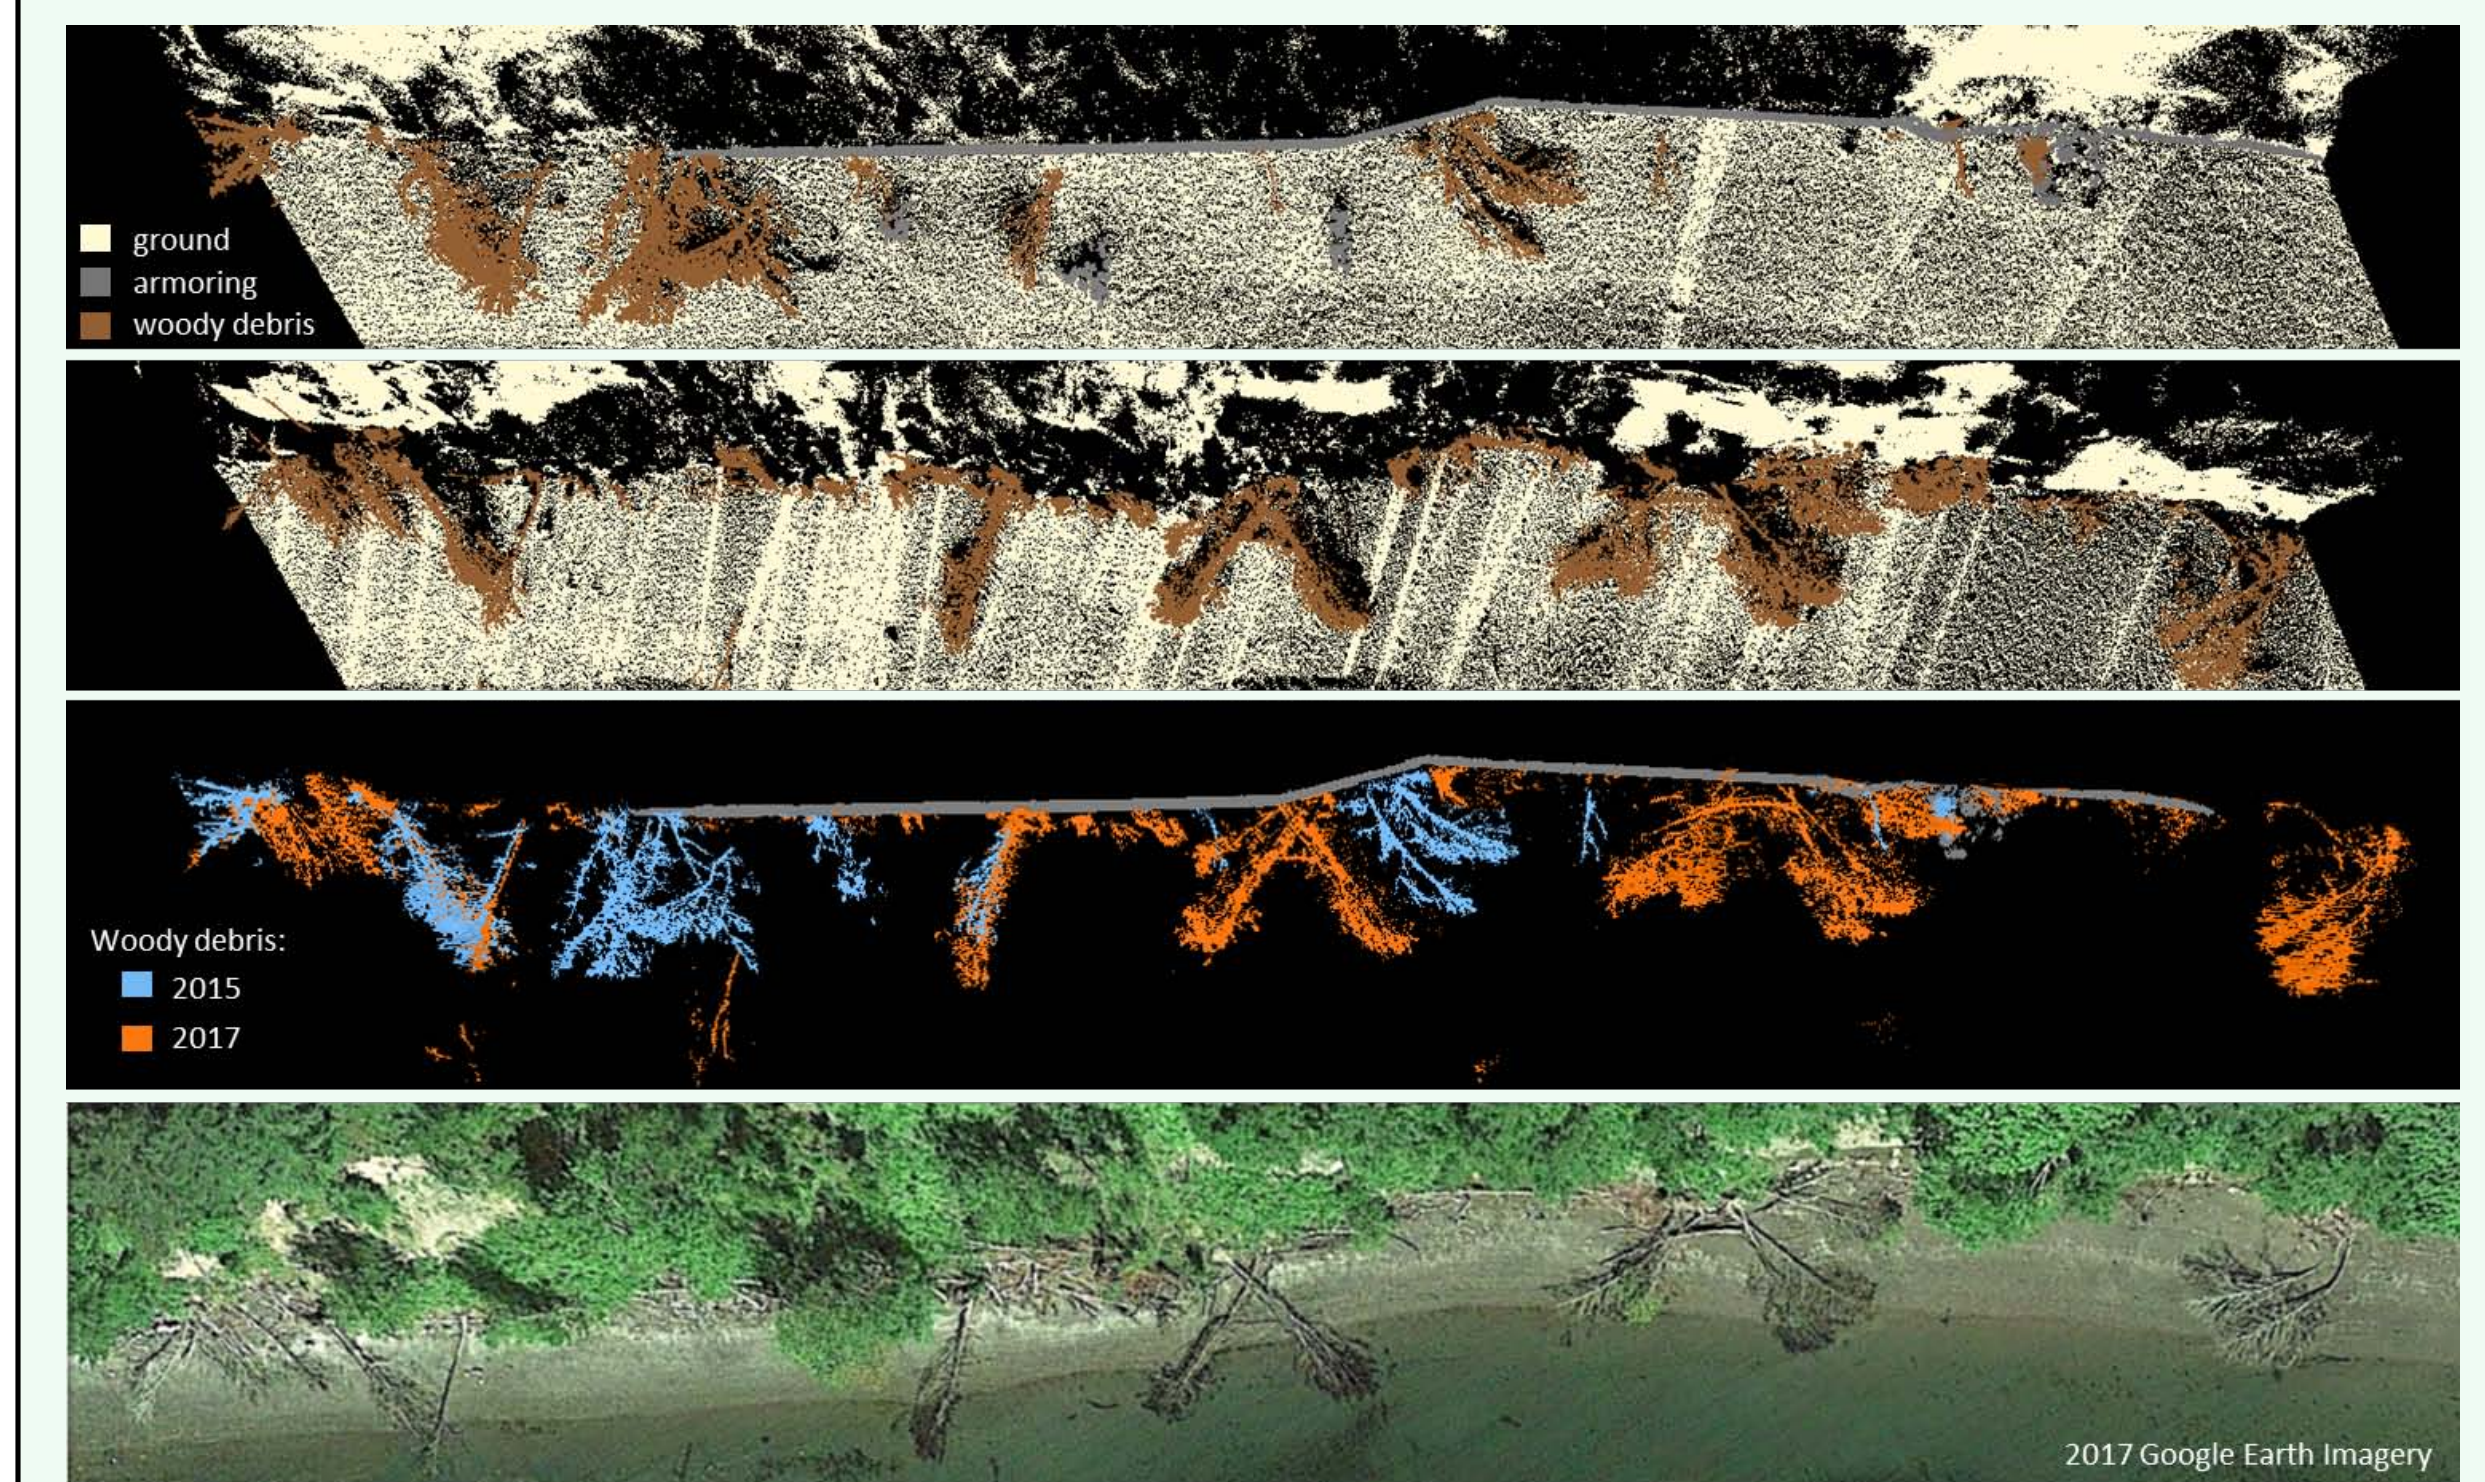
The beach area covered by large woody debris found seaward of the bulkhead at the project site was calculated for each survey, and indicates an 81% increase post-restoration. The classified point cloud and 2D area used for calculations are shown below:
