# **HABITAT RESTORATION OPTIONS**

## **Canyon Creek Alluvial Fan Habitat Restoration**

Whatcom County Public Works

October 2007

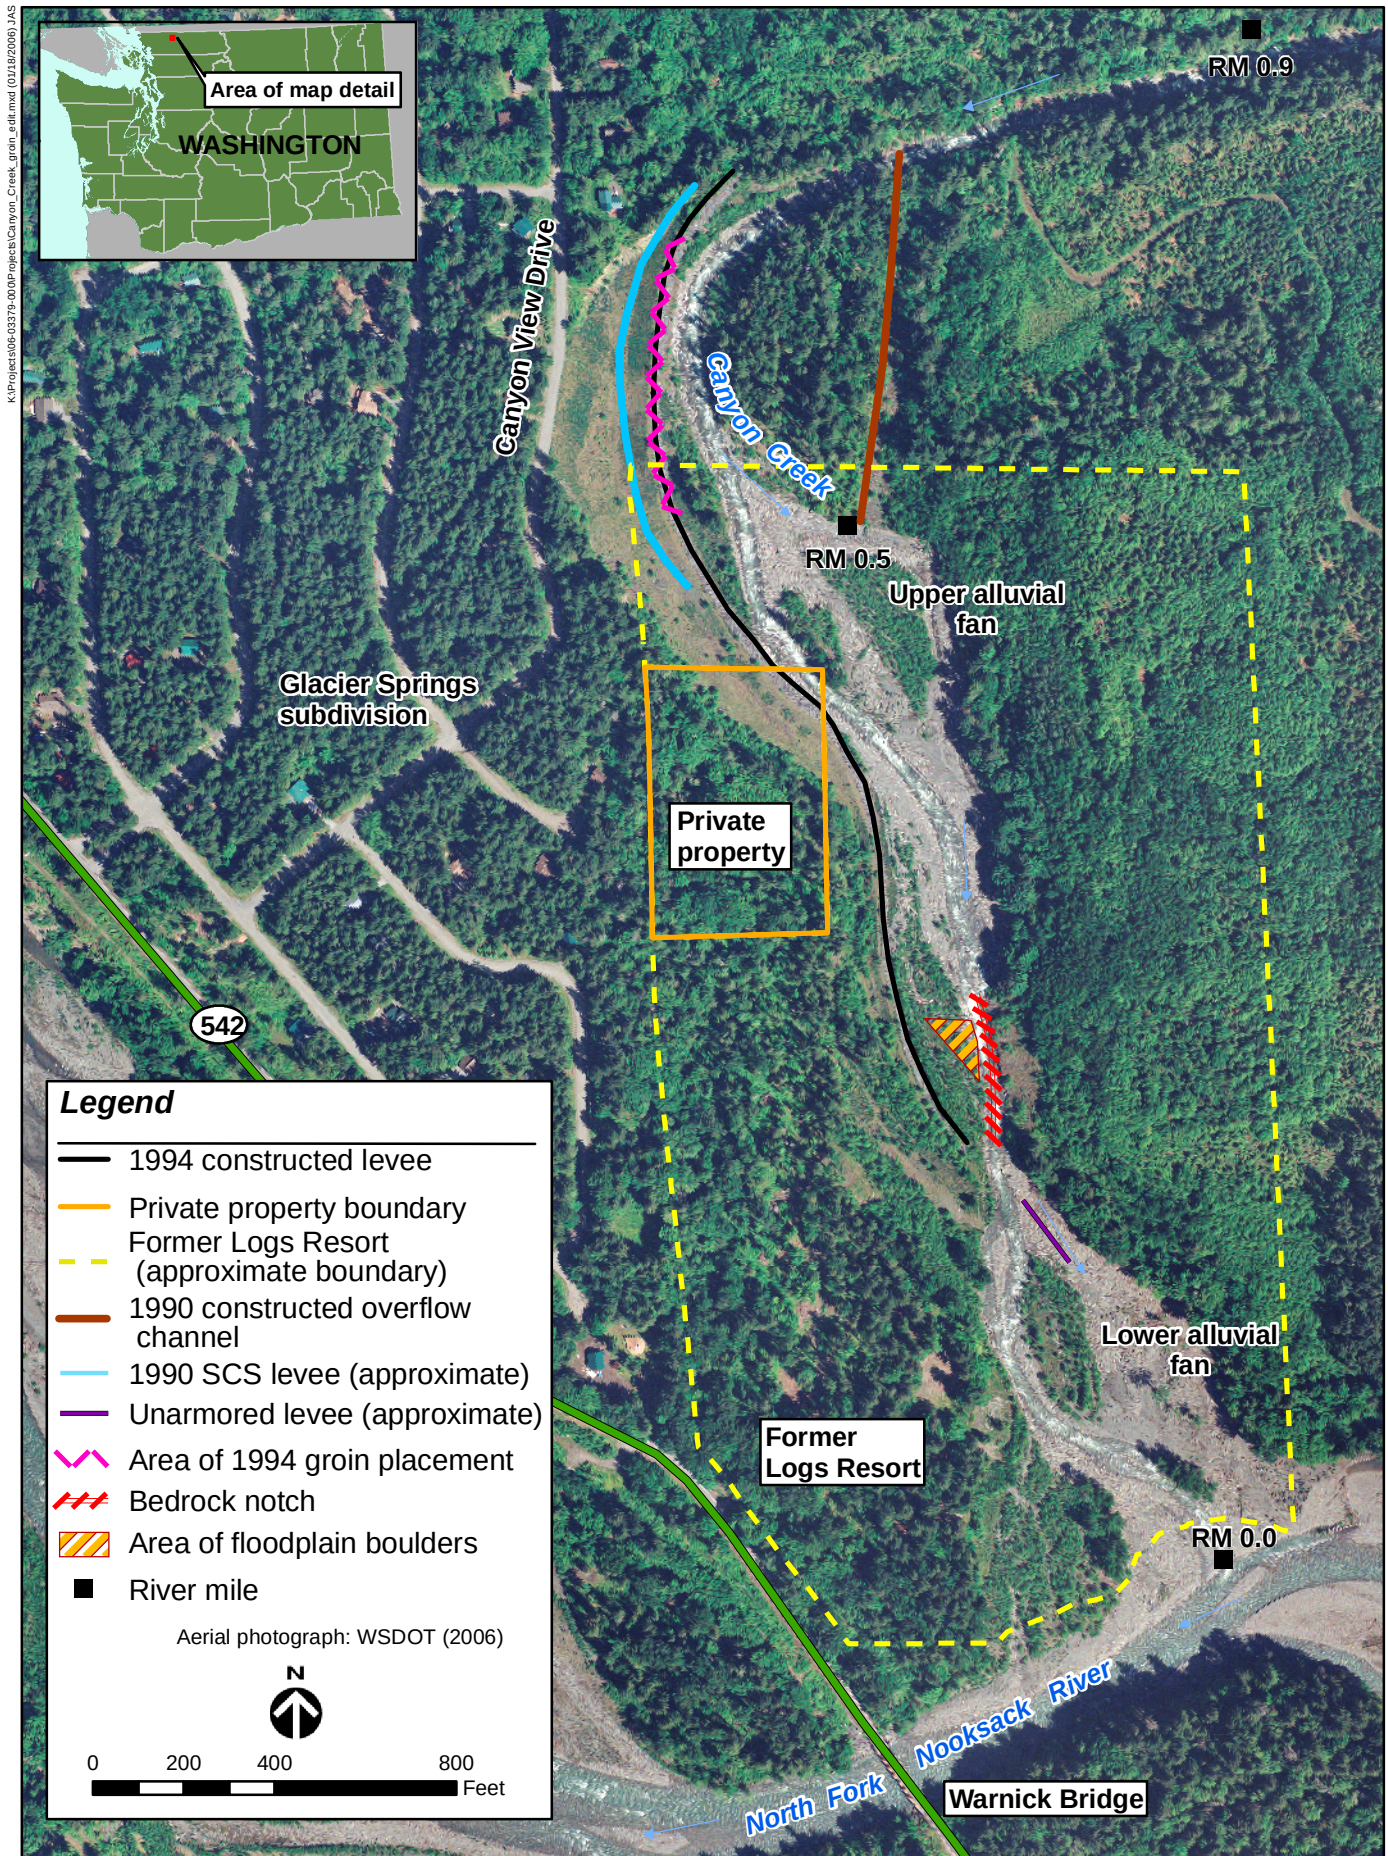
Figure 1. Vicinity and project reach for the Canyon Creek alluvial fan habitat restoration.

Another measure that was implemented in 1994 as part of Option 4 was the blasting of a bedrock outcrop between RM 0.2 and RM 0.3 (Figure 1) to create a “notch” in which the creek would be restricted to prevent its migration across the alluvial fan toward the Logs Resort. This notch is located where the levee constricts the floodplain and channel migration zone (CMZ). The placement of large (5-foot diameter) boulders on the floodplain between the levee and the bedrock notch further constrained the creek flows to the bedrock notch (reducing the effective width of the CMZ to less than 50 feet). This represents a decrease of approximately 66 percent (from 450 feet to 150 feet) in available channel width during flood flows. As evident by the channel alignments since 1994, the channel has not migrated from this notch, and there is an hour-glass constriction of the channel at this location (Figure 2).

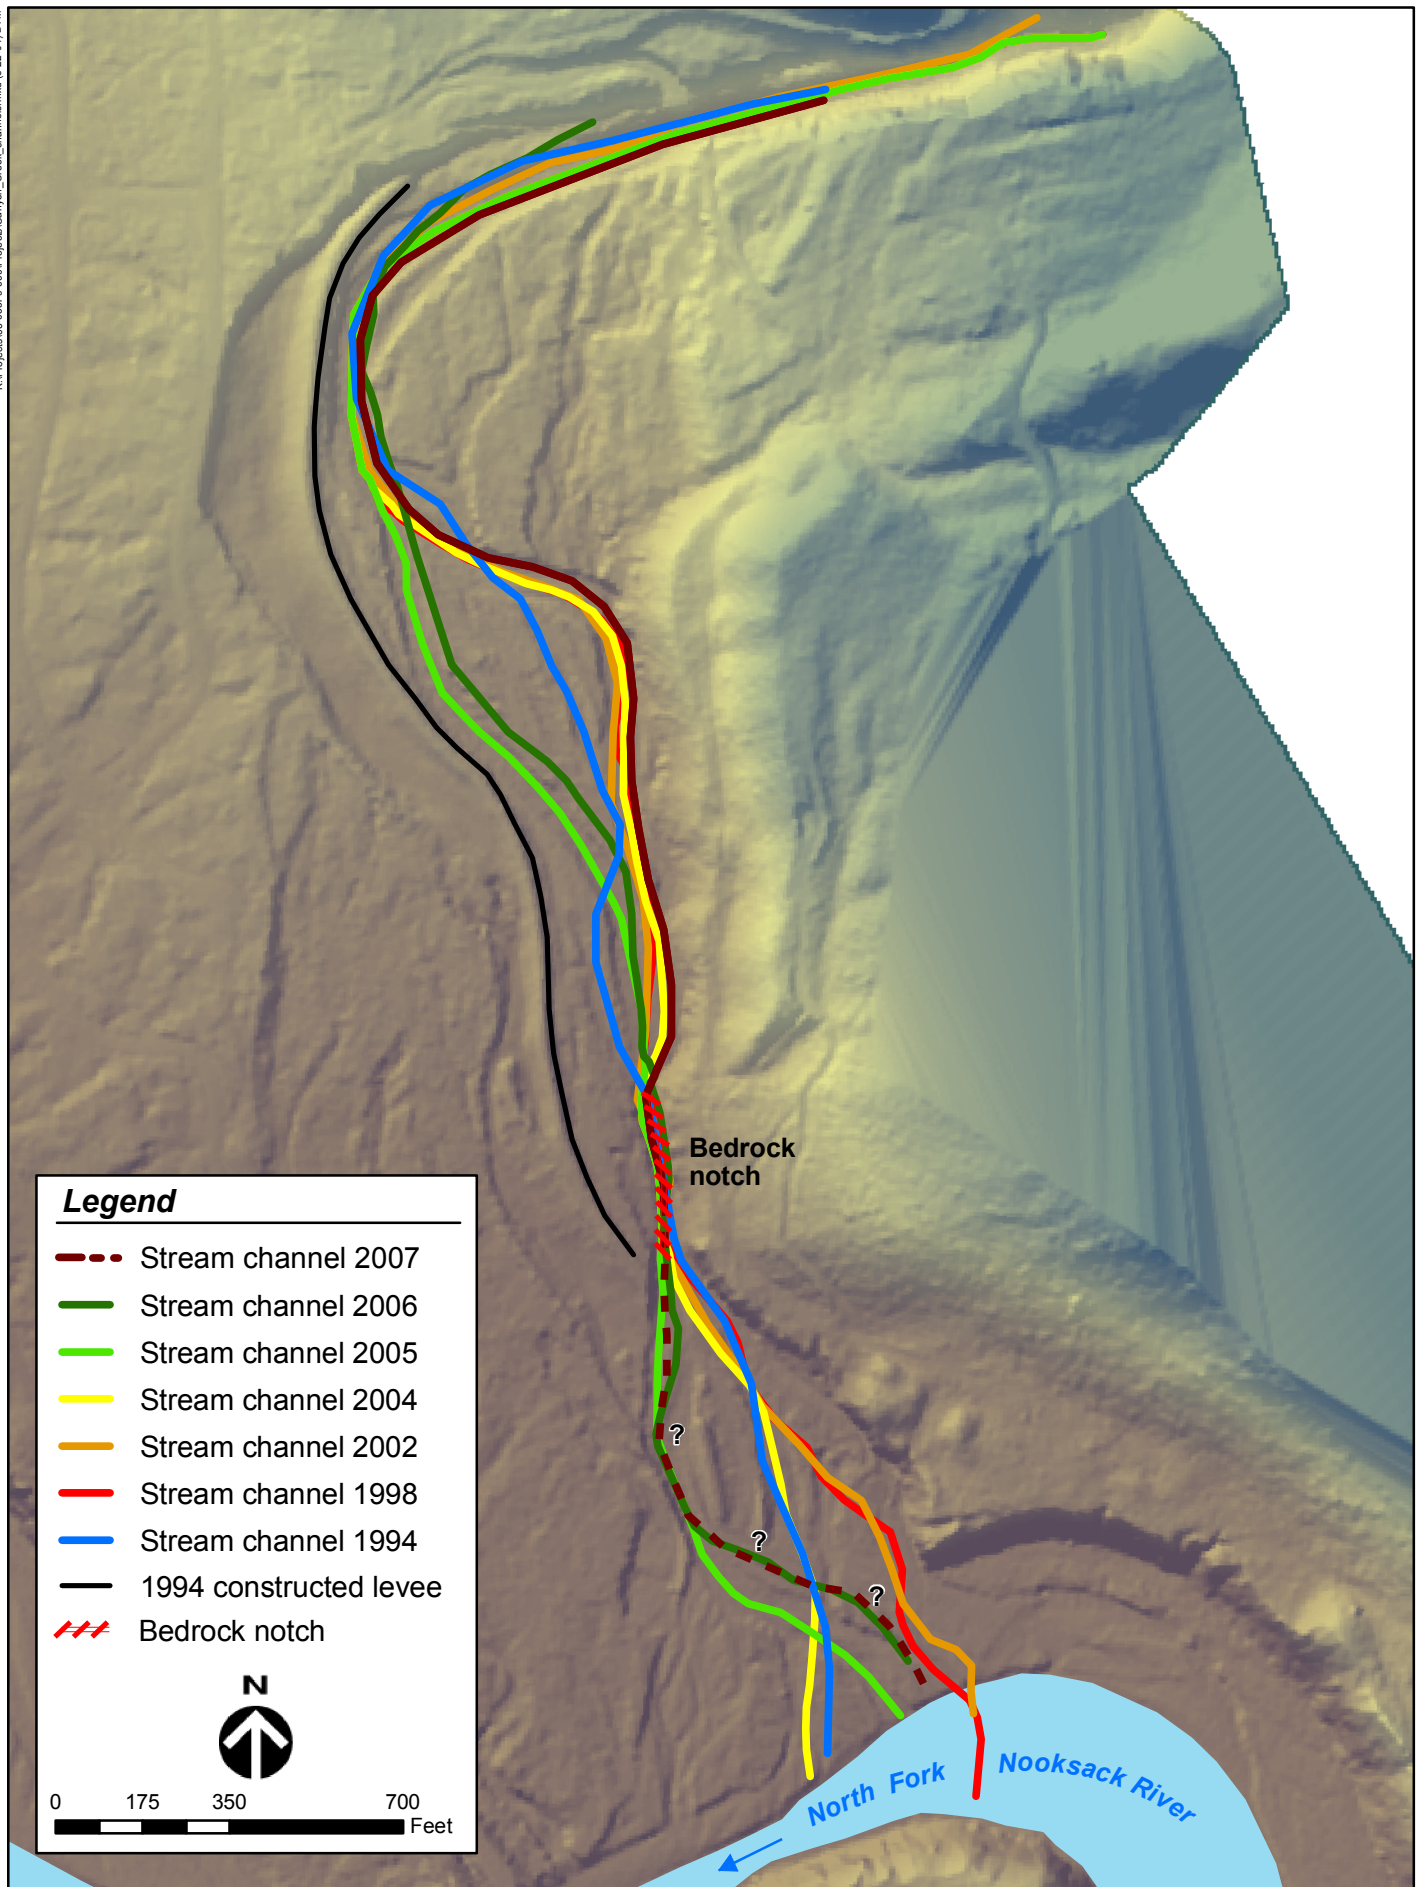
Figure 2. Channel alignments of lower Canyon Creek between 1994 and 2007.

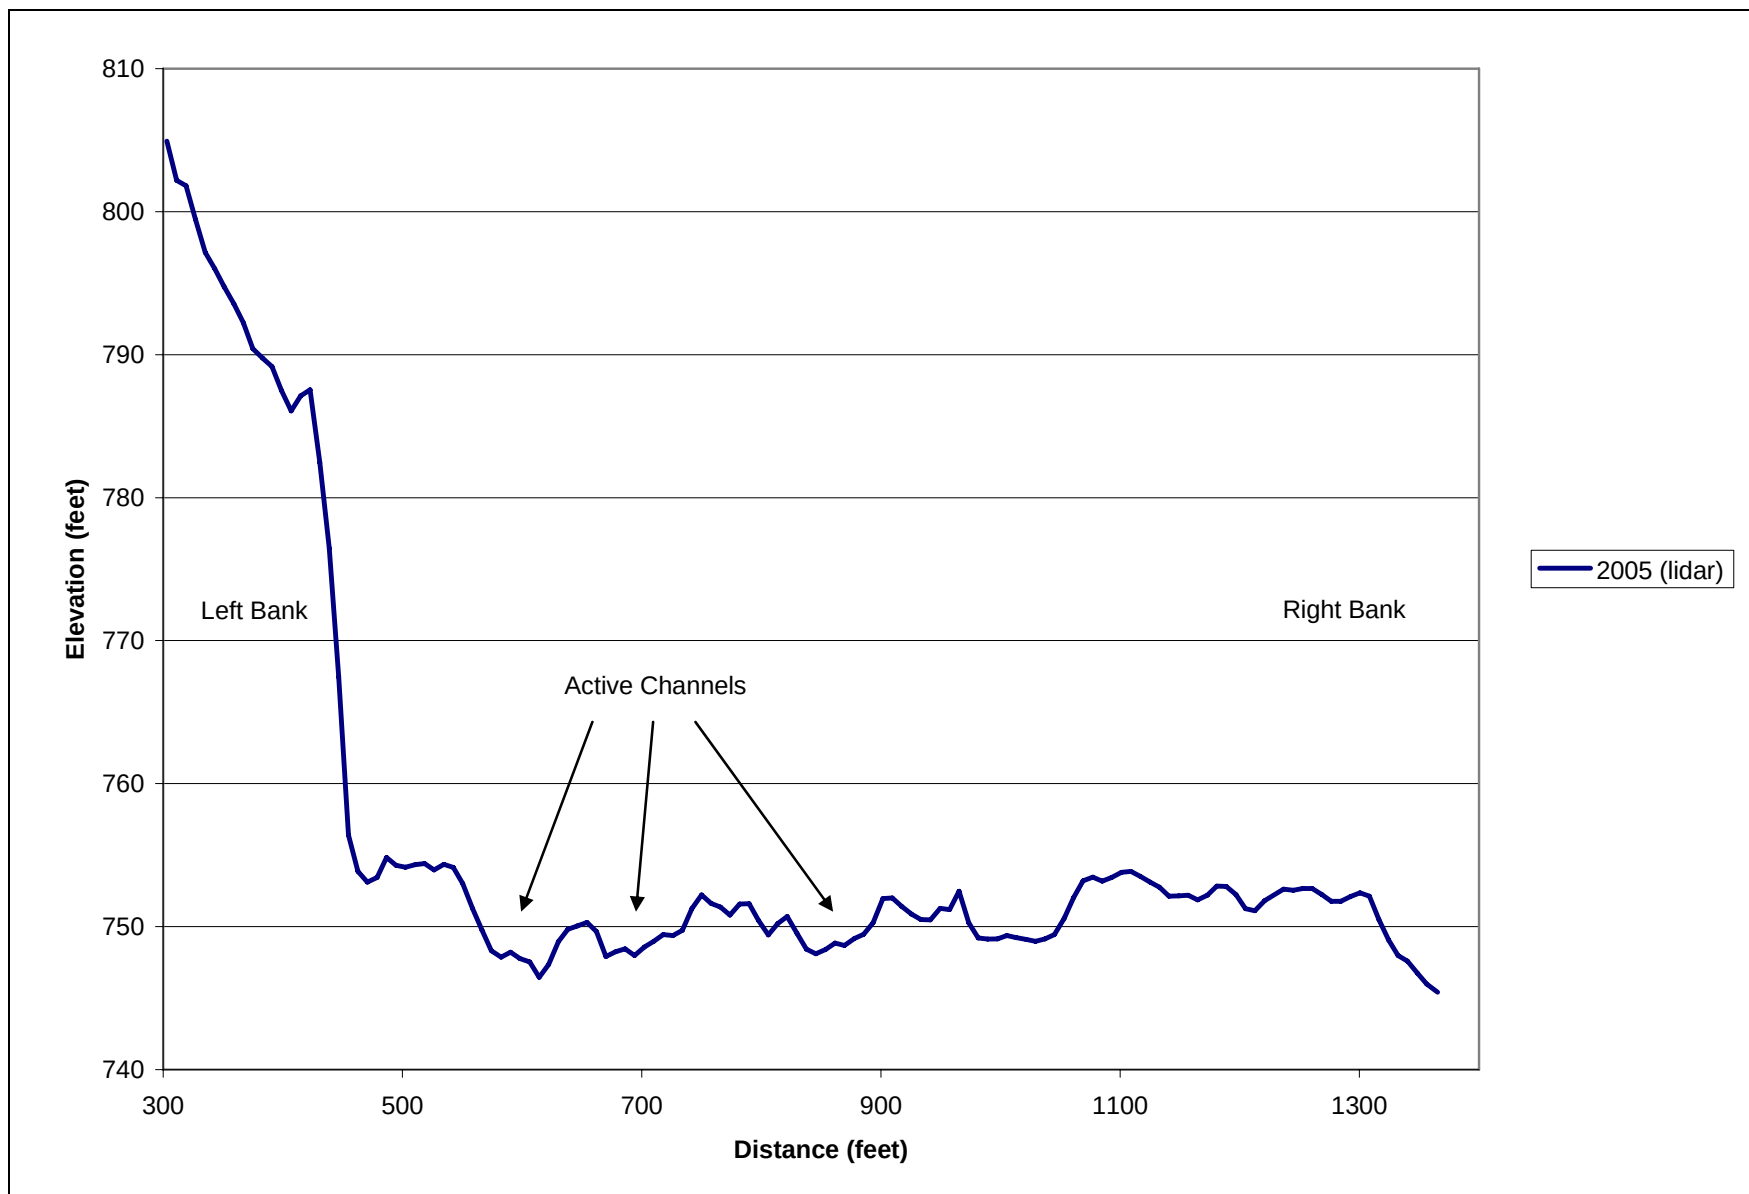
**Figure 3. Cross-section of segment 1 of the project reach in lower Canyon Creek at river mile 0.09.**

Segment 1 (the lower alluvial fan) extends from just below the bedrock outcrop to the mouth of Canyon Creek at its confluence with the North Fork Nooksack River. The average active channel width is approximately 400 feet, with a channel slope of 3.1 percent (based on 2005 LiDAR data) (Figure 3) (Appendix A, photos 2 and 3). The channel alignment within this segment switches in response to flow conditions, sediment load and transport, and the alignment of the North Fork Nooksack River. The North Fork Nooksack River is currently aligned along its left bank opposite the mouth of Canyon Creek, at the base of a steep bluff (remnant of the Church Mountain slide) just upstream of the Warnick Bridge. According to the photographic record and LiDAR data, the North Fork Nooksack River has shifted its channel location at the foot of the Canyon Creek alluvial fan. These shifts are often in response to large debris flood events issuing from Canyon Creek wherein the fan progrades into the North Fork Nooksack River forcing the river towards its left bank. As sediment production wanes from Canyon Creek in subsequent years, the North Fork is able to transport this fan material downstream and migrate laterally toward Canyon Creek. The LiDAR data indicate one historical meander of the North Fork Nooksack River along the right bank, where it cut into the lower alluvial fan.

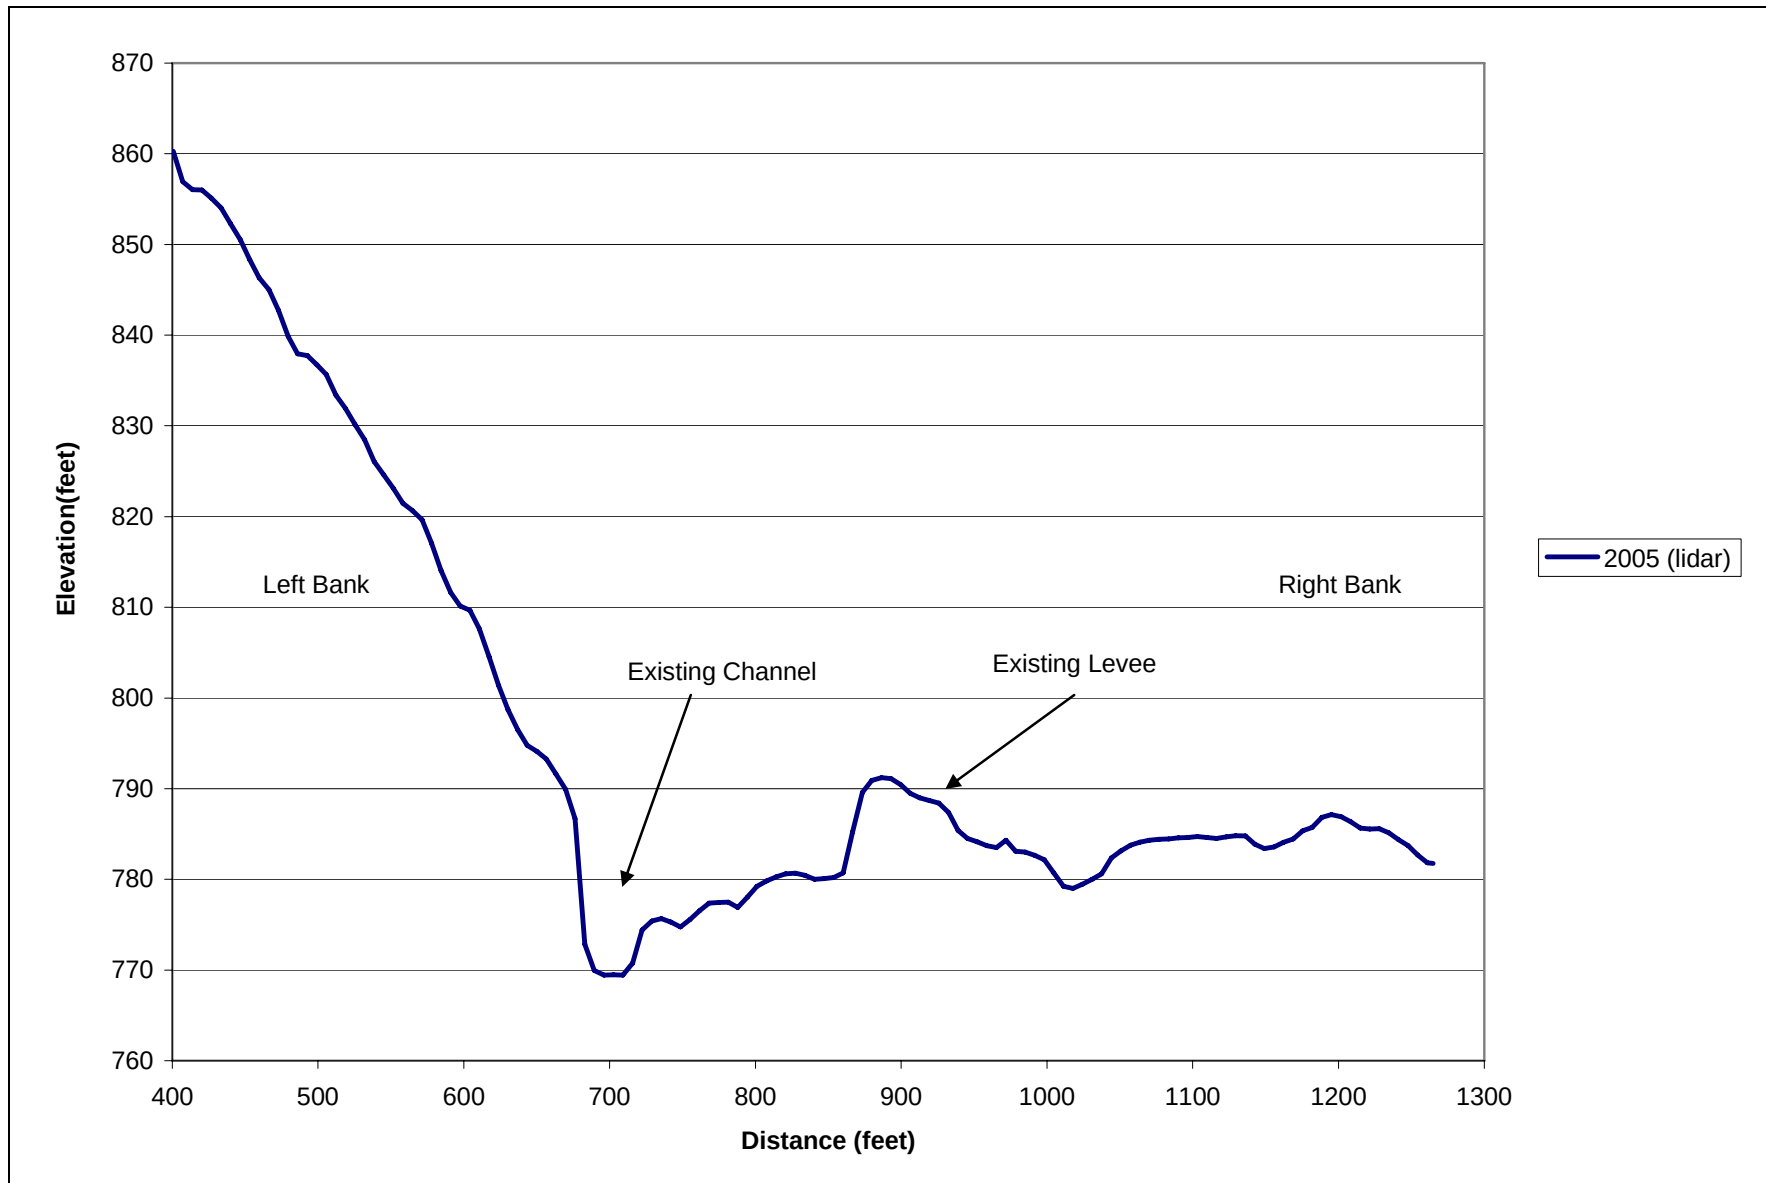
**Figure 4. Cross-section of segment 2 of the project reach in lower Canyon Creek at river mile 0.25.**

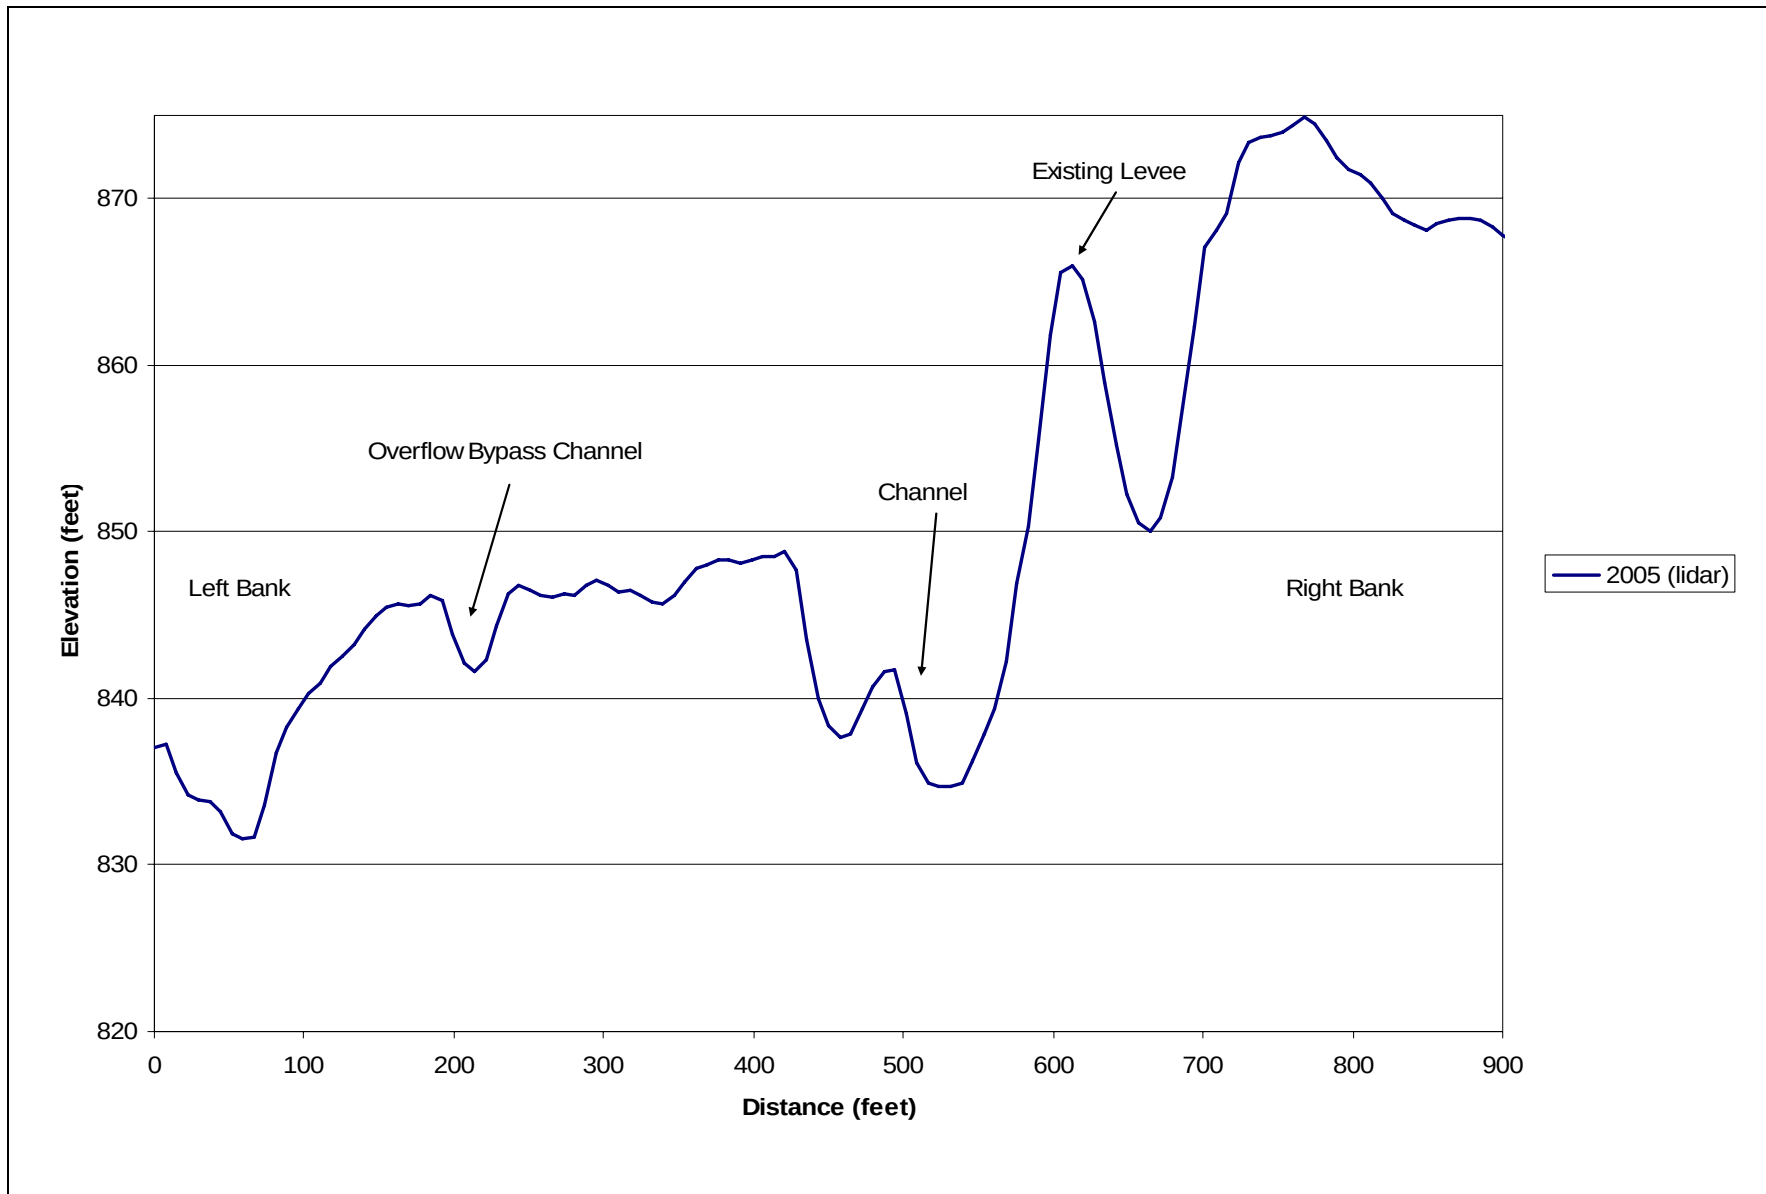
Figure 5. Cross-section of segment 3 of the project reach in lower Canyon Creek at river mile 0.62.

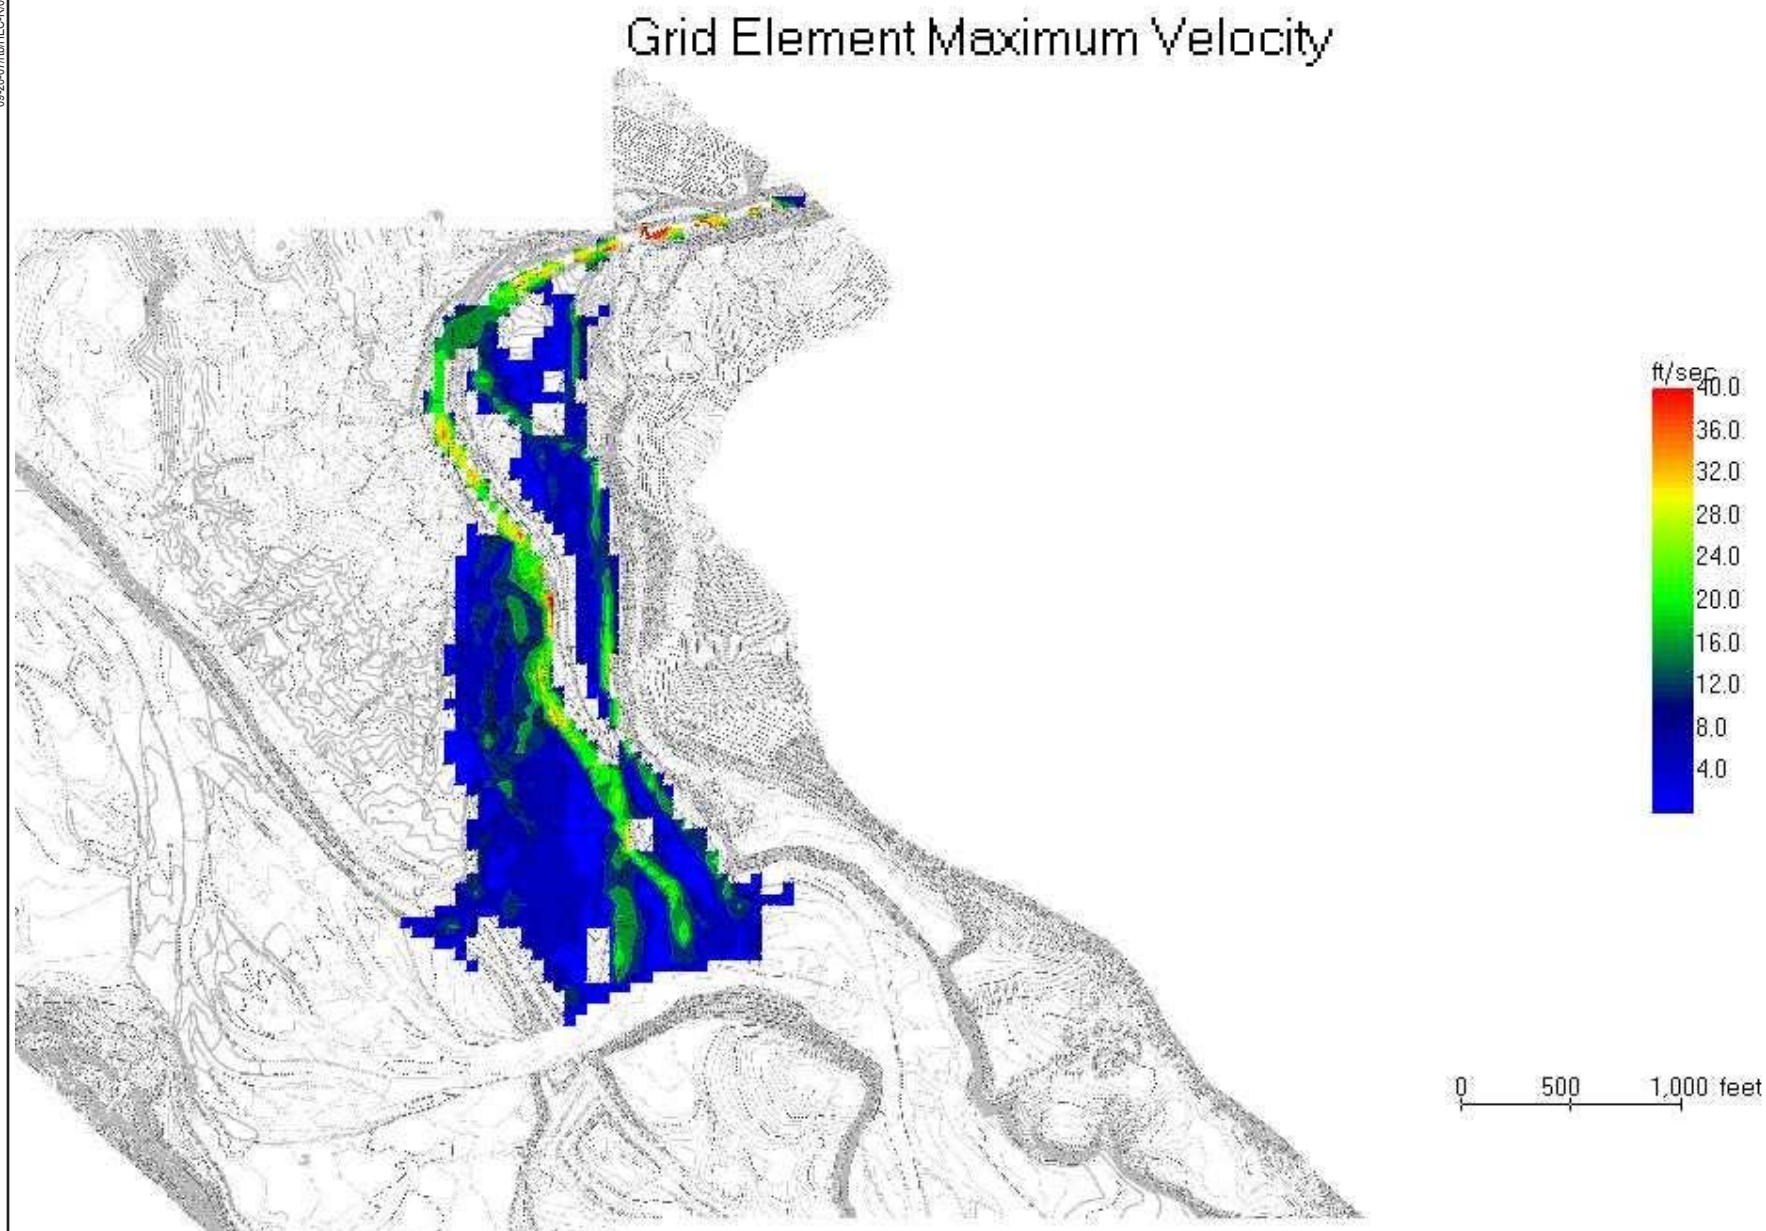
**Figure 6.** FLO-2D velocity modeling results for lower Canyon Creek at a debris flood magnitude similar to the 1989 event (16,000 cfs) with a breach in the existing levee.

The extent of this protection is based on the results of FLO-2D modeling performed by Kerr Wood Leidal as part of its risk analysis (KWL 2003). FLO-2D is an unsteady state two-dimensional finite difference flood routing model used to predict flow depth and velocity for riverine, floodplain, alluvial, and debris flow environments. The velocities and depths for an event of the same magnitude as the 1989 event (approximately 16,000 cfs) were used to size the riprap and determine the extent of treatment necessary (Figures 6 and 7, respectively) (Pittman 2007). As a worst-case scenario, a breach of the existing levee was modeled. Under this scenario, the remaining levee deflects the overflow away from the channel towards the highway. The depth and velocities generated by FLO-2D were used for sizing the potential riprap. Based on preliminary sizing equations, the necessary median diameter ( $D_{50}$ ) of the rock would range from 3.2 to 4.1 feet (Table 5). KWL Flo-2D modeling results indicate a flow magnitude similar to the 200-year event (16,000 cfs) would largely be contained within the historic active channel area of Canyon Creek with the levee in place (Figure 8).

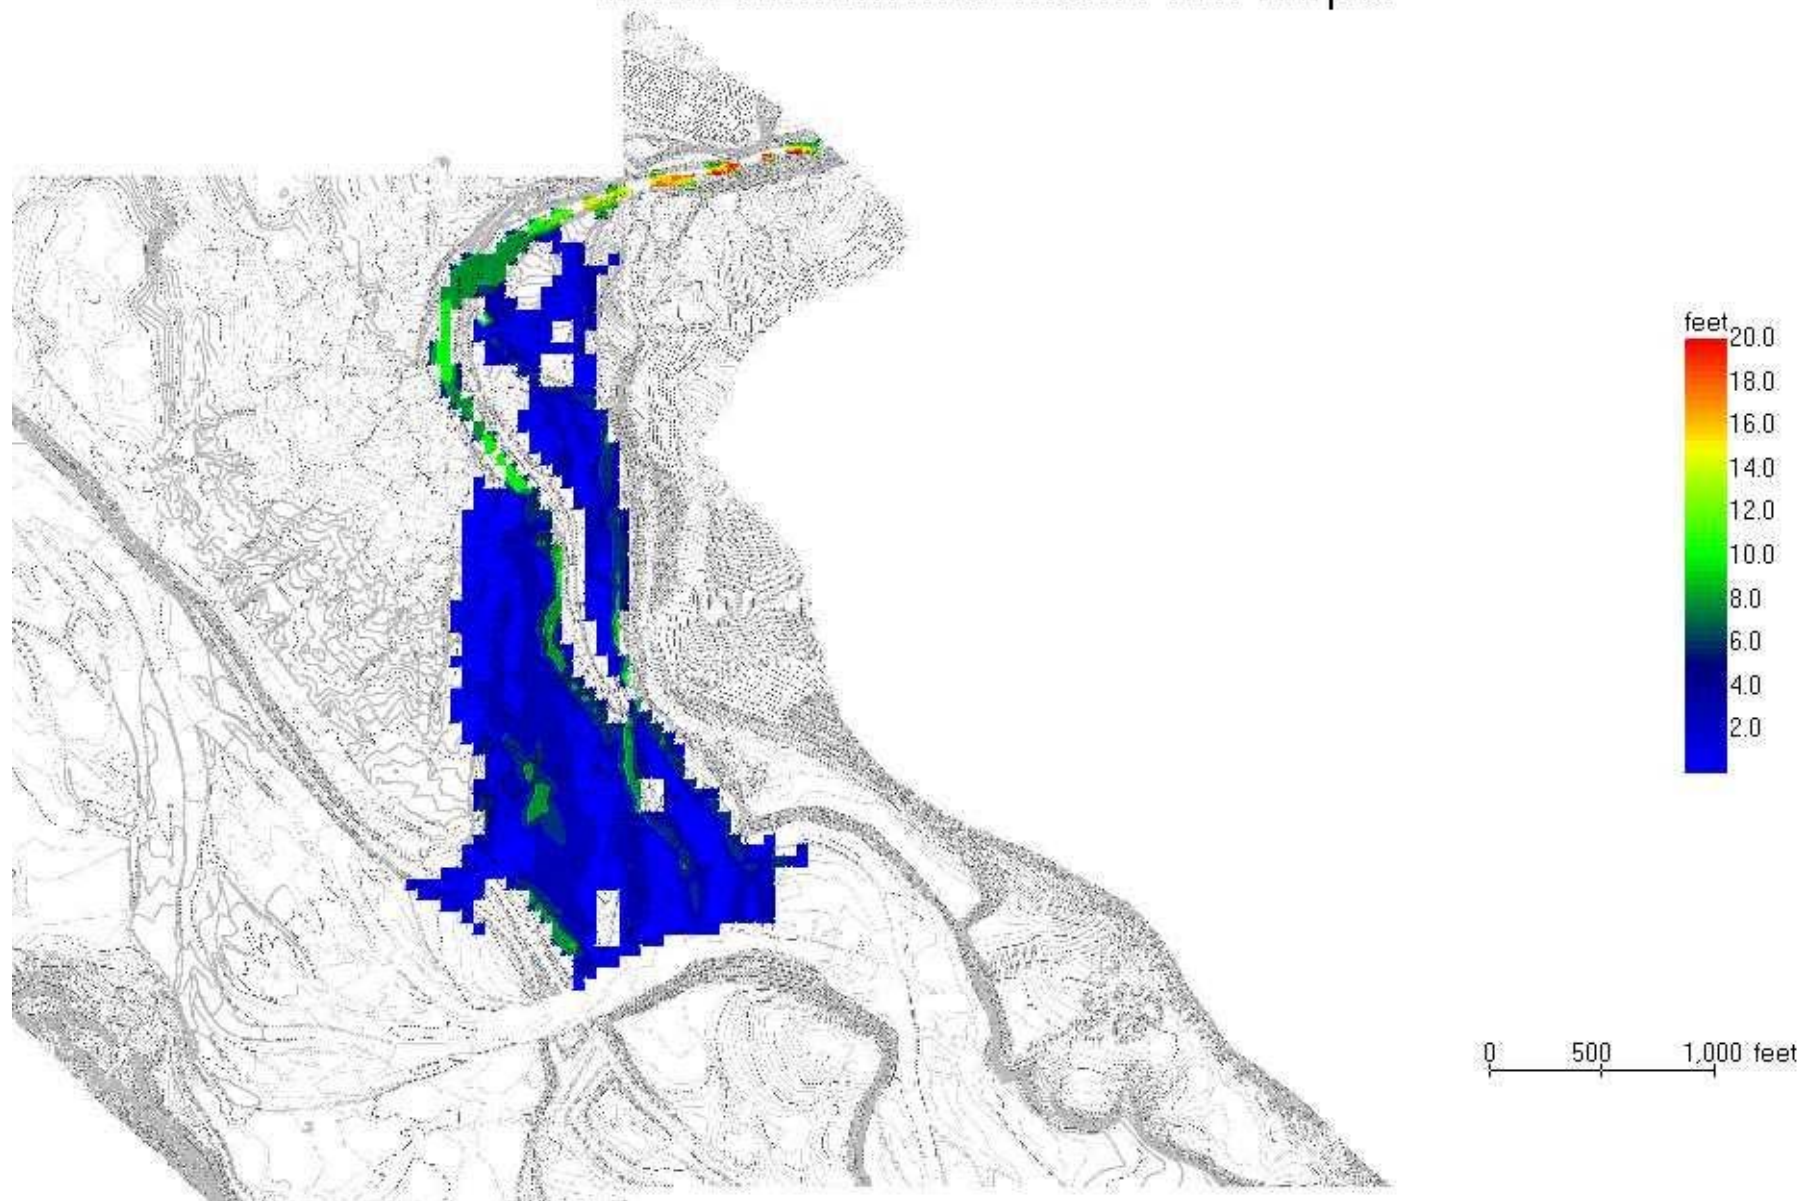
**Figure 7.** FLO-2D depth modeling results for lower Canyon Creek at a debris flood magnitude similar to the 1989 event (16,000 cfs) with a breach in the existing levee.

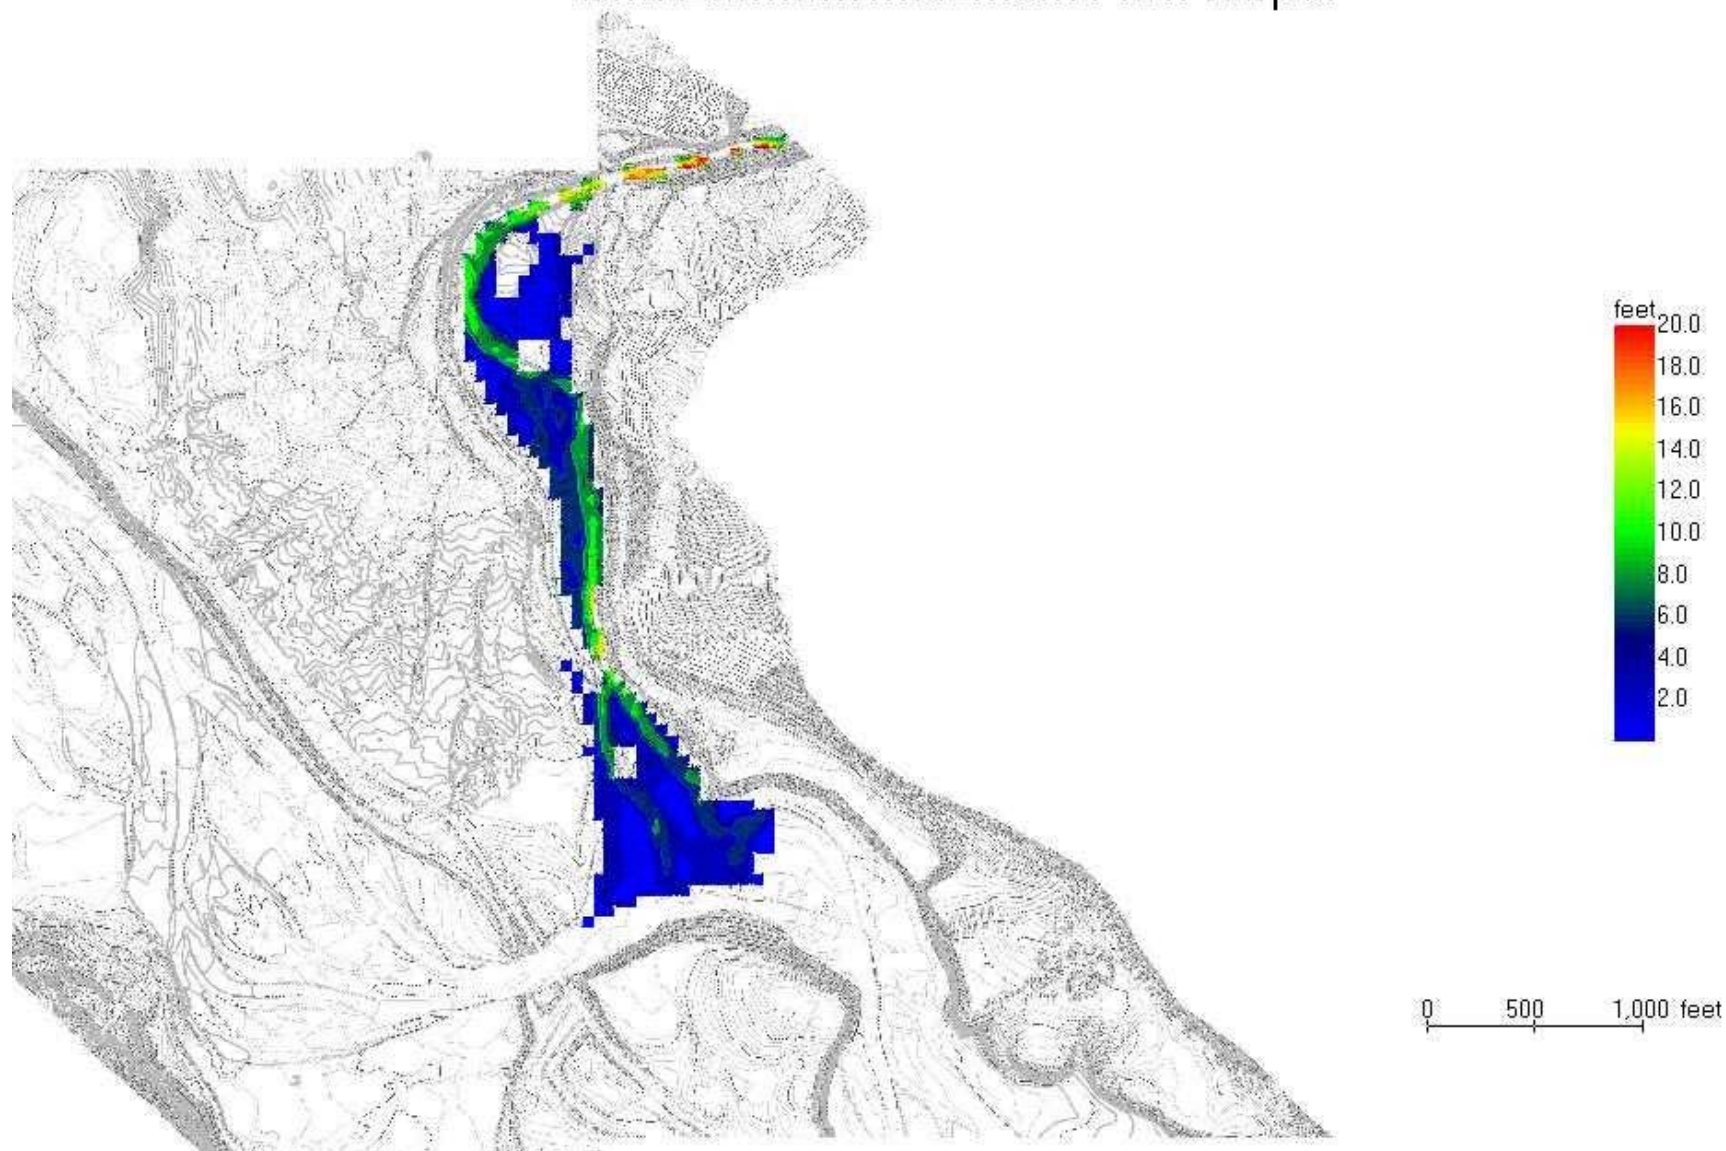
**Figure 8.** FLO-2D depth modeling results for lower Canyon Creek at a debris flood magnitude similar to the 1989 event (16,000 cfs) with the existing levee alignment.
