# **HABITAT RESTORATION OPTIONS**

## **Canyon Creek Alluvial Fan Habitat Restoration**

Whatcom County Public Works

October 2007

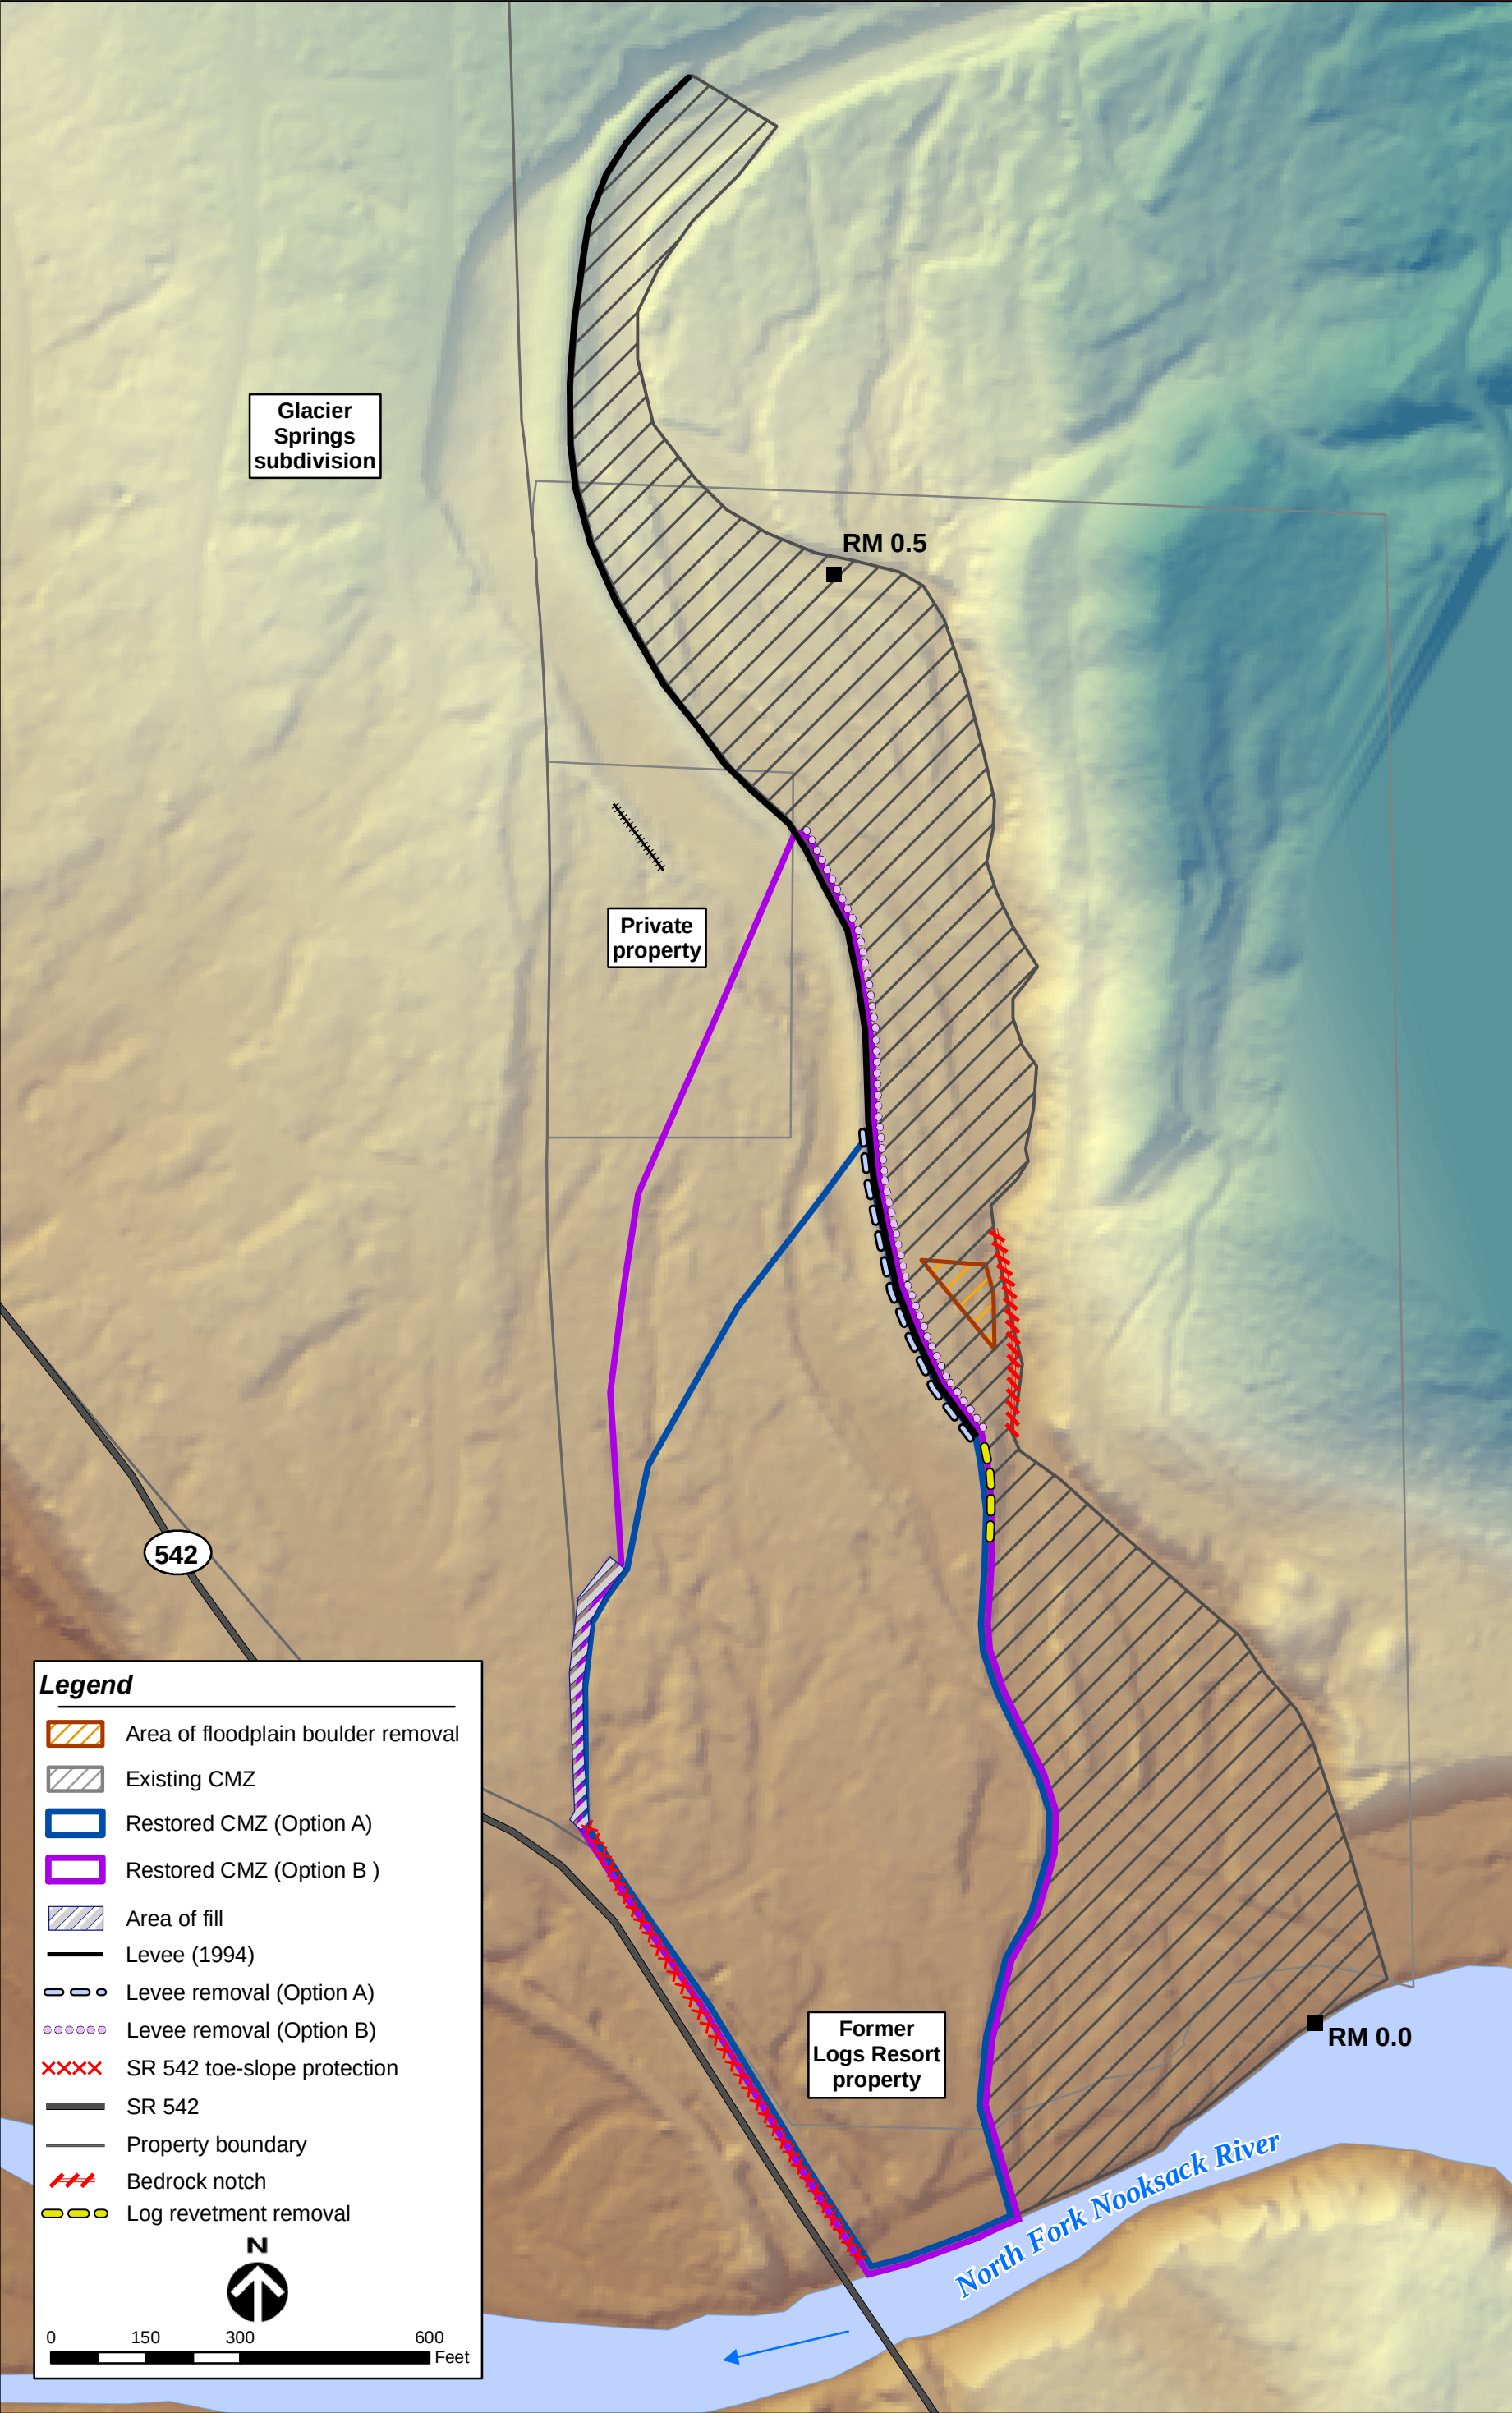
Figure 9. Proposed Phase I Option A and Option B for the Canyon Creek alluvial fan habitat restoration.

Option A would involve removing the lower 520 feet of the existing Canyon Creek levee and removing the floodplain boulders that have been placed along the right bank (Figure 8). The levee would be removed to the downstream boundary of the 5-acre private in-holding. What remains of the cabled log revetments would be removed along the right bank, downstream of the bedrock notch (RM 0.21) so that lateral channel migration (to the west) would not be impeded. The removal of the lower part of the levee and the log revetments would increase the available CMZ by approximately 18.4 acres (Figure 9), encouraging the creek to move away from the bedrock notch and develop a new channel alignment within segment 2 (without further manmade alteration to the channel or bedrock). This new channel alignment would allow the creek an opportunity to self correct the fish passage barrier in a passive or indirect manner. The correction would likely occur during a higher flow event, when overbank channel flow conditions are occurring upstream of the bedrock notch. Such conditions would allow water to flow along the right side of the channel in the area of the existing levee and floodplain, which would be available for the creek after the removal action.

After the removal of the lower section of the levee, the riprap could be used to construct toe-slope protection along SR 542 to further protect the highway from Canyon Creek up to at least the 100-year clearwater flood. Ideally, this highway protection would be 800 feet long, extending northwest from the Warnick Bridge along the east side of the bridge. This toe-slope

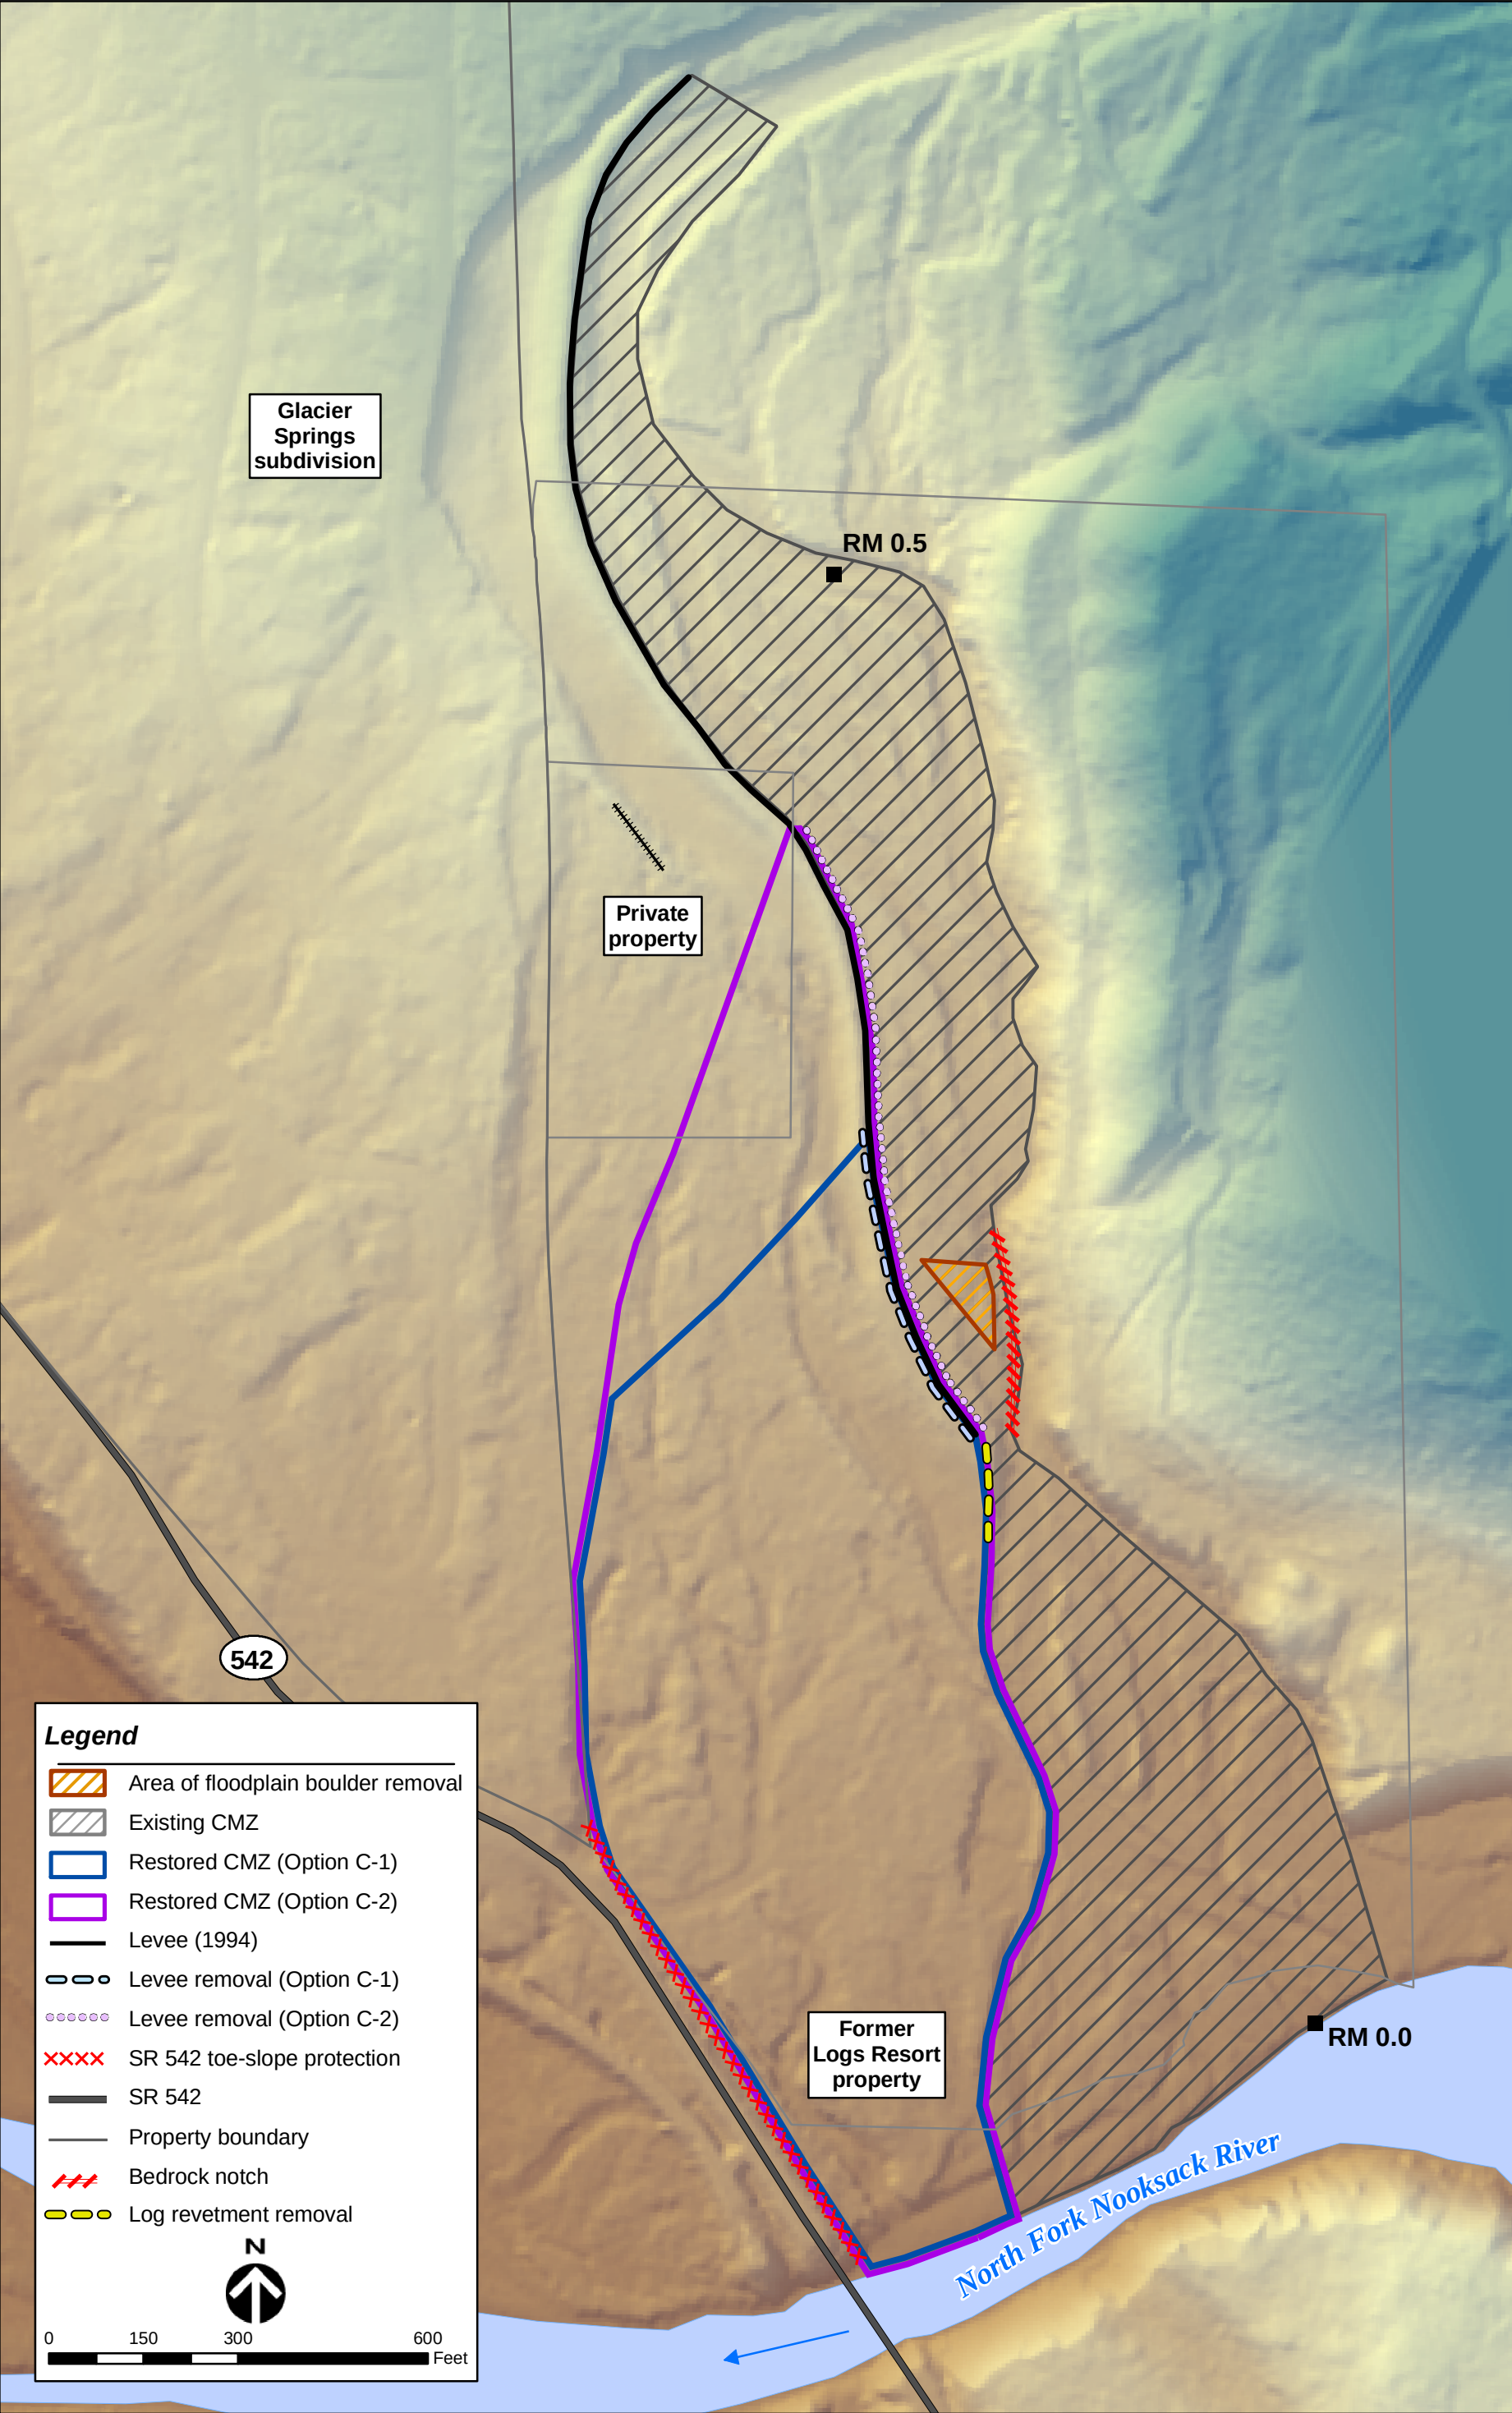
Figure 10. Proposed Phase I Option C for the Canyon Creek alluvial fan habitat restoration.

The difference between Option A and Option B in terms of increase in available CMZ would be approximately 4.3 acres, 18.4 acres under Option A and 22.8 acres under Option B (Table 6). Option C would allow for approximately the same increase in available CMZ, depending on the amount of the existing levee that is removed (520 linear feet under Option C-1 or 1,025 linear feet under Option C-2). The Phase I habitat restoration options would allow passive measures to improve conditions resulting from the manmade bedrock notch, by encouraging the channel to naturally shift away from the bedrock notch. However, there is a possibility that the levee removal would not result in channel migration away from the bedrock notch and no improvement in fish passage would occur in segment 2. If this is the case, the County or another WRIA 1 restoration partner would address the bedrock notch as part of Phase II restoration actions.

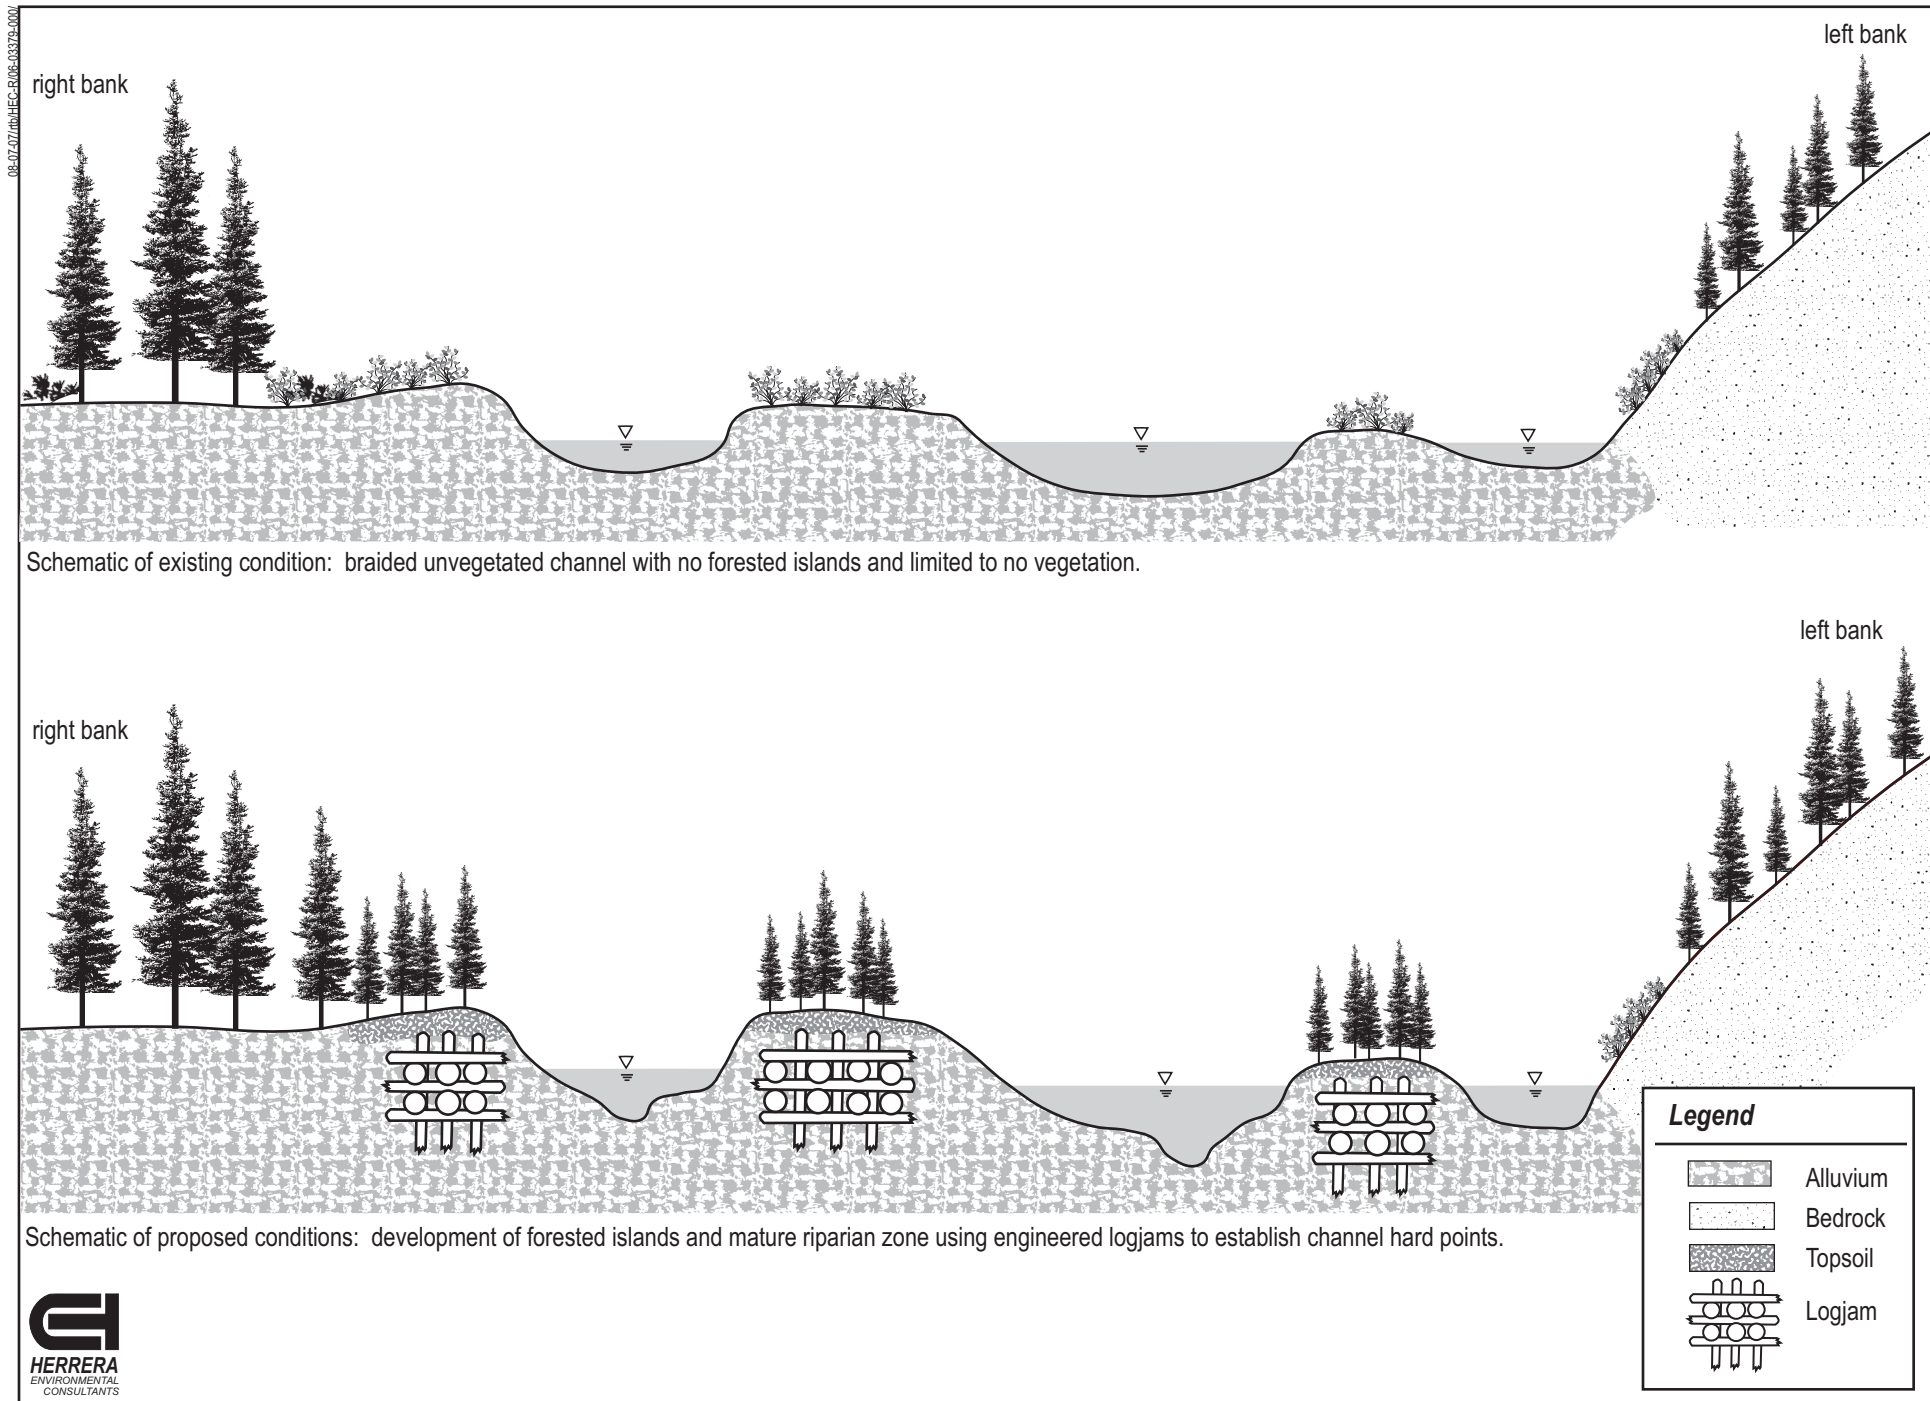
**Figure 11. Potential Phase II restoration option in sement 1 of the Canyon Creek project reach (after levee removal as part of Phase I), showing existing and proposed conditions.**

- **Creation of channel hard points.** Channel hard points could be created by constructing logjam structures (Figure 11). The intent of these logjams is to develop areas with the potential for establishing and sustaining a mature riparian forest, which could provide the following benefits:
  - Increase large woody debris in the system
  - Increase the potential for future recruitment of large woody debris
  - Improve riparian habitat conditions
  - Increase habitat diversity by increasing channel length, pools, and complexity.

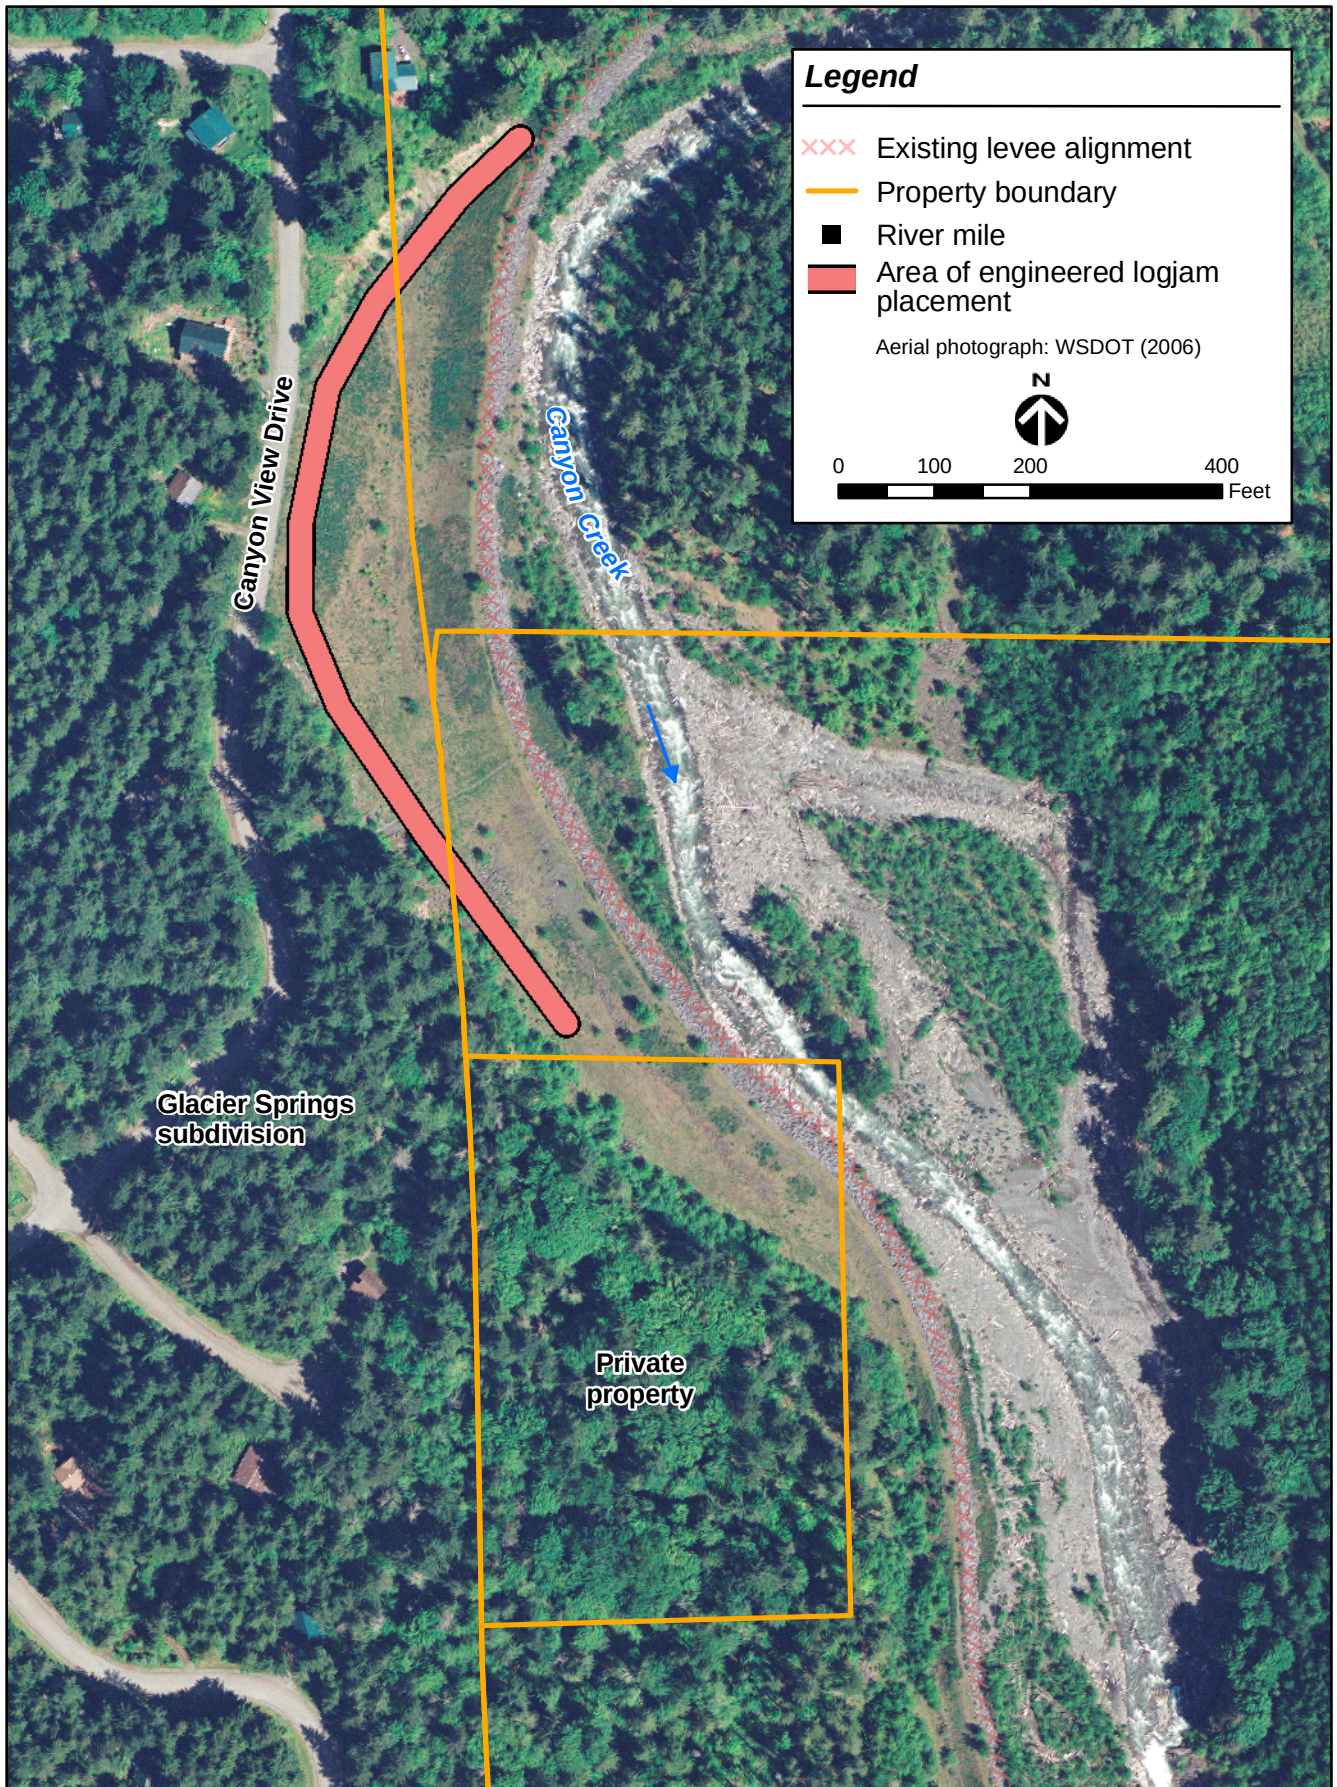
Figure 13. Potential Phase II restoration option in segment 3 of the Canyon Creek project reach.

- **Construction of engineered logjams.** ELJs could be constructed along the banks or in the channel to improve fish habitat. In addition, ELJ structures could be built behind the right bank levee along Canyon View Drive (Figure 13). These structures would provide habitat enhancement along the right bank in the upper alluvial fan. Given the exposure of the current revetment toe, this would provide significant habitat should the levee fail, and minimize the potential for public demand of a new riprap structure. In addition, placement of these structures would have to be supported by hydraulic modeling to ensure that backwater effects from the ELJs does not increase the flood risk to the Glacier Springs subdivision. Because of the proximity to the Glacier Springs subdivision, these structures would be designed to meet “factor of safety” requirements to limit risk to property. The greater the factor of safety requirements, the greater these structures would cost to build. Log jam construction costs, depending on design complexity and size, may range from \$80,000 to \$120,000 per structure.

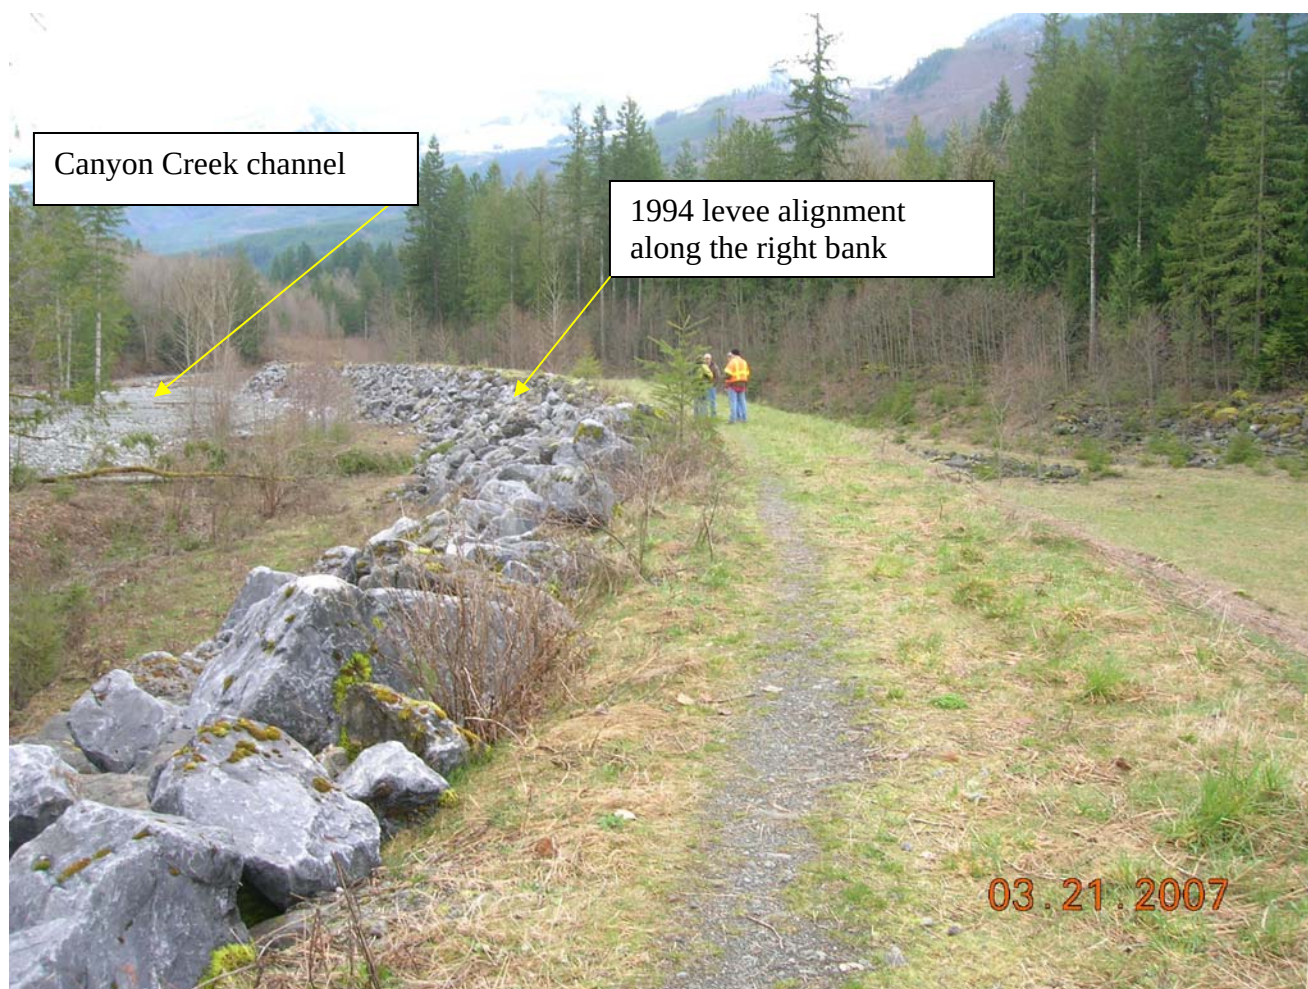
**Photo 1. View looking downstream along the Canyon Creek 1994 levee, March 2007.  
Photo by Herrera.**

Because of the sharp left turn due to the location of the levee, the creek has remained constricted within a single-thread channel that has been incising since the construction of the levee in 1994 along the upper part of this segment. This incision was evident during field investigations by Herrera in 2006 and 2007. The creek has incised below the floodplain constructed in 1994, and the toe of this levee appears to be exposed along the right bank. However, the November 2006 event deposited a large amount of sediment within this segment, resulting in a change in the channel position to the left side of the unvegetated channel (Figure 2). The channel through this segment is classified as having mostly a step-pool morphology (Figure 5). The slope of the channel in this segment is 2.7 percent (based on 2005 LiDAR data).

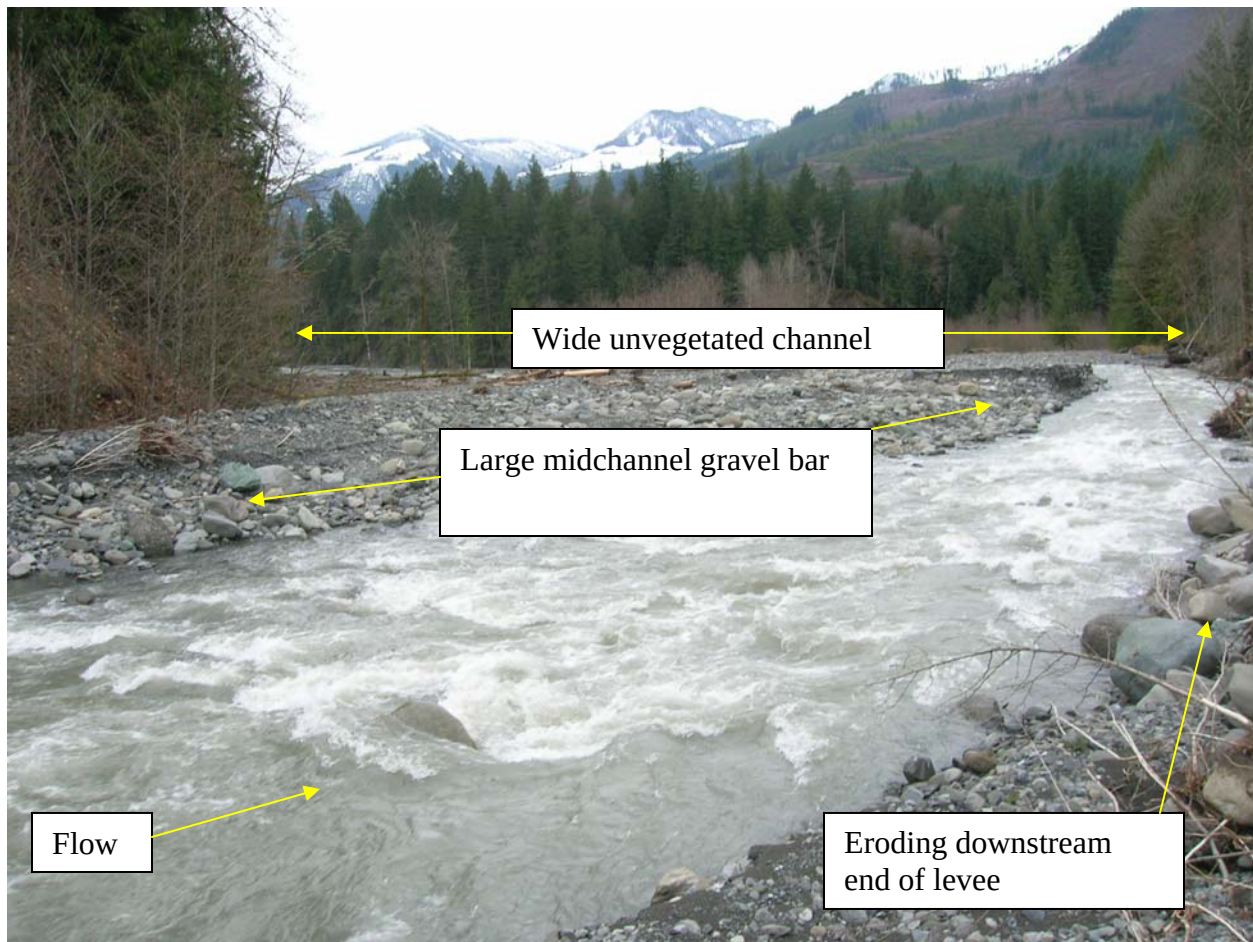
**Photo 2.** Segment 1 of Canyon Creek project reach, looking downstream from lower extent of the 1994 levee along the right bank, March 2007. Photo by Herrera.

Segment 1 (the lower alluvial fan) extends from just below the bedrock outcrop to the mouth of Canyon Creek at its confluence with the North Fork Nooksack River. The average active channel width is approximately 400 feet, with a channel slope of 3.1 percent (based on 2005 LiDAR data) (Figure 3) (Appendix A, photos 2 and 3). The channel alignment within this segment switches in response to flow conditions, sediment load and transport, and the alignment of the North Fork Nooksack River. The North Fork Nooksack River is currently aligned along its left bank opposite the mouth of Canyon Creek, at the base of a steep bluff (remnant of the Church Mountain slide) just upstream of the Warnick Bridge. According to the photographic record and LiDAR data, the North Fork Nooksack River has shifted its channel location at the foot of the Canyon Creek alluvial fan. These shifts are often in response to large debris flood events issuing from Canyon Creek wherein the fan progrades into the North Fork Nooksack River forcing the river towards its left bank. As sediment production wanes from Canyon Creek in subsequent years, the North Fork is able to transport this fan material downstream and migrate laterally toward Canyon Creek. The LiDAR data indicate one historical meander of the North Fork Nooksack River along the right bank, where it cut into the lower alluvial fan.

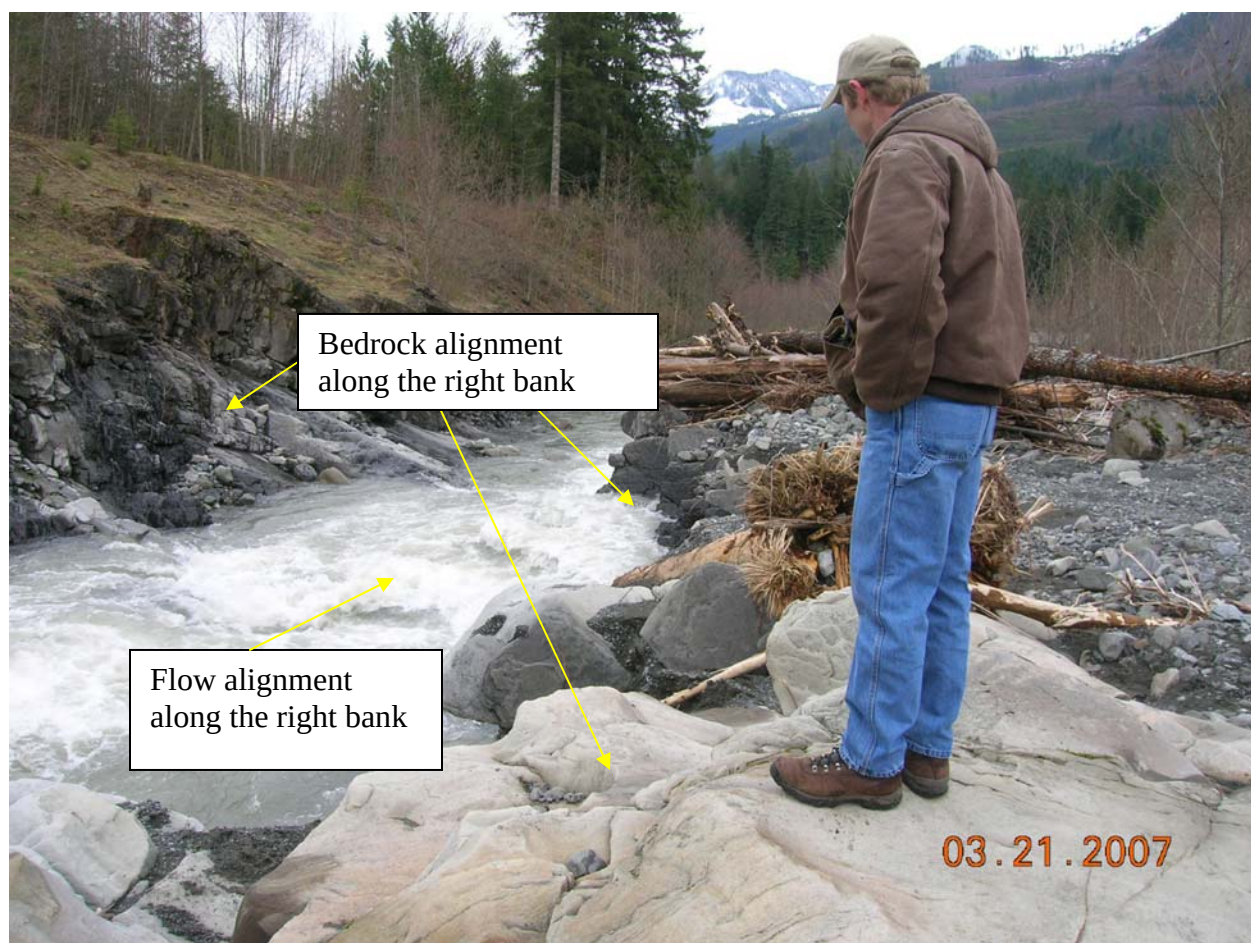
**Photo 4.** Segment 2 (bedrock notch) of Canyon Creek project reach, looking downstream from the right bank, March 2007. Photo by Herrera.

Segment 2 extends through the bedrock step cascades that constitute a partial barrier to fish passage through the alluvial fan (Appendix A, photos 4 and 5). Throughout this constricted segment, the creek is confined within its channel by the bedrock notch. These bedrock step cascades present a partial fish barrier blocking access to approximately 4 river miles of previously accessible (prior to 1994 corrective measures) habitat for early chinook, sockeye,

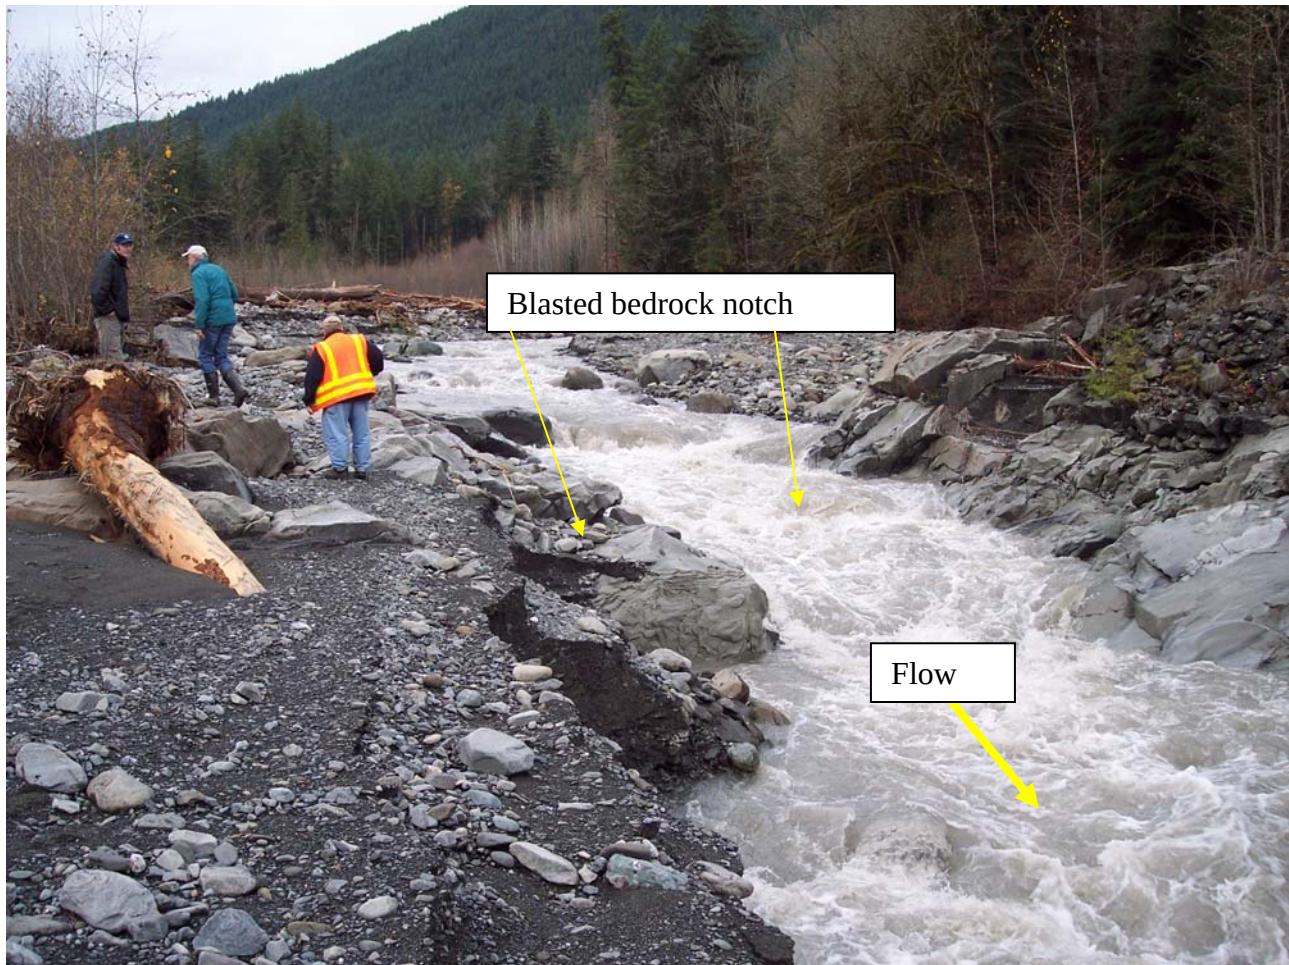
**Photo 5.** Segment 2 of Canyon Creek project reach, looking upstream from the right bank, February 2007. Photo by Whatcom County.

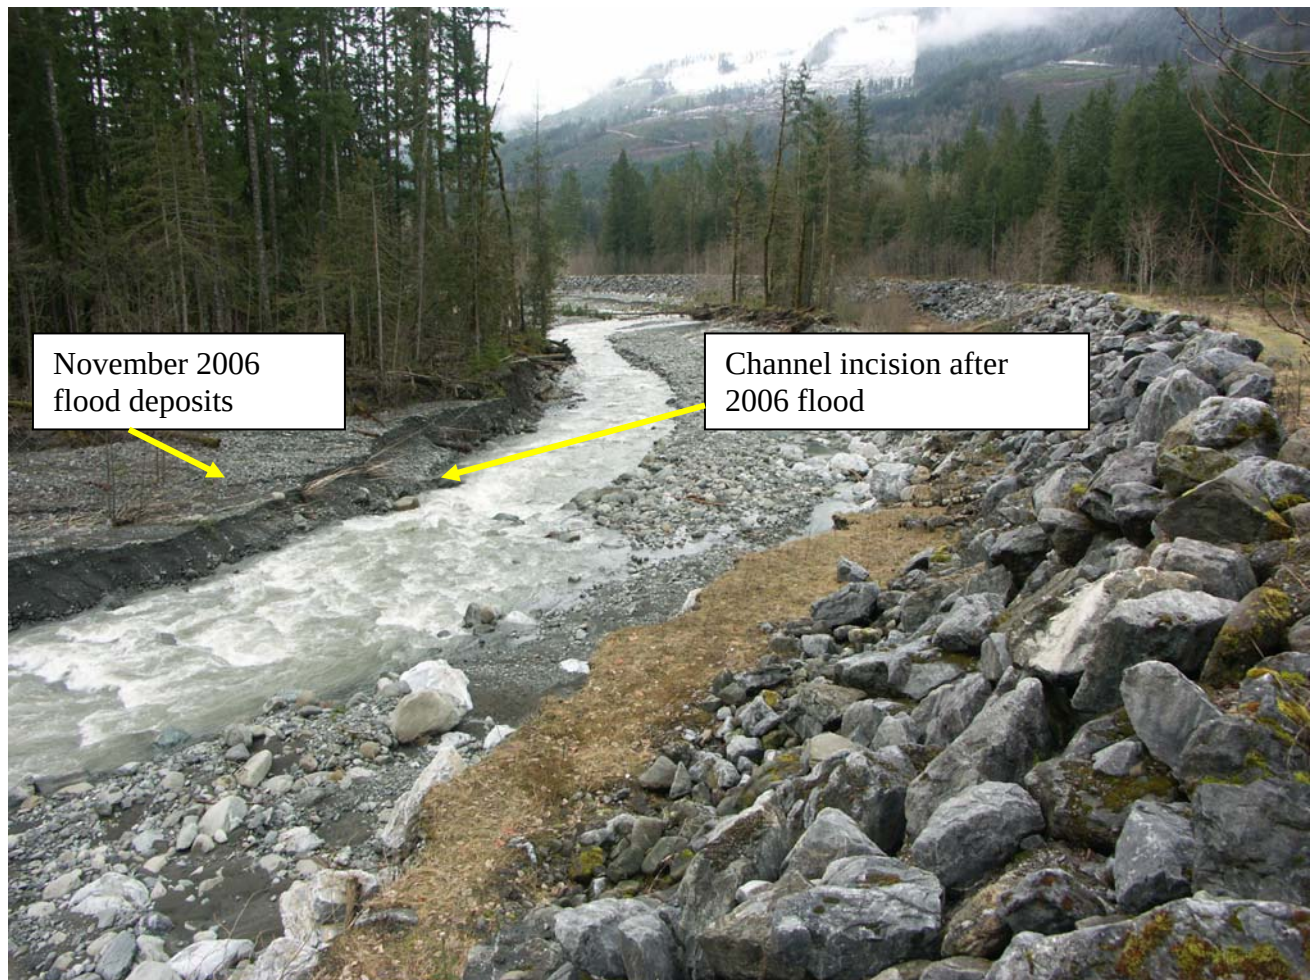
**Photo 8.** View looking downstream along the 1994 levee (right bank) showing post-November 2006 flood channel incision, February 2007. Photo by Whatcom County.

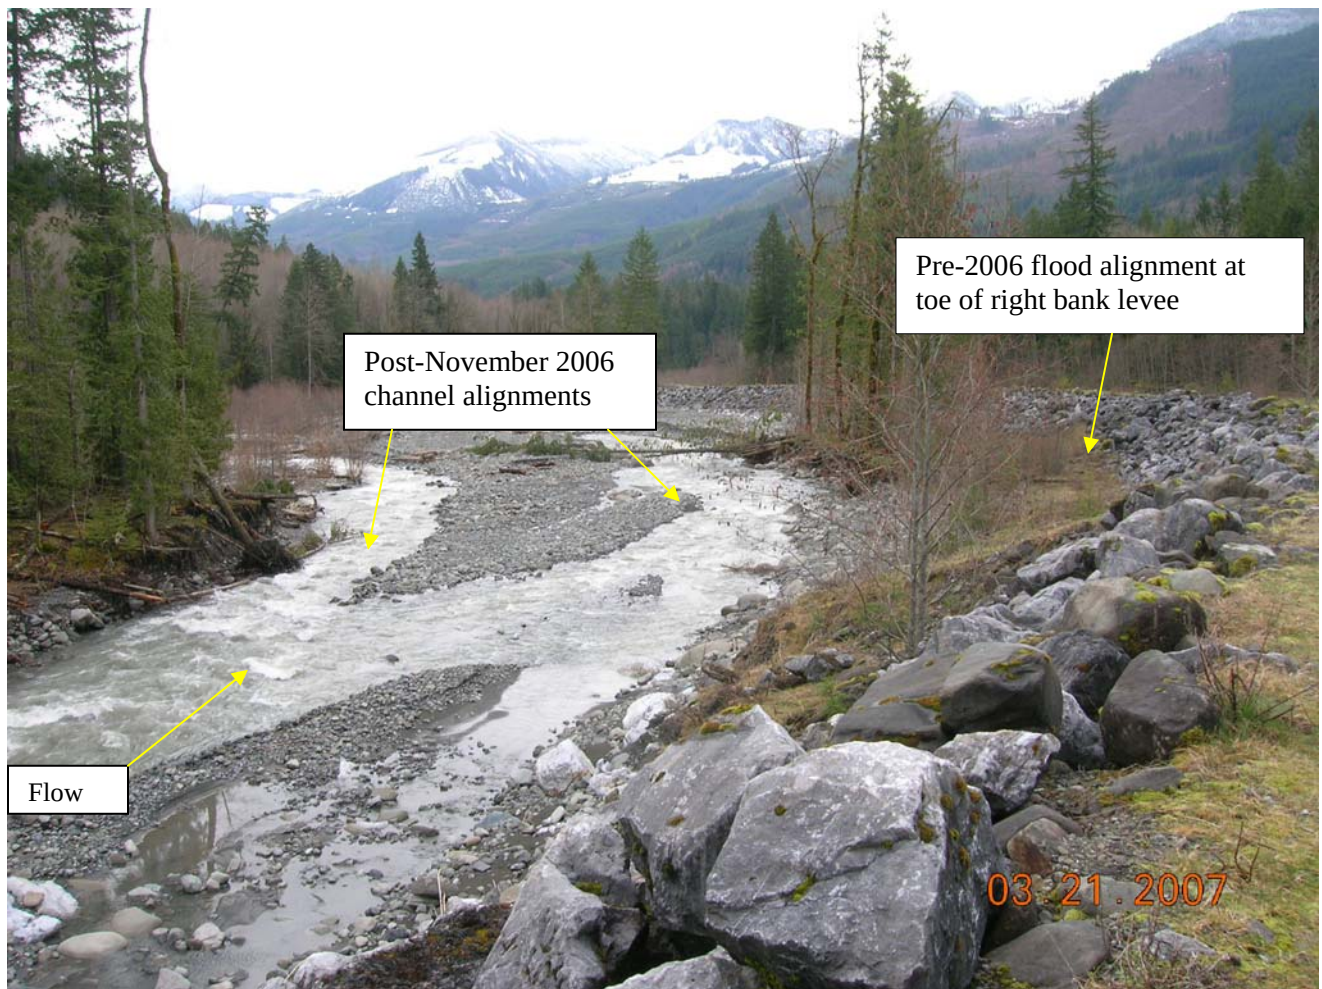
**Photo 10.** Segment 3 of Canyon Creek project reach, looking downstream from the right bank levee, March 2007. Photo by Herrera.
