# **HABITAT RESTORATION OPTIONS**

## **Canyon Creek Alluvial Fan Habitat Restoration**

Whatcom County Public Works

October 2007

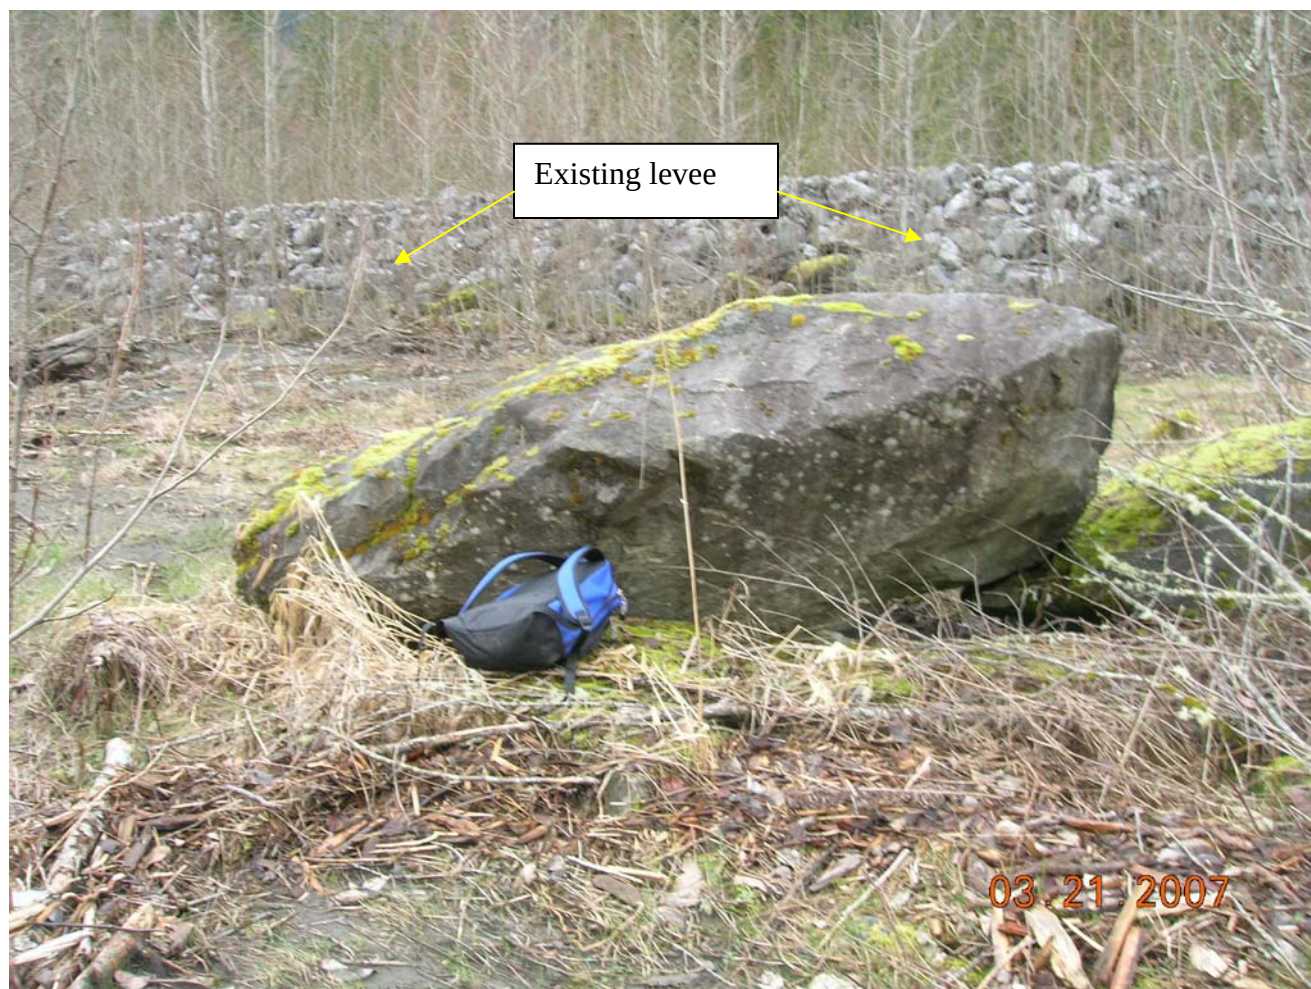
**Photo 11. Floodplain boulders within the Canyon Creek floodplain (segment 2), March 2007. Photo by Herrera.**

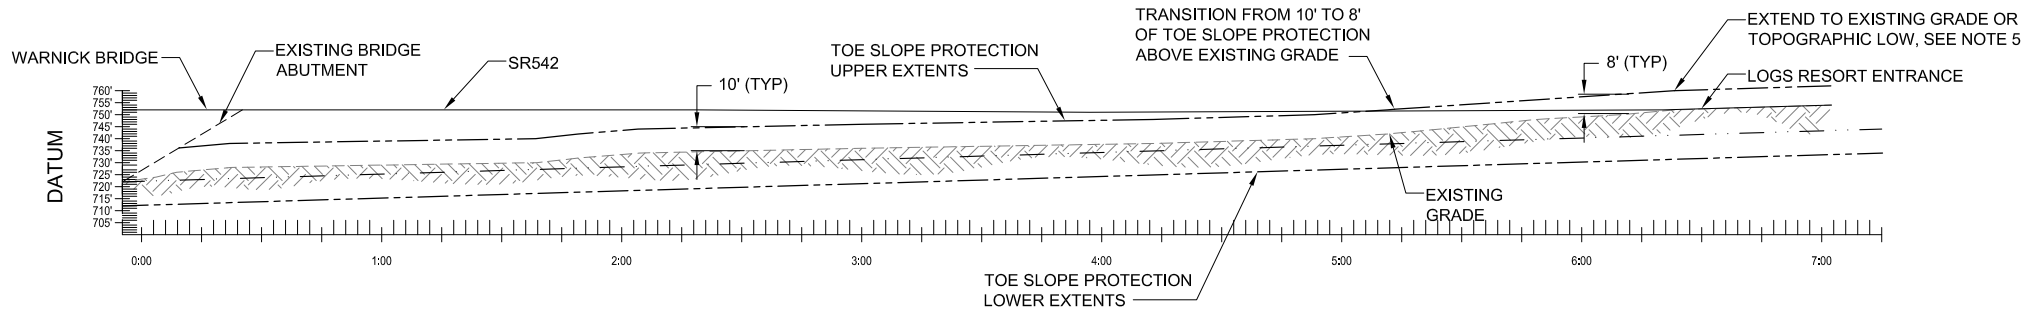
TOE SLOPE PROTECTION PROFILE  
SCALE: NTS

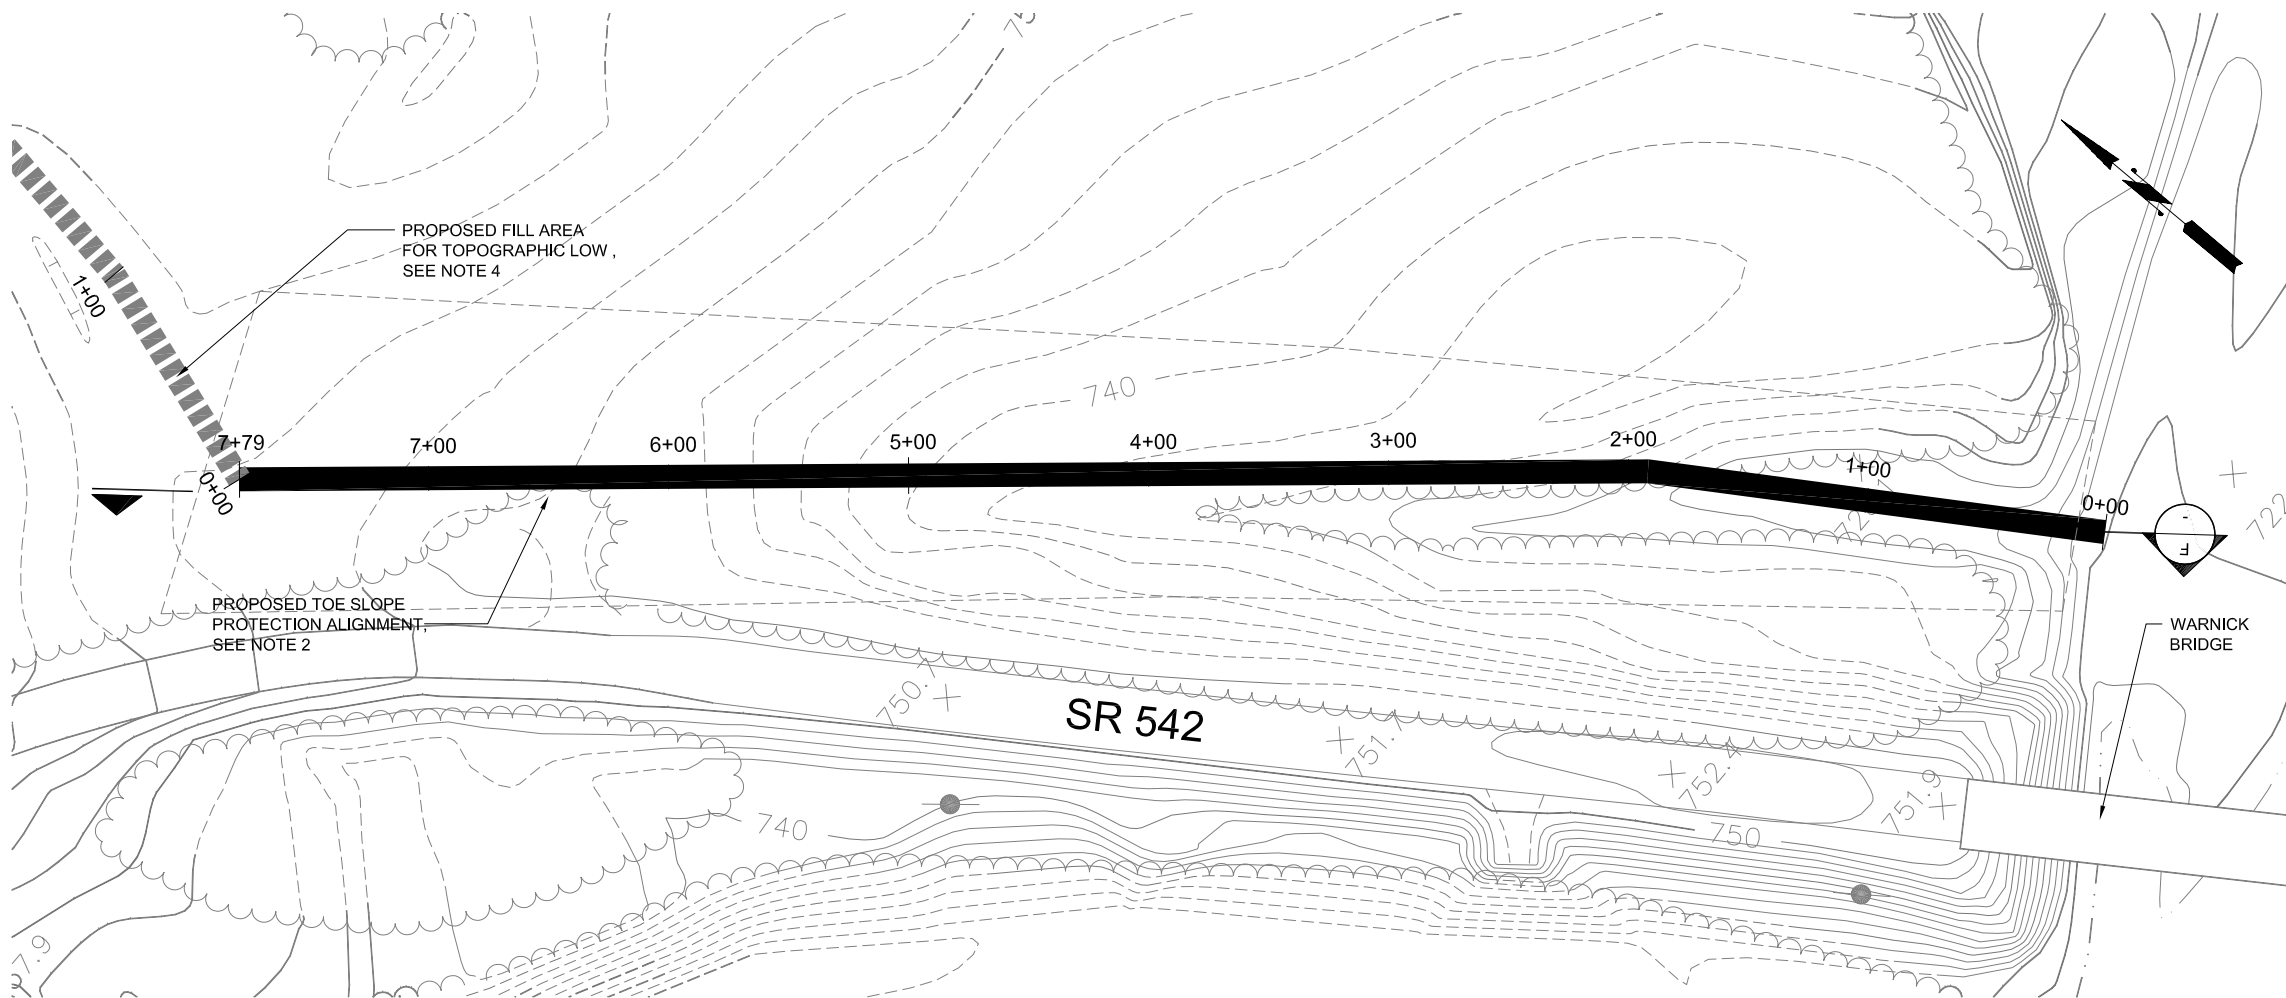
TOE SLOPE PROTECTION PLAN  
SCALE: 1"=40'

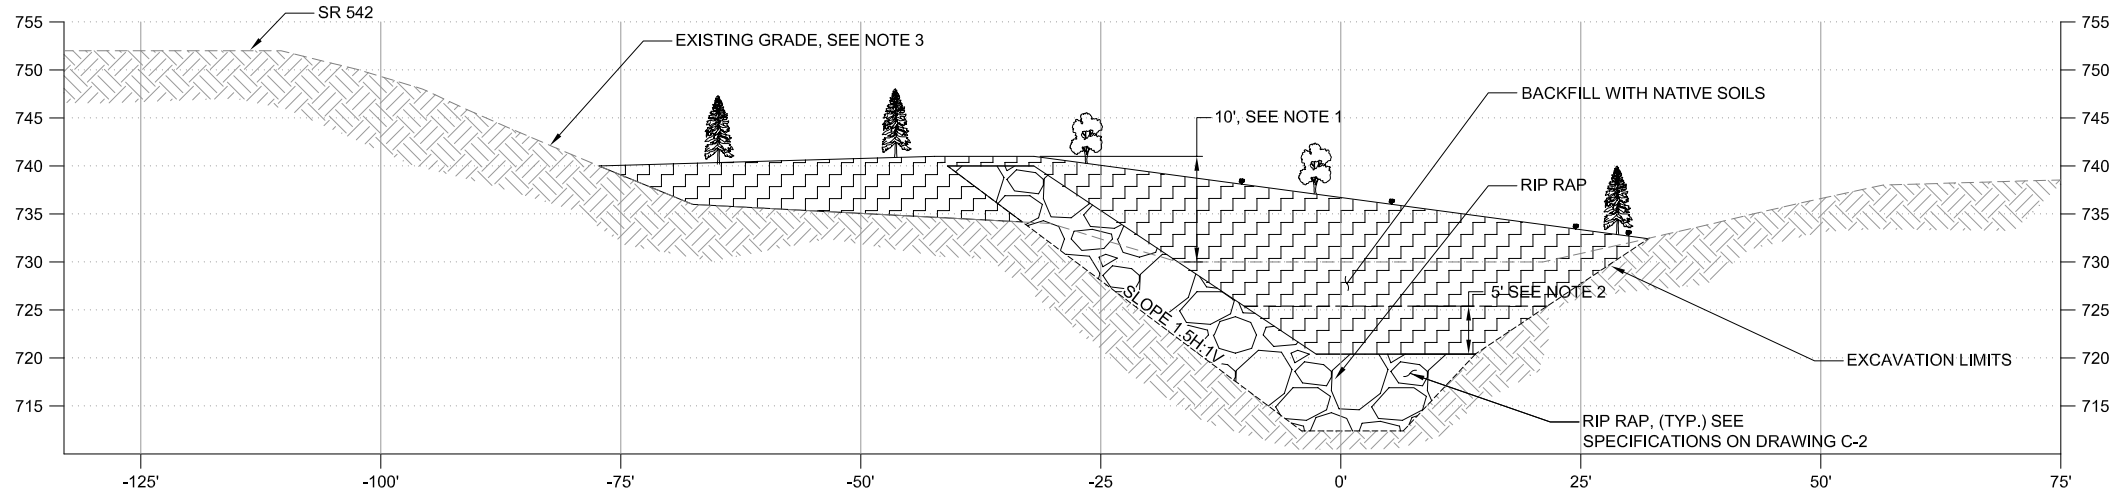
A  
C-1

TOE SLOPE PROTECTION SECTION

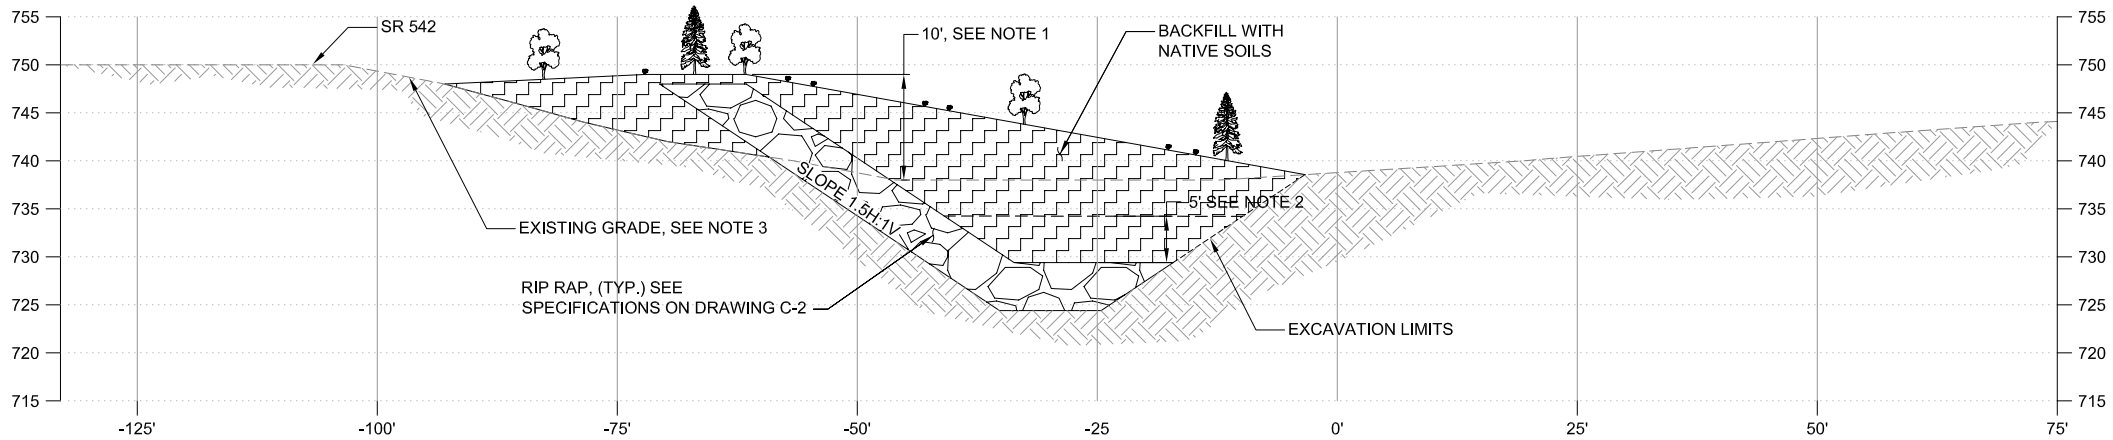
B  
C-1

TOE SLOPE PROTECTION SECTION

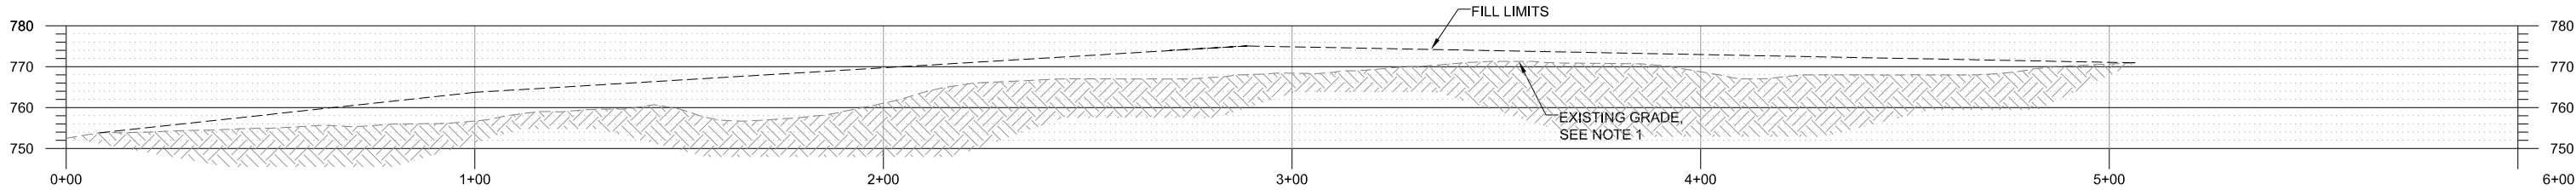
G  
C-1

TOPOGRAPHIC LOW PROFILE  
SCALE: 1" = 20'

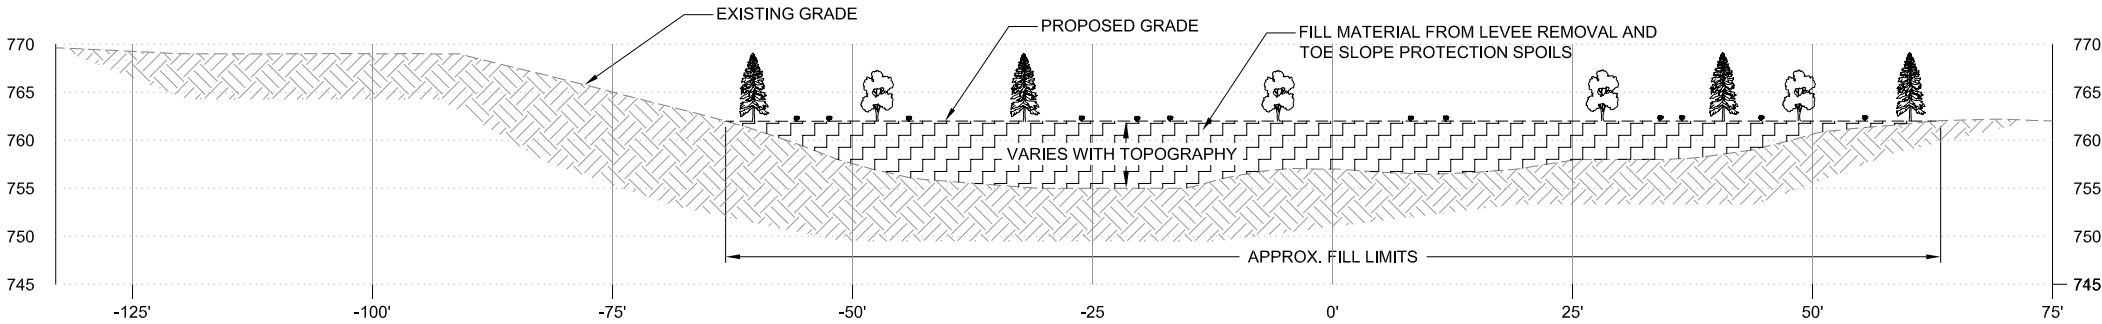
D  
C-1

TOPOGRAPHIC LOW SECTION  
SCALE: 1" = 10'

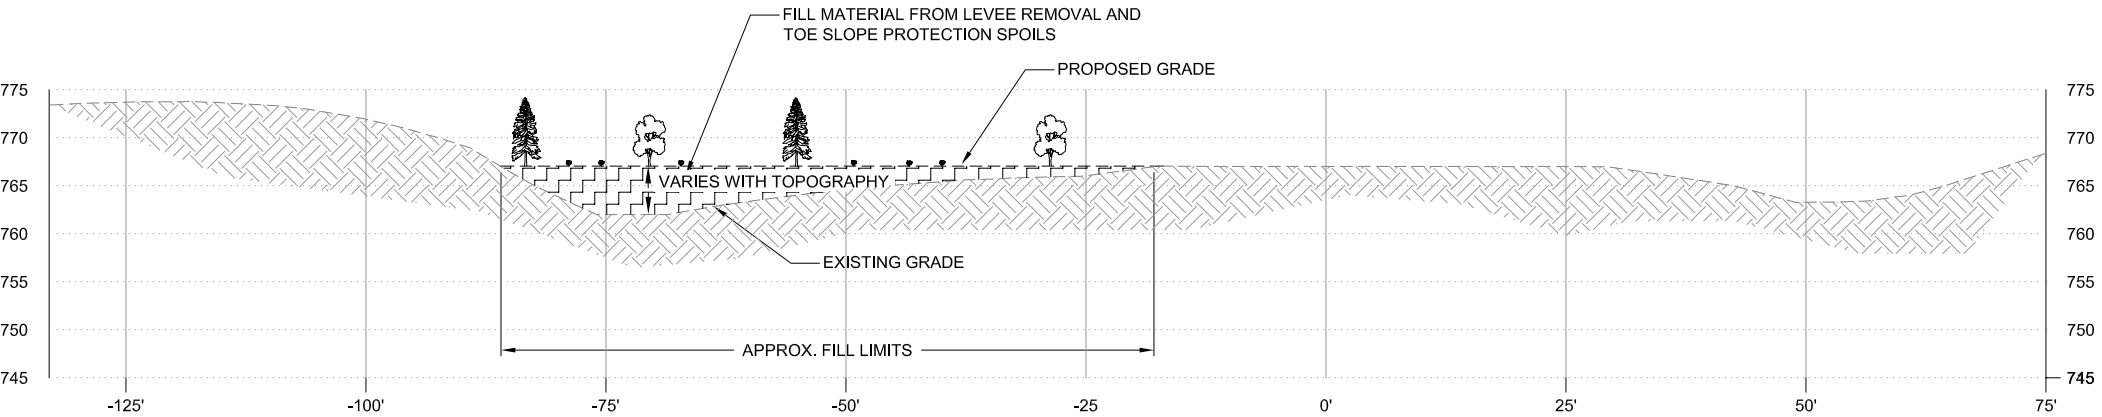
E  
C-1

TOPOGRAPHIC LOW SECTION  
SCALE: 1" = 10'

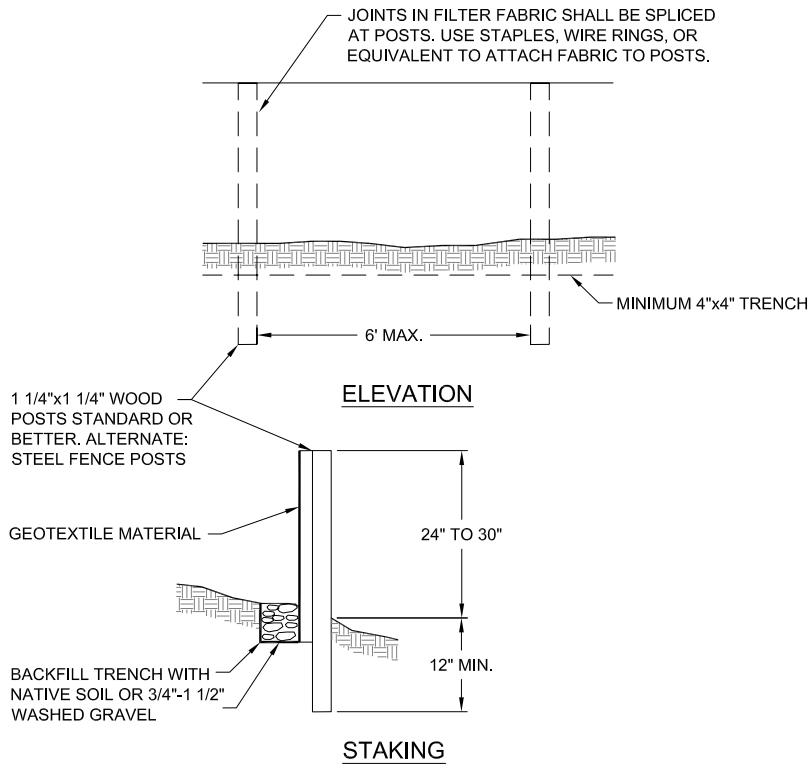
**DETAIL: SILT FENCE**

- C. THE UPHILL SIDE OF THE SILT FENCE SHALL BE CHECKED FOR SIGNS OF THE SILT FENCE CLOGGING, ACTING AS A BARRIER TO FLOW, AND CAUSING CHANNELIZATION OF FLOWS PARALLEL TO THE FENCE. IF SUCH CHANNELIZATION OCCURS, THE CONTRACTOR SHALL REPLACE THE FENCE OR REMOVE THE TRAPPED SEDIMENT.

- D. SEDIMENT SHALL BE REMOVED AND PROPERLY DISPOSED OF WHEN THE SEDIMENT IS 6 INCHES HIGH.
  - E. IF THE FILTER FABRIC HAS DETERIORATED DUE TO ULTRAVIOLET BREAKDOWN, IT SHALL BE REPLACED.

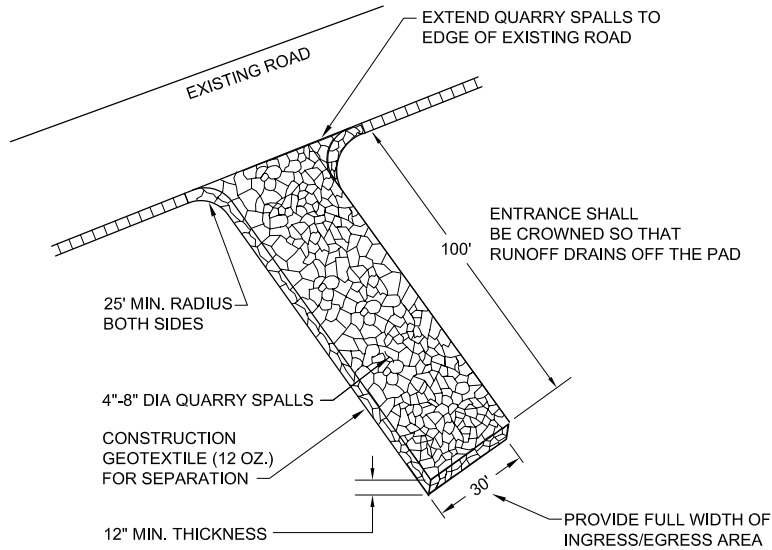
**DETAIL: STABILIZED CONSTRUCTION ENTRANCE**

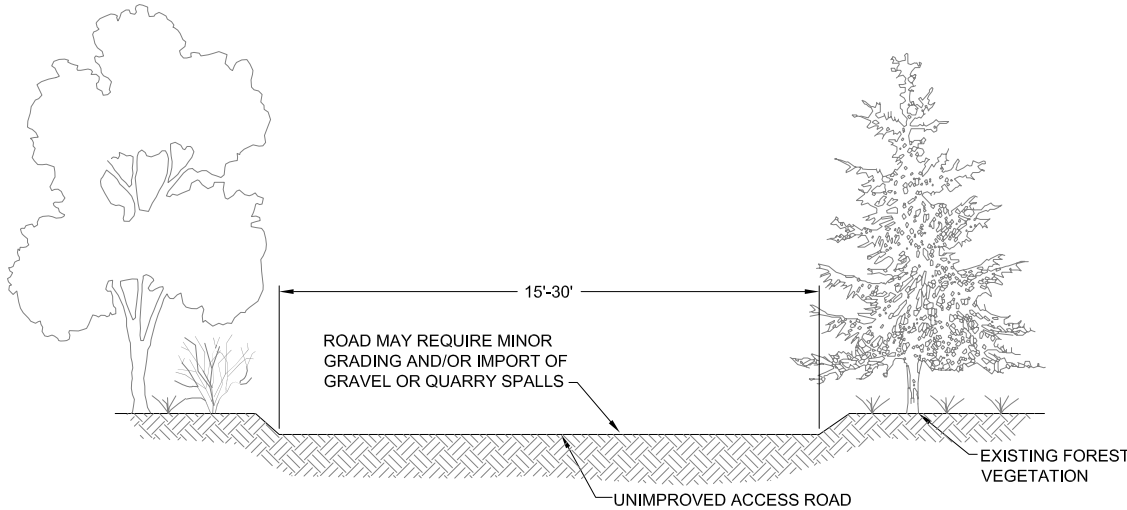
**DETAIL: TEMPORARY CLEARED ACCESS ROAD**
