# 2011 North Fork Stillaguamish River Habitat Inventory and Assessment of Change Since 2002

Snohomish County Public Works  
Surface Water Management Division  
3000 Rockefeller Ave., M/S 607  
Everett, WA

The recommended citation is: Leonetti, F.E., Rustay, M.D., Tran, T., & Purser, M.D. (2015). 2011 North Fork Stillaguamish River Habitat Inventory and Assessment of Change since 2002. Snohomish County Public Works, Surface Water Management. Everett, WA.

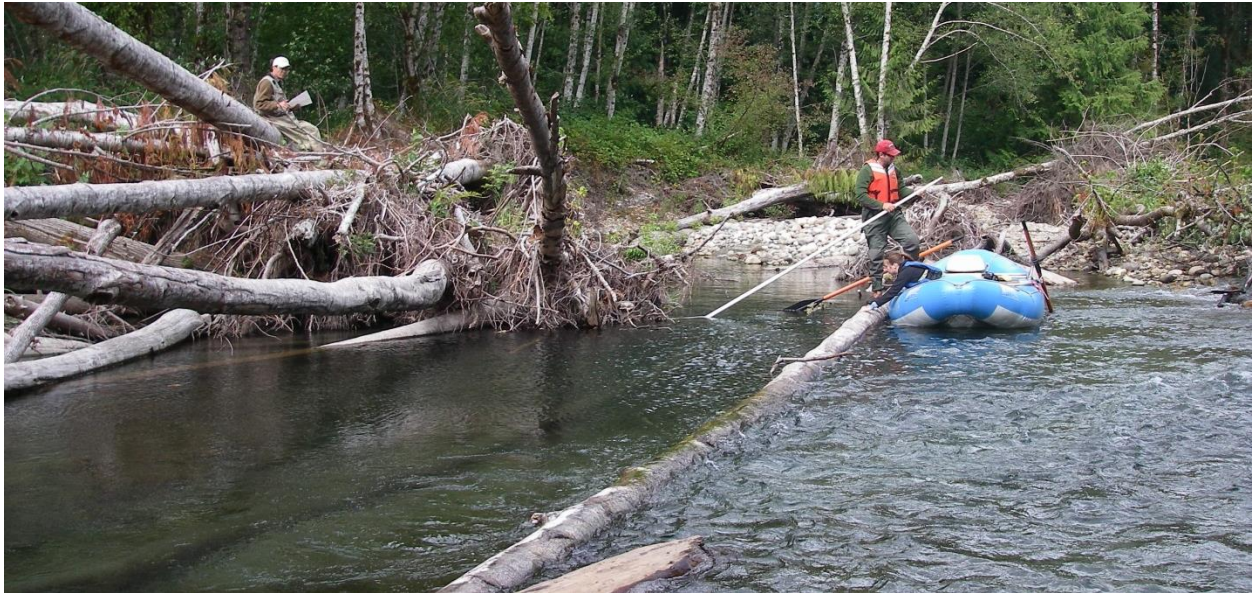
Figure 2: Raft-based data collection of habitat unit dimensions and wood inventory NF6, August 31, 2011. All woody debris was absent in 2002. Note the gravel-bedded inlet to a side channel behind the raft.

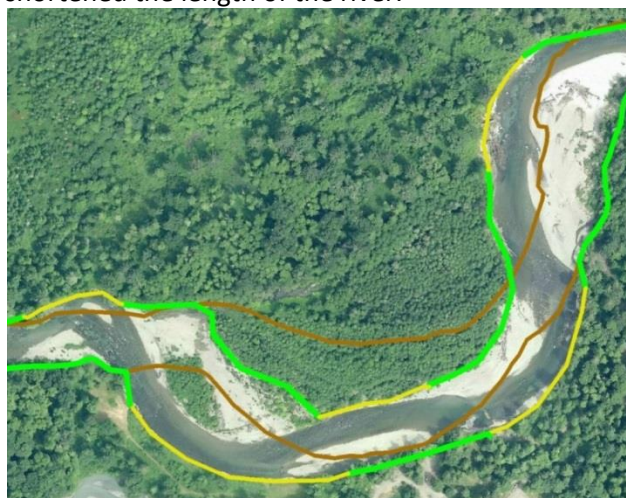
Figure 5: Example of 2002 river bank alignment (brown lines) versus 2011 alignment (yellow/ green lines). 2011 river banks are coded as natural/stable (green) and natural/unstable (yellow).

2011 aerial photos were used to map the alignment of the mainstem of the NF Stillaguamish River (Appendix B: Map Folio). Figure 5 highlights one location in NF6 where the alignment of the river changed. Total streambank length (combined right and left banks) and the percent total modified versus natural edge conditions are shown in Table 1. Total bank length did not change appreciably. An increase in total bank length within the same river miles would be indicative of increasing river sinuosity or increasing length of floodplain islands that split flow. Compared to 2002, the total length of natural stream bank decreased by more than two kilometers in 2011 (Table 4), even given the higher peak flow events. Most of the decrease occurred in NF5 because of the 2006 Steelhead Haven landslide that filled the previous channel and shortened the length of the river.
