# Effects of levee removal on channel dynamics and fish habitat in the Lower Tolt River

# PROJECT SETTING – TOLT RIVER

Levee prevents channel migration and floodplain connectivity

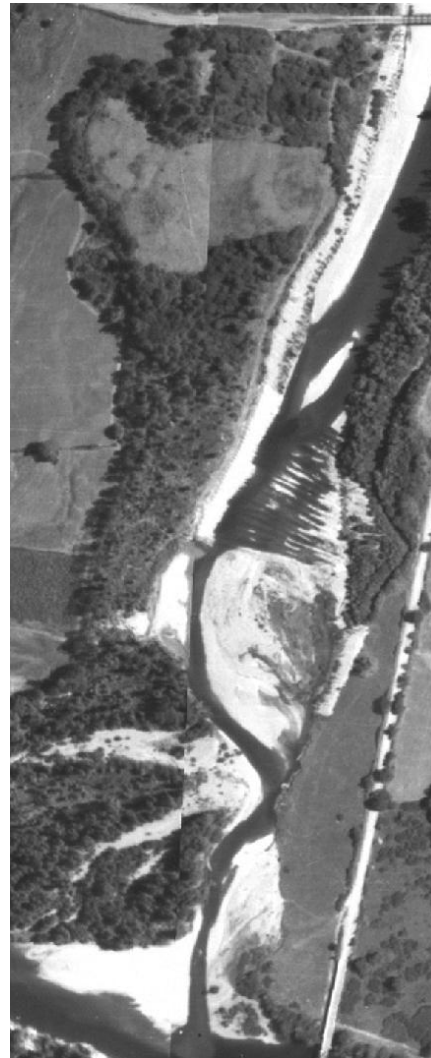
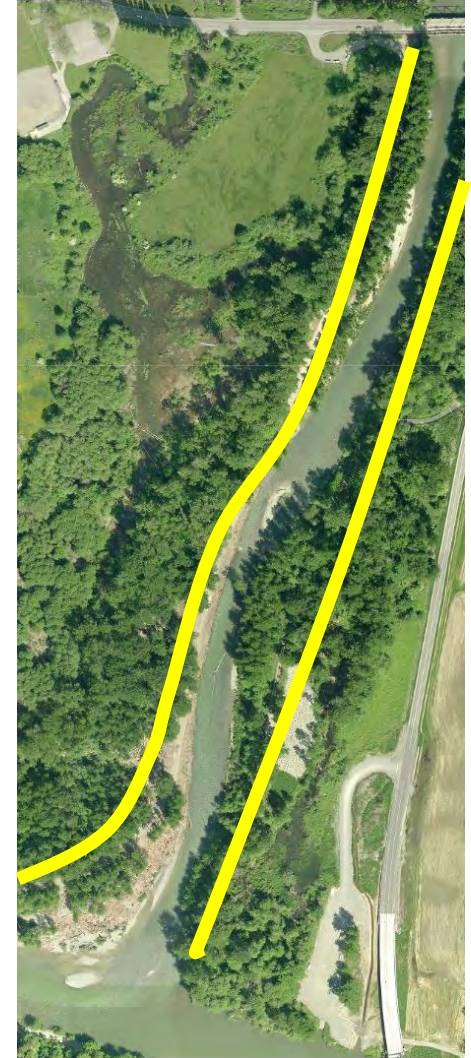
1936

2009

## PROBLEM:

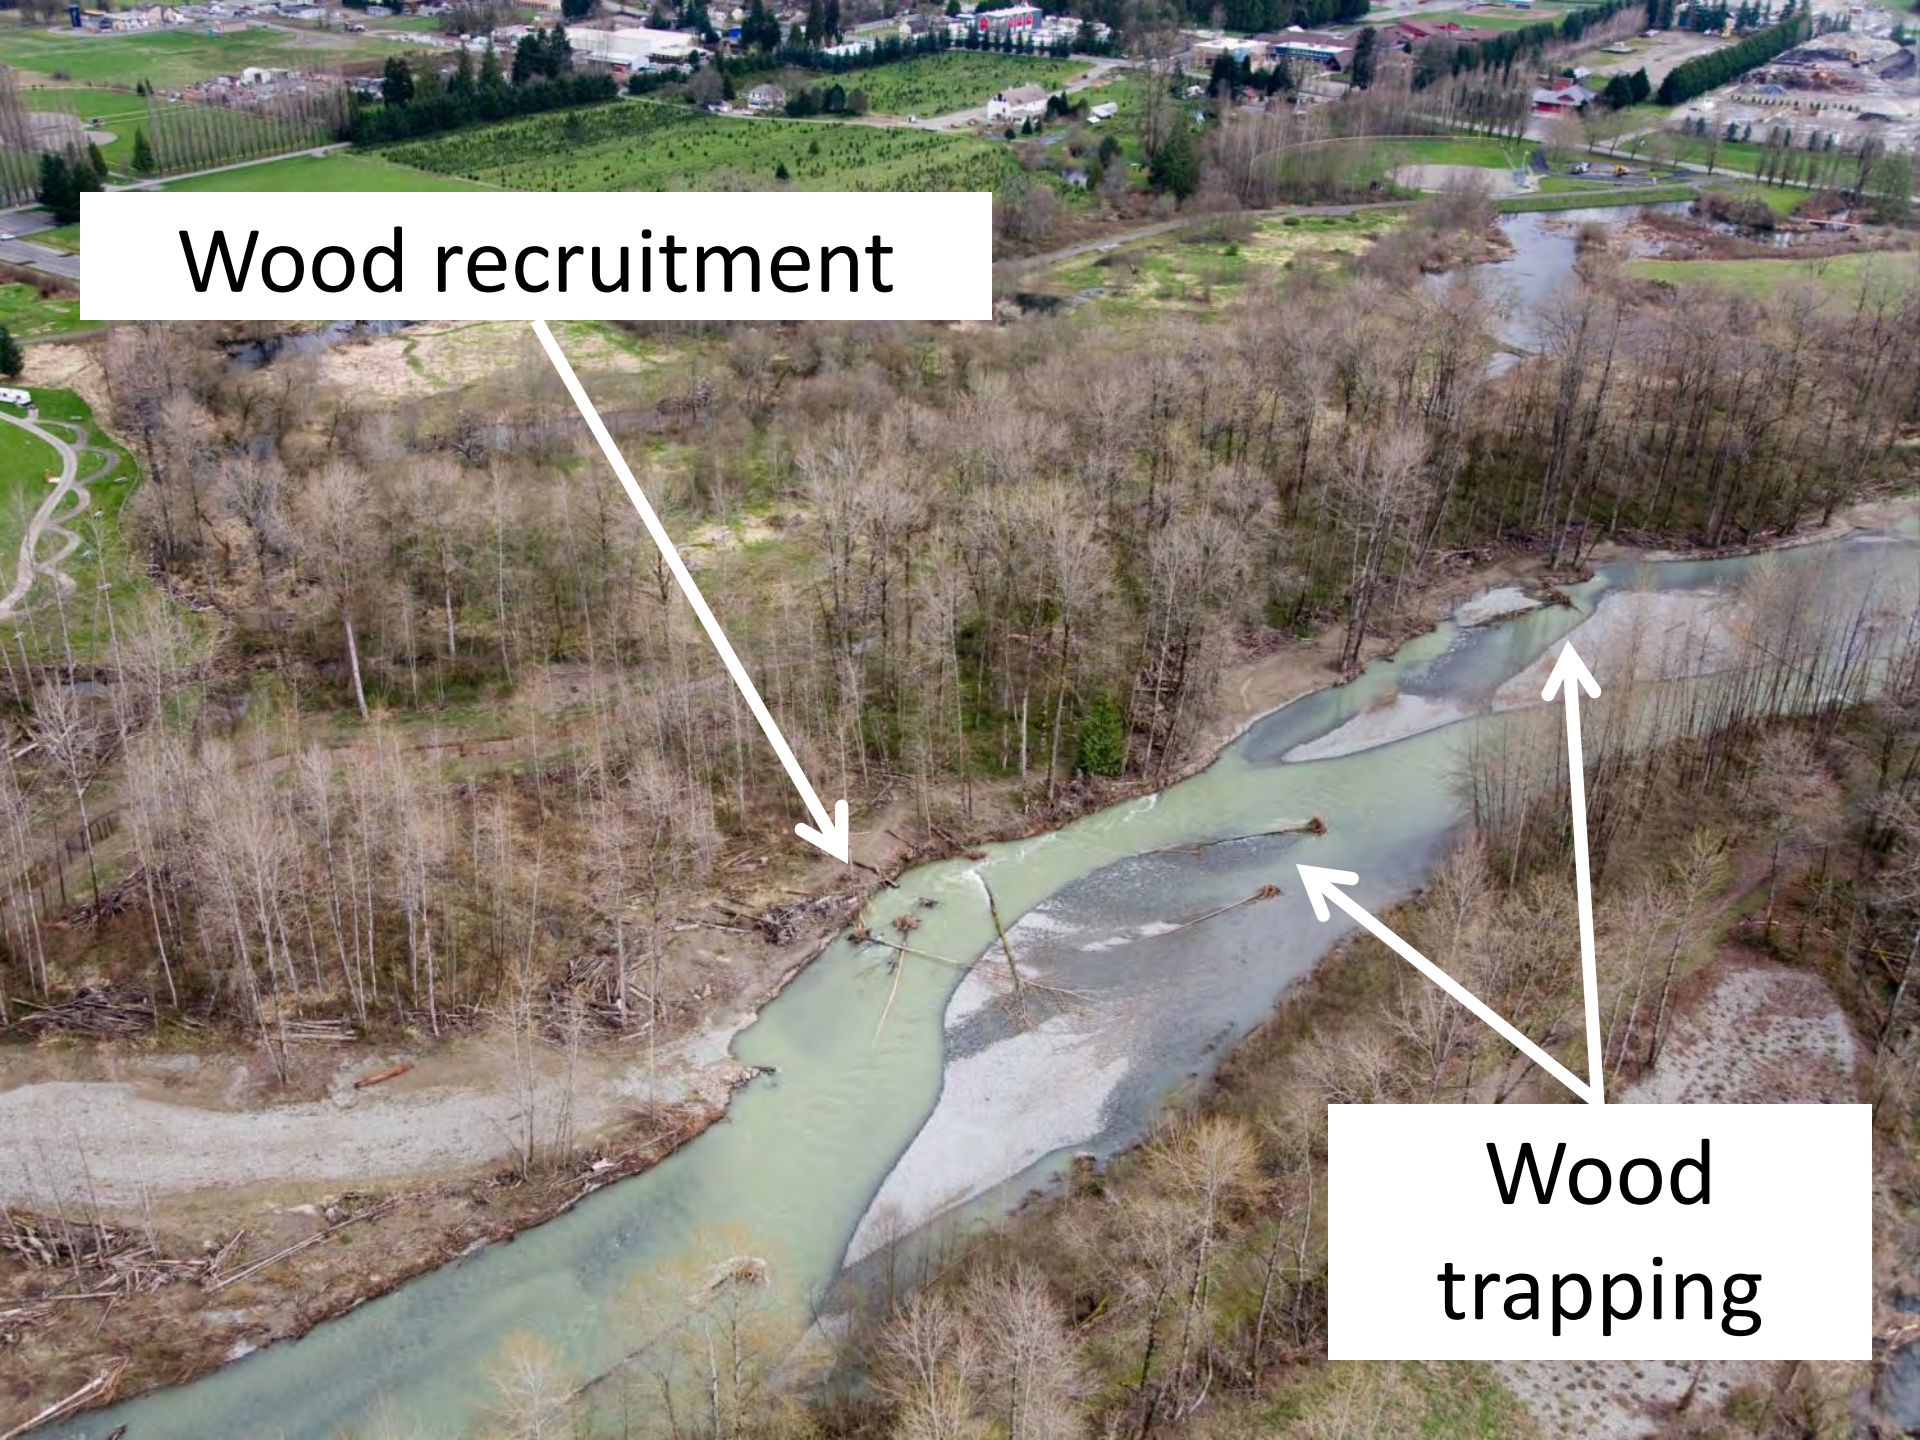
An aerial photograph of a river flowing through a wooded area. The river is light green, indicating turbidity. There are several large, light-colored sandbars or gravel bars in the river. The surrounding forest is mostly bare trees, suggesting late autumn or winter. In the background, there are some buildings and a parking lot. Two white arrows point from text labels to specific areas in the river. One arrow points to a section where a large log is partially submerged, and the other points to a section where a large log is completely submerged.

Wood recruitment

Wood  
trapping

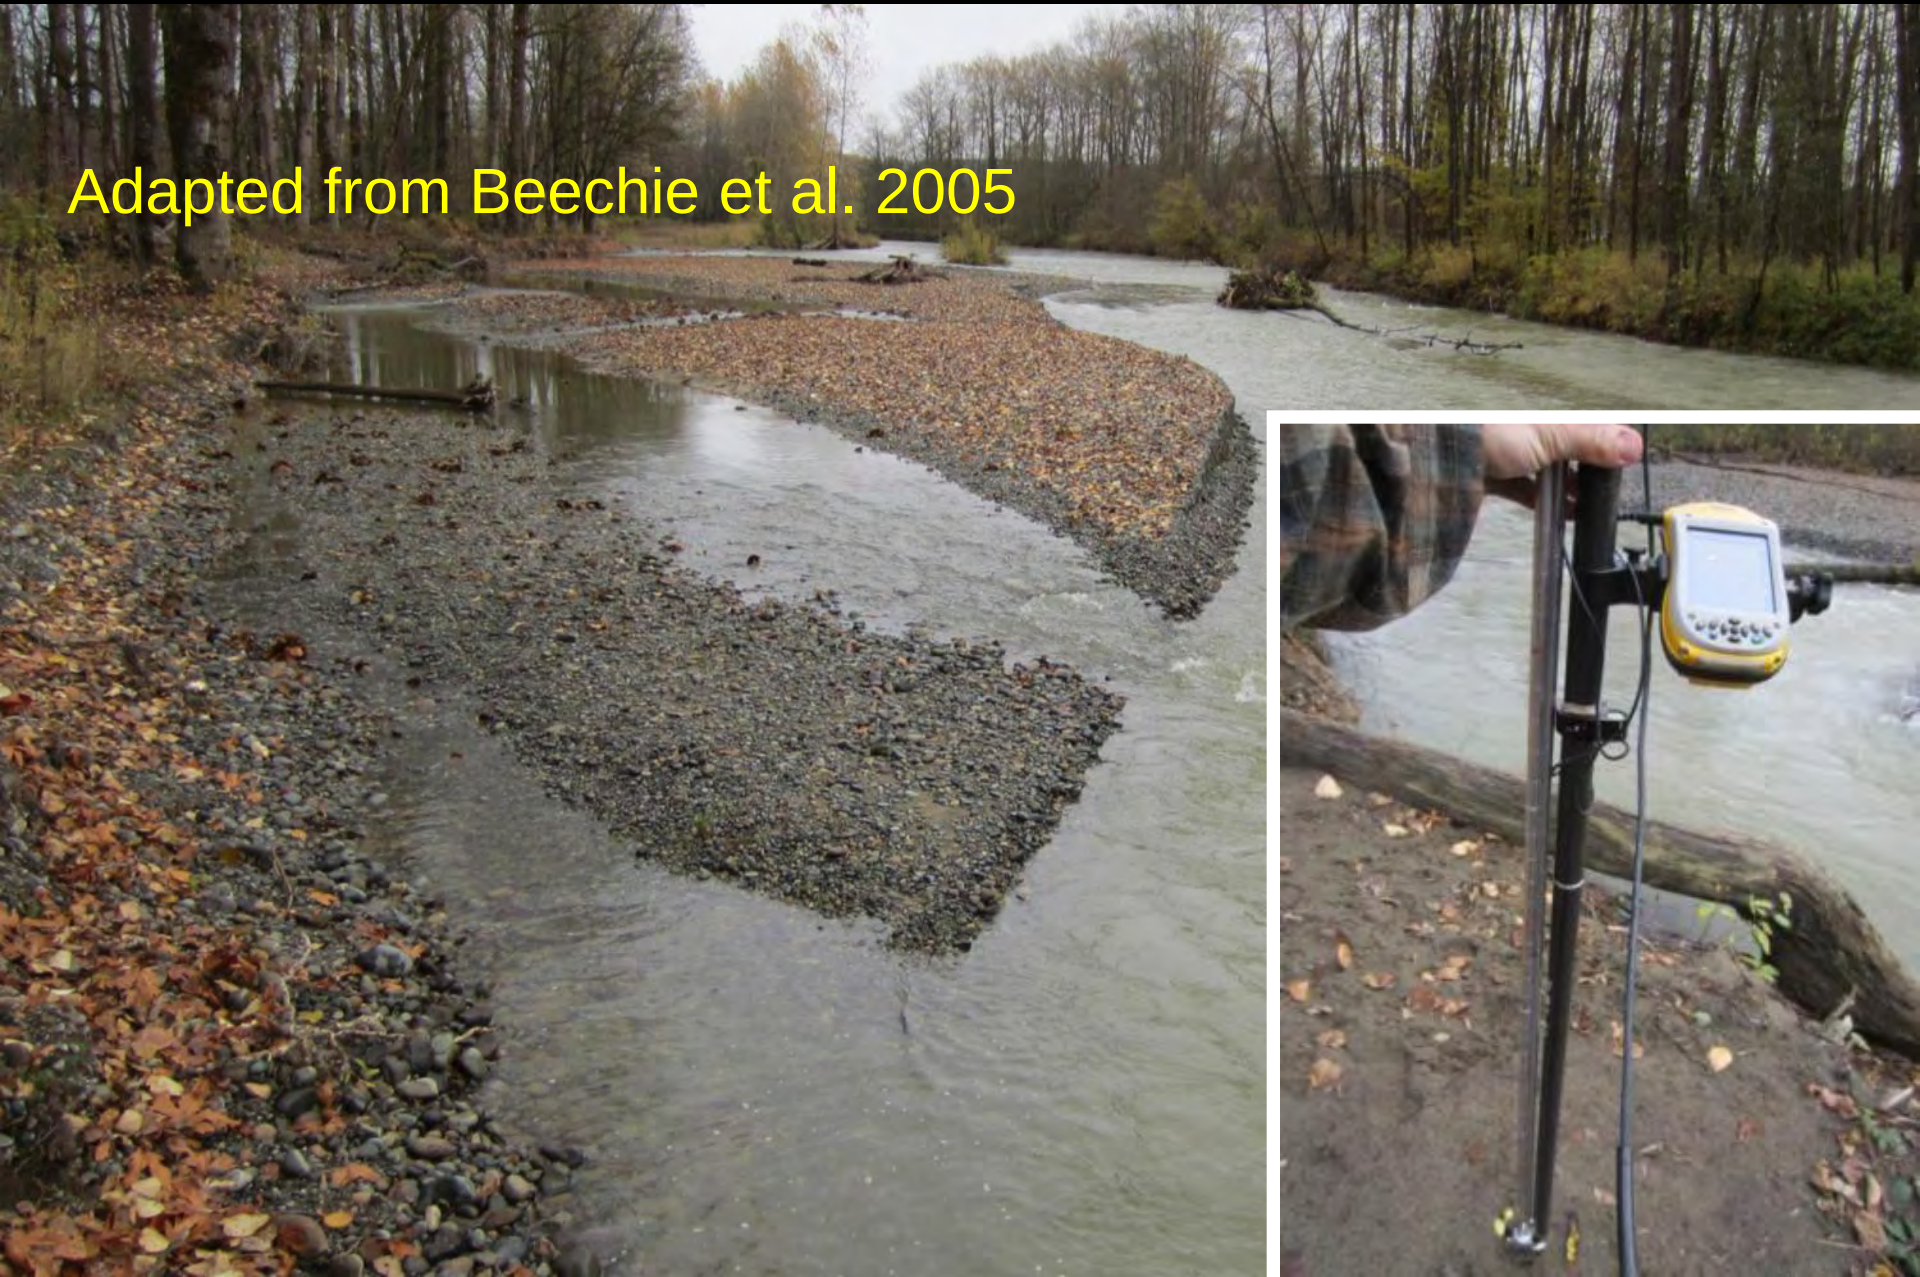
# LOW-VELOCITY EDGE MAPPING

Adapted from Beechie et al. 2005
