# **Fir Island Farms 3<sup>rd</sup>-year Post-Restoration Tidal Marsh Monitoring Report**

9 December 2019

W. Gregory Hood  
Skagit River System Cooperative, LaConner, WA

prepared for  
Washington Department of Fish and Wildlife

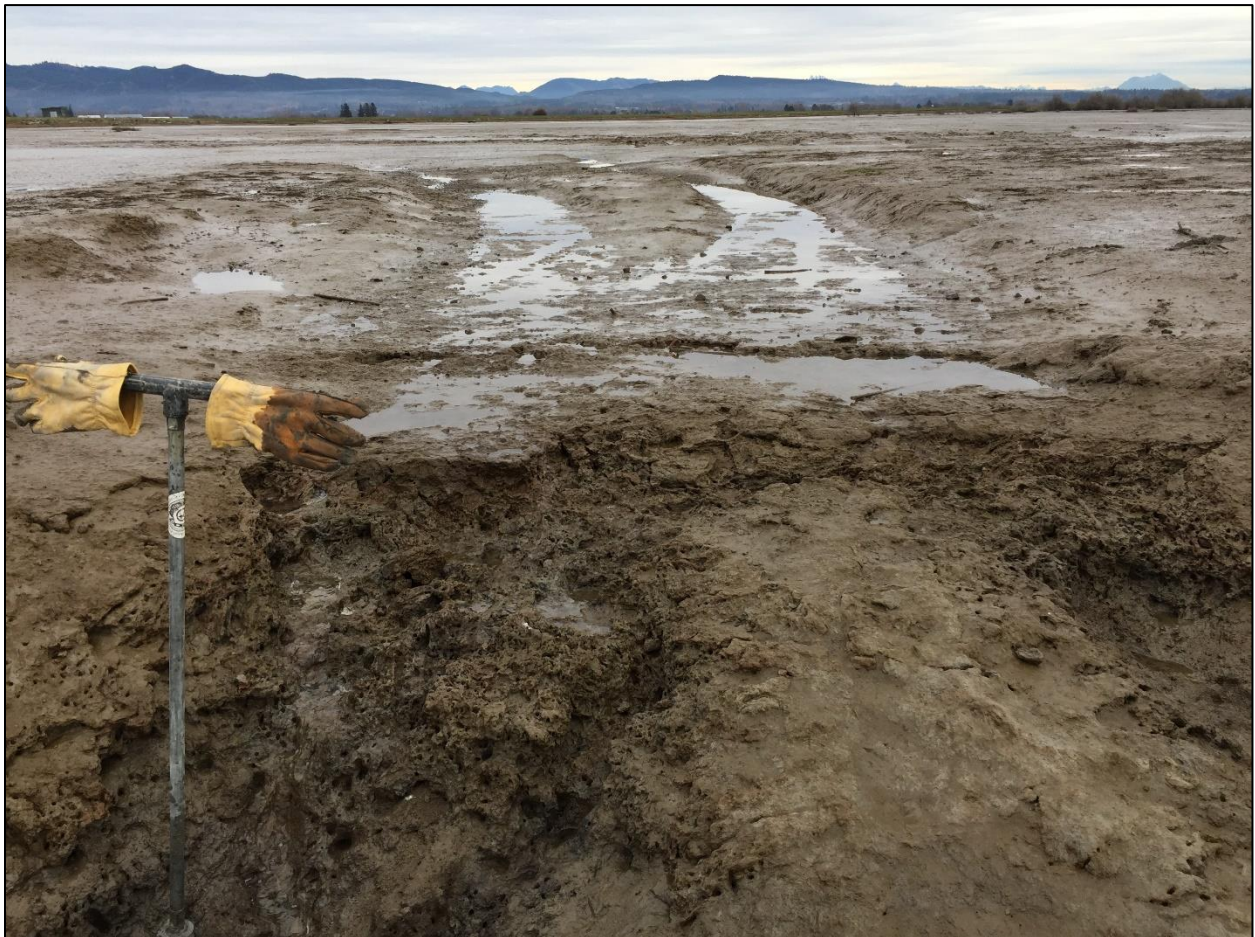
A view of an incipient tidal channel on the Fir Island Farms restoration site. The channel has been eroded by tidal flushing, but constrained in its development by clay hard pan. The view is at low tide from an excavated tidal channel to which the incipient channel is a tributary. The soil auger is for scale.

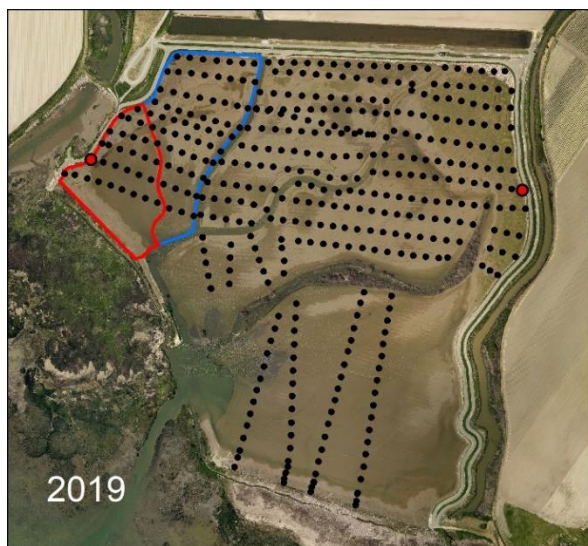
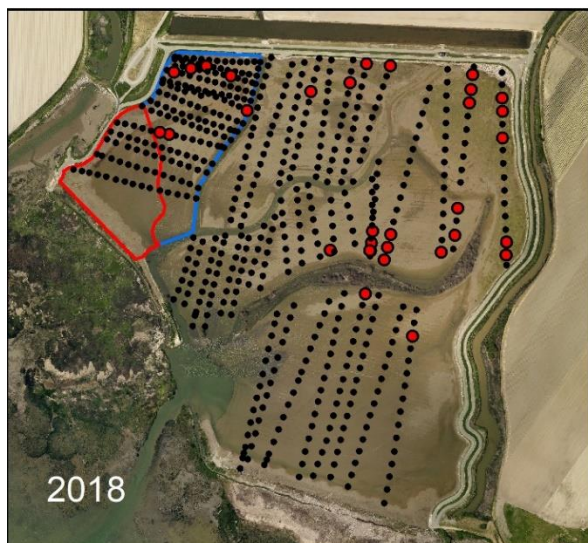
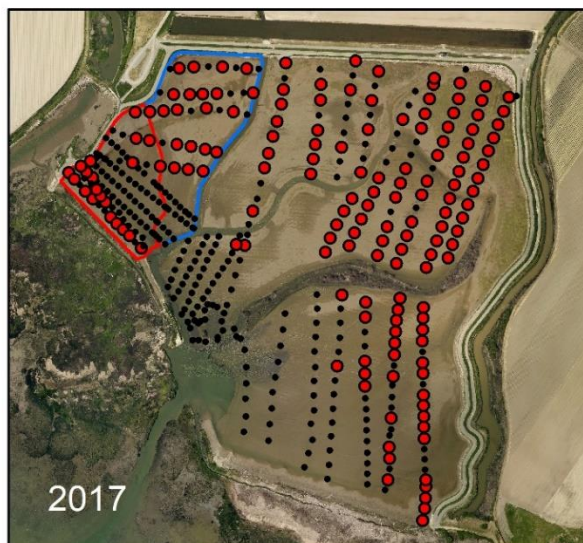
**Figure 3.** Contrasting presence (red circles) and absence (black dots) of non-native cattail (*Typha angustifolia*) for RTK-GPS survey points within the restoration site in 2019 vs. 2018 vs. 2017. Areas experimentally seeded with native sedges are outlined by red and blue polygons. Background photo is from 2017.

Bare ground was extensive at lower elevations; it had a mean elevation of 1.74 m (NAVD88) in 2019, compared to 1.75 m in 2018 and 1.67 m in 2017. In 2017 the most abundant plant species within the restoration site was the invasive, non-native cattail (*T. angustifolia*), which dominated 52% of the vegetated sampling points, and was present as a dominant or subdominant in 64% (Fig. 2). Following control efforts to reduce the presence of this invasive species, cattail was dominant in only 0.5% of vegetated sampling points in 2018, and was present as a dominant or subdominant in only 8%. In 2019, cattail was not dominant in any portion of the site; it was present in only two spot samples (0.7% of vegetated points), though it was occasionally visible in areas not randomly sampled—along the higher margins of the site, and only as a subdominant presence in areas dominated by maritime bulrush (*Bolboschoenus maritimus*). This striking reduction in the occurrence of cattail was visibly evident when walking through the restoration site (Fig. 3).

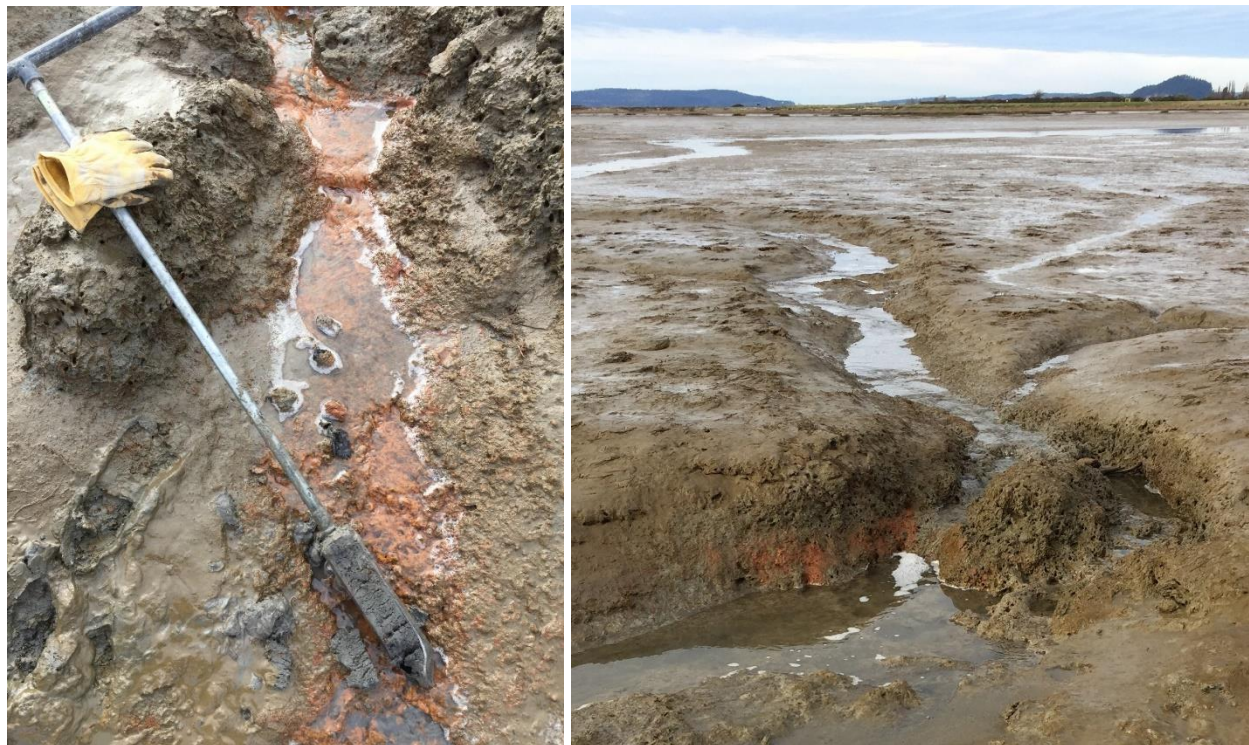
**Figure 12.** Surface exposure of clay soils in shallow tidal channels showing rusty colors diagnostic of iron-oxides bound to clay particles. Sediment in the auger is not rusty because at depth it is not exposed to oxidation. These tidally-eroded channels have limited depth due to the erosion resistance of the clay.

limits the depth to which channels can erode, thereby forcing much of the tidal exchange to occur over the marsh surface as sheet flow rather than channelized flow, which further limits development of channel networks through tidal erosion. Soil auger samples showed that the clay layer extends from near the surface of the marsh to depths as much as four feet below the marsh surface (Fig. 11). Soil texture, determined using the ribboning technique (Ritchey et al. 2015), indicated the soil was a sandy clay loam (ribbons generally varying in length from 25 to 50 mm, with gritty feel). Surface exposures of clay soils were compact and erosion-resistant, with a rust color that is diagnostic of positively charged iron-oxide particles bound to negatively charged clay particles (Fig. 12).
