# Fisher Slough Tidal Marsh Restoration

## 2012 Monitoring Report

Skagit River System Cooperative, LaConner, WA

May 2013

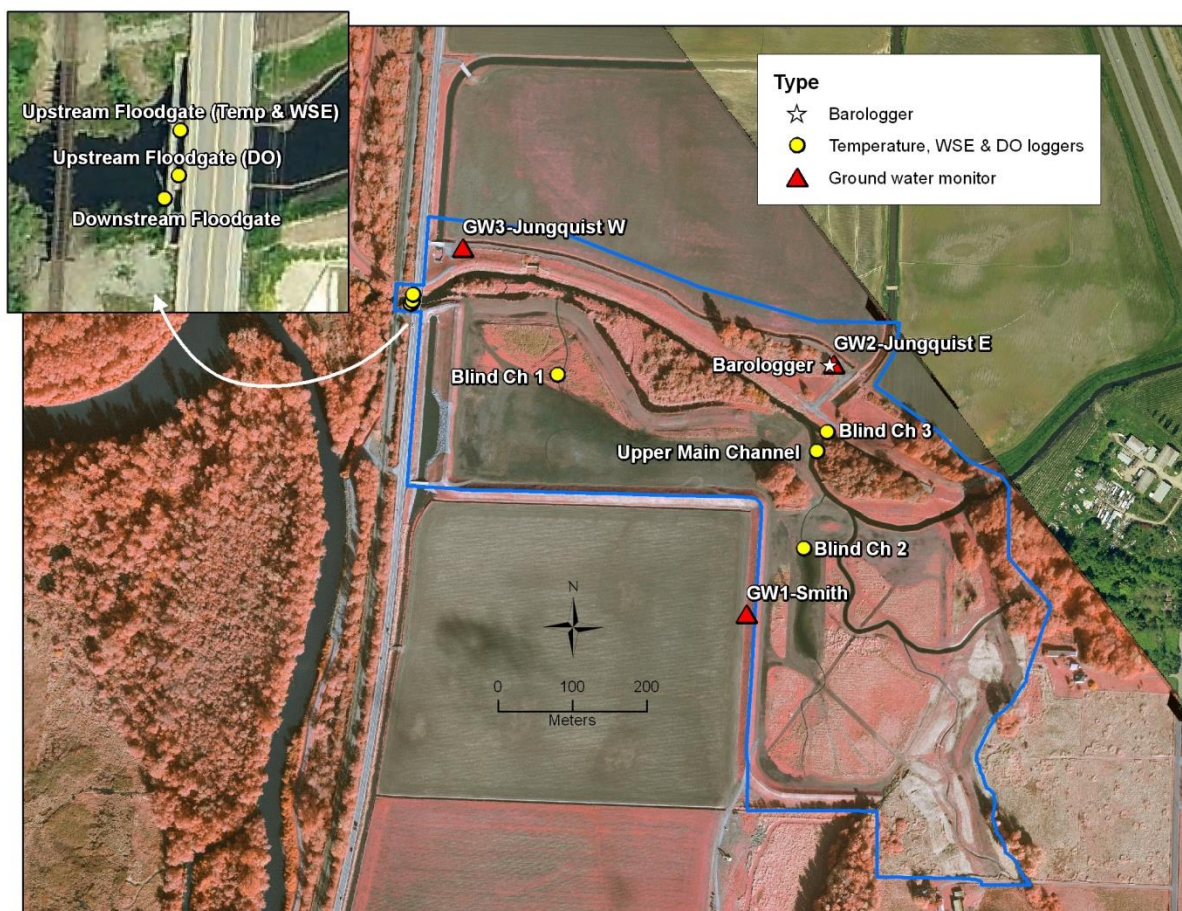
Figure 1-3. Location of barometric pressure (barologger), groundwater, water surface (WSE), and DO monitoring equipment for Fisher Slough project site. Datalogger at Downstream Floodgate also includes floodgate-door-openness monitoring. Project area is outlined in blue.

Methods used for monitoring the Fisher Slough Project are detailed in Parametrix (2010) unless otherwise noted in sections below. Locations of monitoring equipment are shown in Figure 1-3.

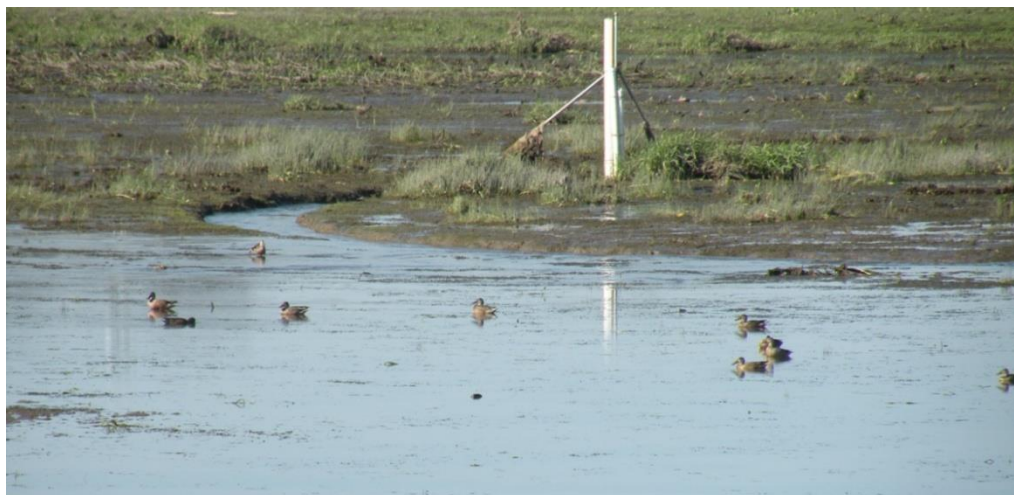
Figure H3-4. Ducks using the flooded portions of the newly restored Fisher Slough acreage in Blind Channel 1 (September 24, 2012); a water surface elevation logger is visible in one of the excavated tidal channels in the background. See photos in section H5 for additional examples of site inundation.

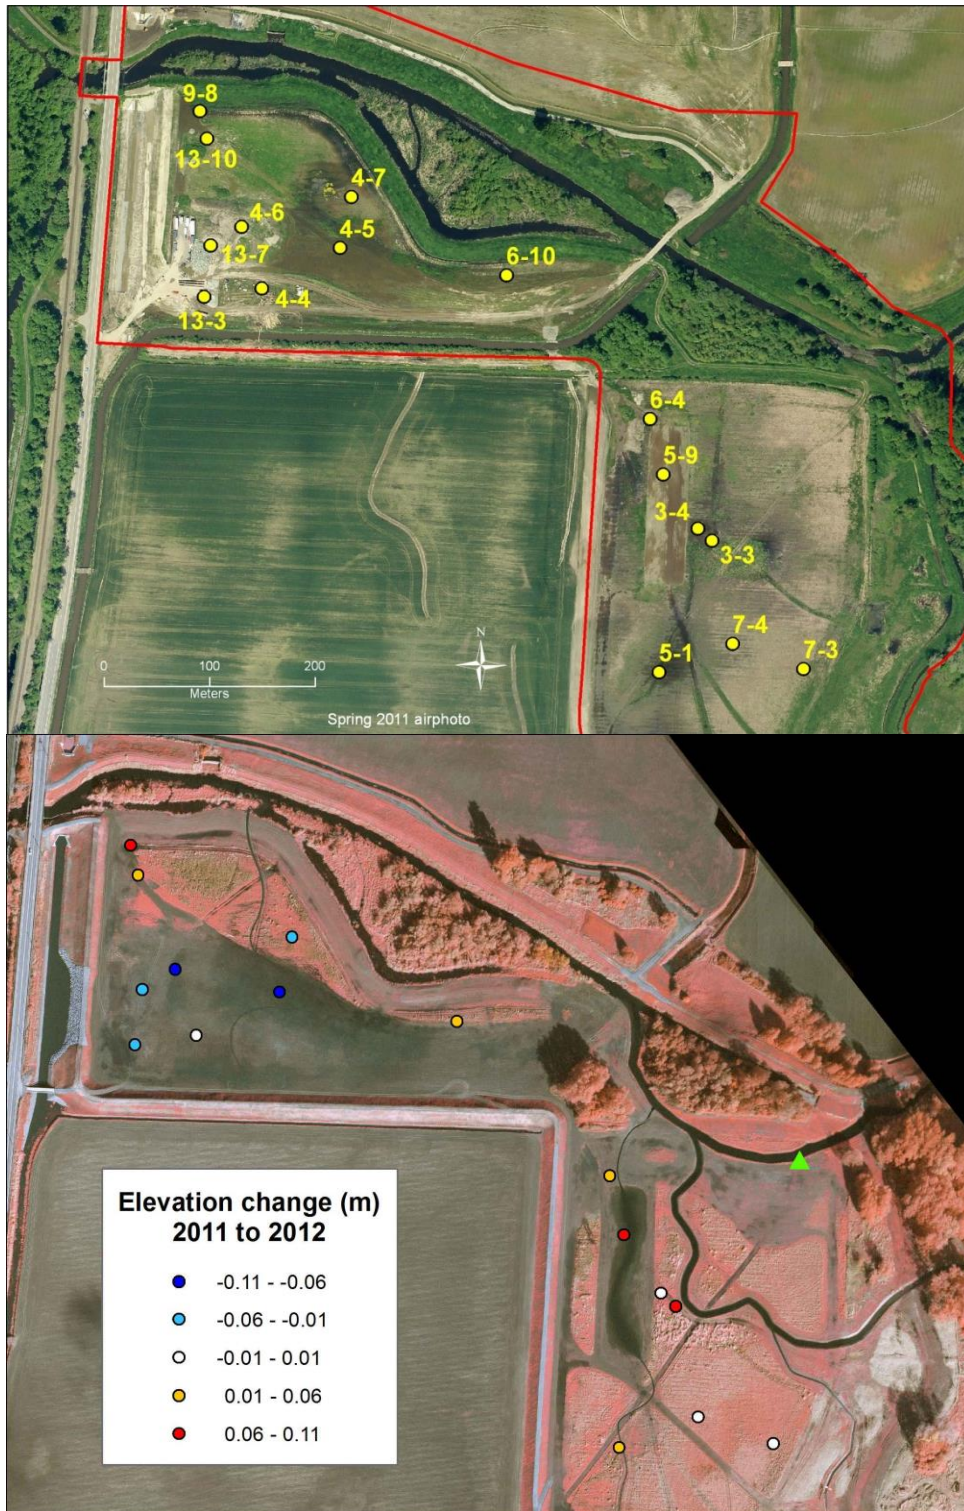
Figure H4-1. Top frame: Sediment stake locations (see Table H4-1 for elevations). Project area is outlined in red. Bottom frame: Elevation change at sediment pins (shown on October 2011 airphoto). Negative values (blue) indicate erosion; positive values (orange-red) indicate sedimentation. Green triangle indicates likely new tidal channel initiation.

The early results suggest the possibility that the restoration targets are simplistic, at least as measured by sediment pins. Erosion and sedimentation appear likely to vary spatially, with greater sedimentation in proximity to tidal channel margins and erosion occurring where new tidal channels are developing. The limited spatial sampling allowed by 16 sediment pins is unlikely to capture the true extent of this spatial variation. More extensive LiDAR data (due in 2015) may do so depending on the amount of vertical change relative to the vertical resolution of the LiDAR.

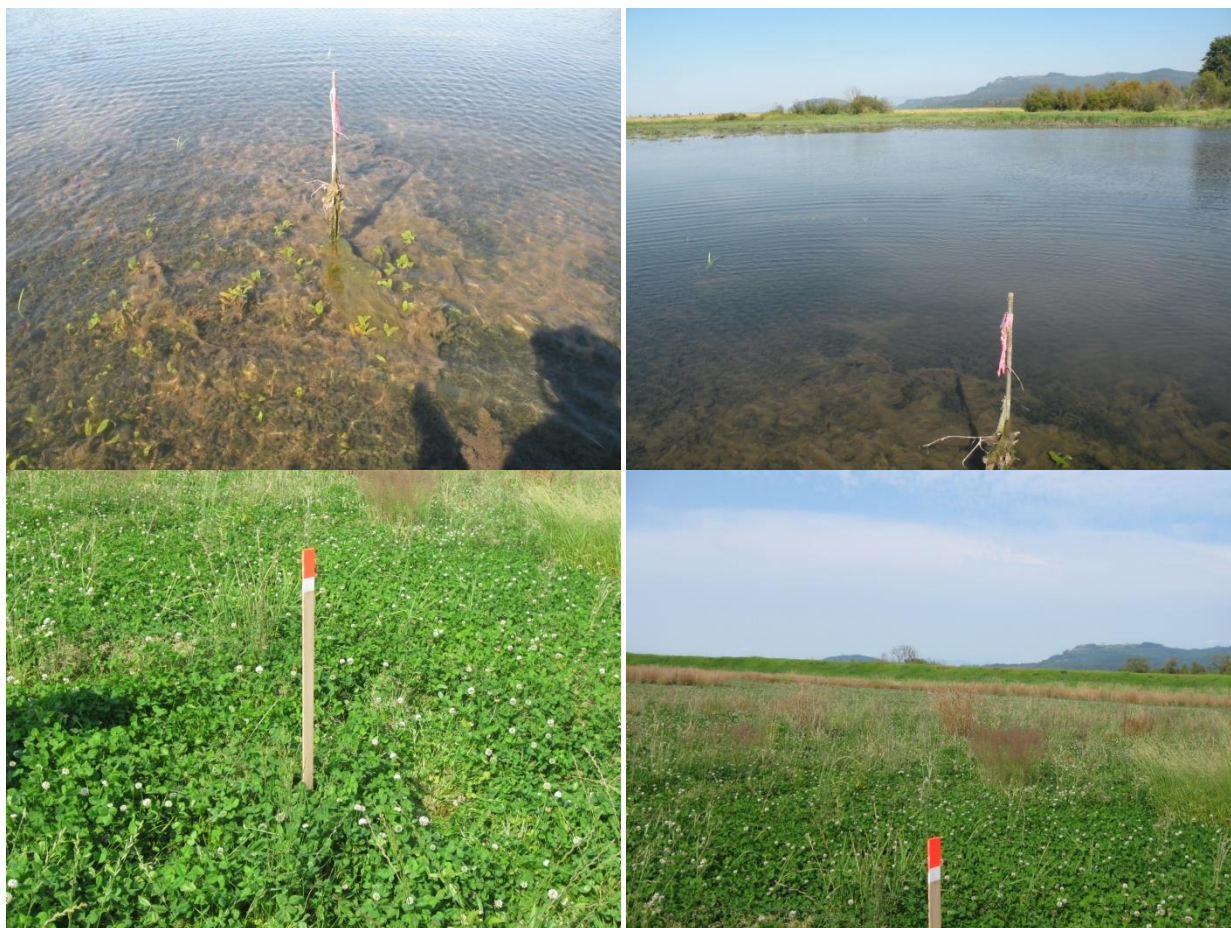
Figure 4-5a (plot-scale, left side), b (landscape-scale, right side) for 2012 (top) and 2010 (bottom). Note that the 2010 photos show a dike in the background (removed by 2012) that obscures view of distant shrub vegetation.

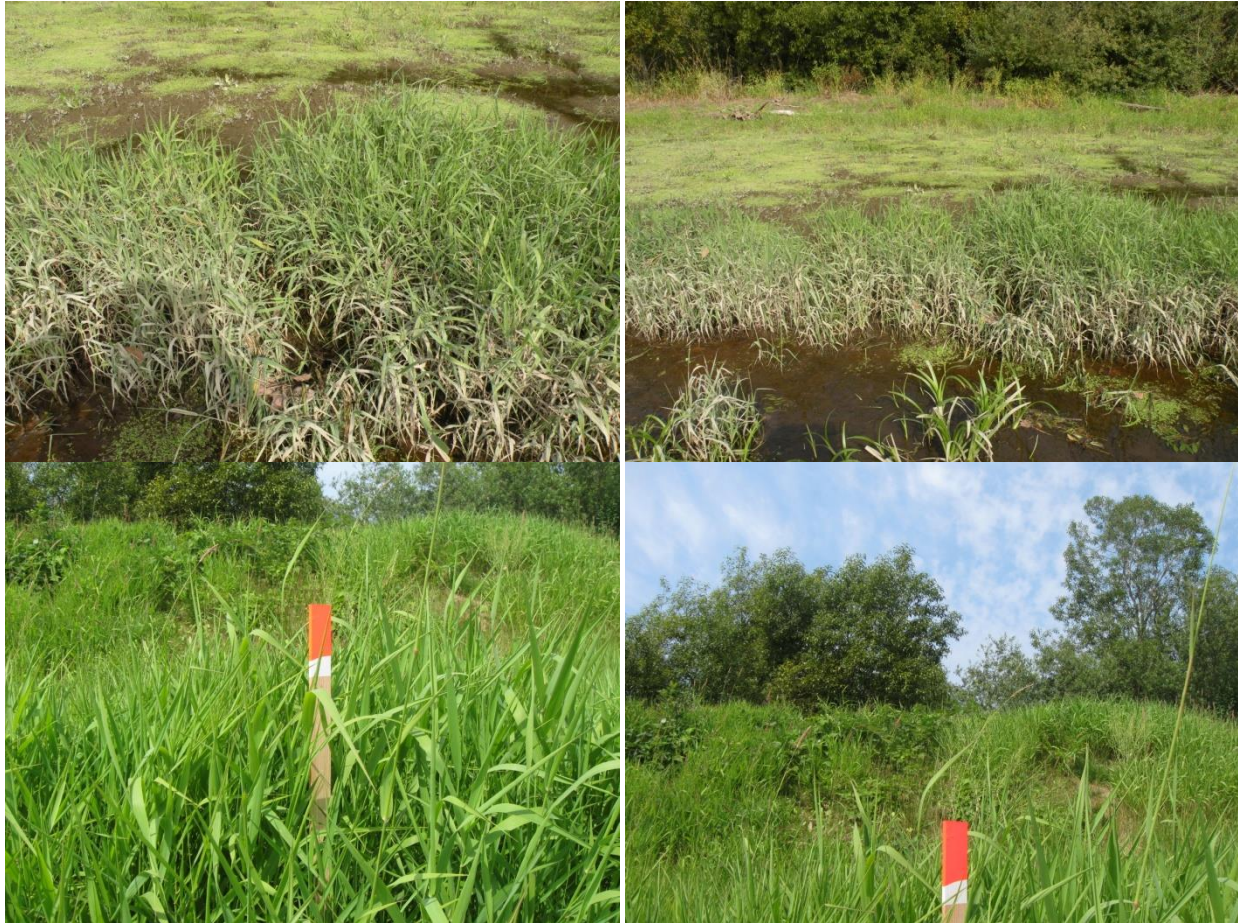
Figure 9-2a (plot-scale, left side), b (landscape-scale, right side) for 2012 (top) and 2010 (bottom). Note that the 2010 photos show a dike in the background (removed by 2012) that obscures view of shrub vegetation; the vegetation in the foreground is reed canarygrass in 2010 and 2012.

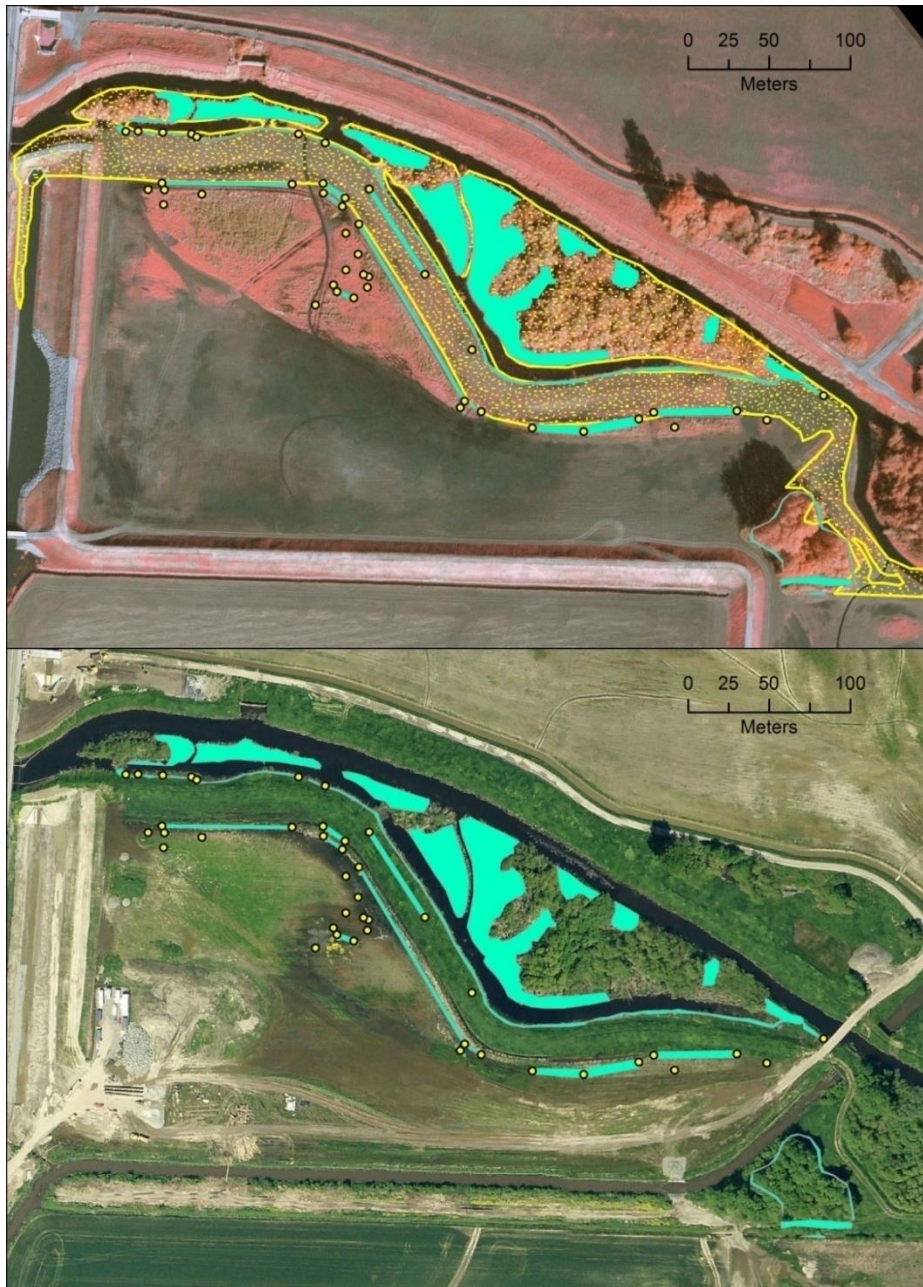
Figure H6-1. Blind Channel 1 (Smith A), with Reed Canary Grass (RCG) patches as green polygons; yellow dots are GPS locations of small RCG patches, the beginning and end of RCG strips, or the edges of large patches (2012 data). RCG distributions are overlaid on photos depicting post- and pre-restoration conditions (October 25, 2011, top frame; summer 2011, bottom frame) to illustrate the association of post-restoration RCG with the pre-restoration borrow ditches and dike margins. For comparison, 2010 RCG distributions are shown as yellow stippling in the top frame.

In retrospect, it seems that pre-restoration treatment of RCG should have been attempted to minimize its ability to persist after restoration. This may be one “lesson learned” from this experience, although hopefully RCG coverage may shrink in Smith A and B fields with continued future inundation.

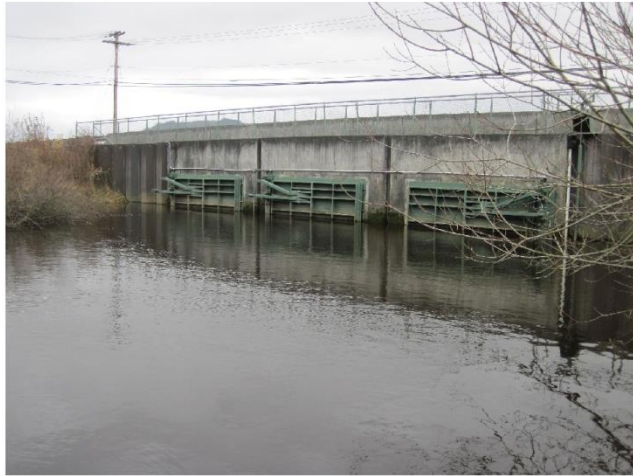
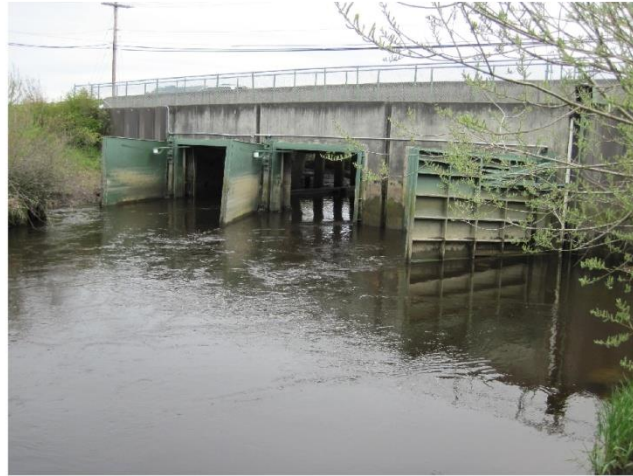
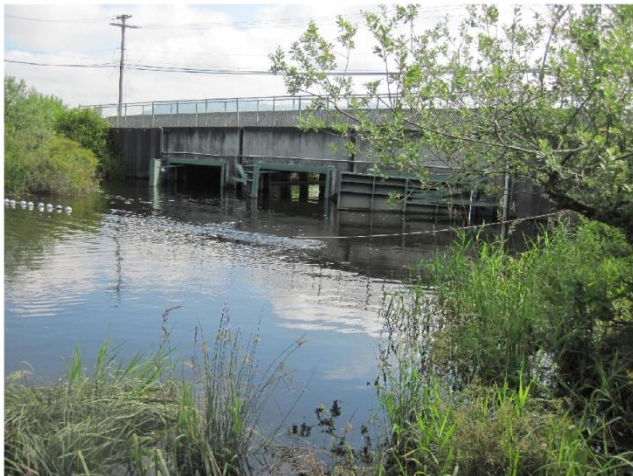
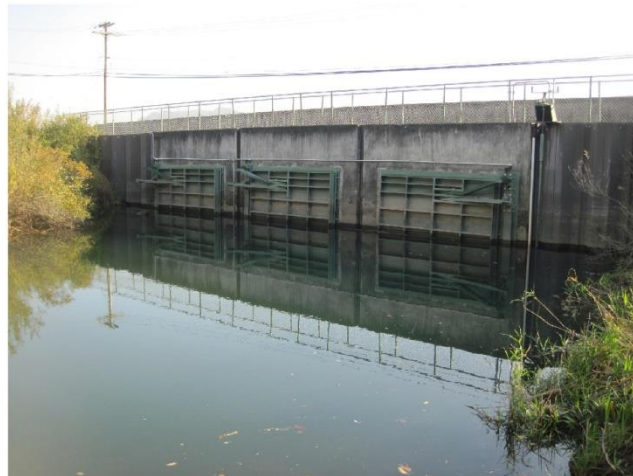
FS01 Photograph 1: Taken from the south bank of Fisher Slough at the railroad bridge looking at the downstream side of floodgates.

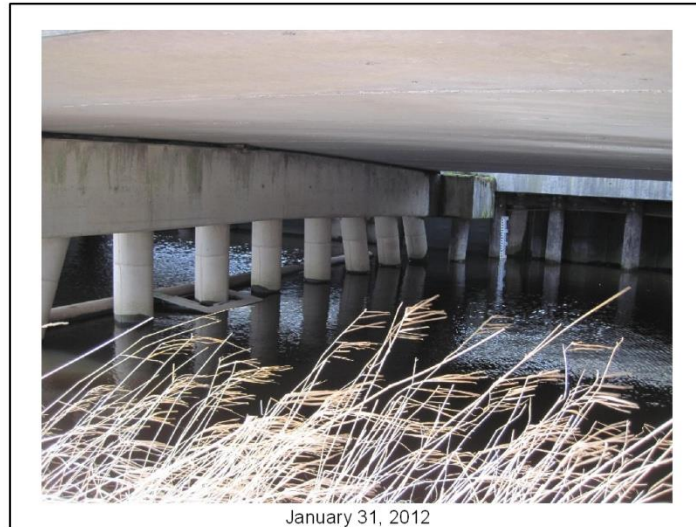
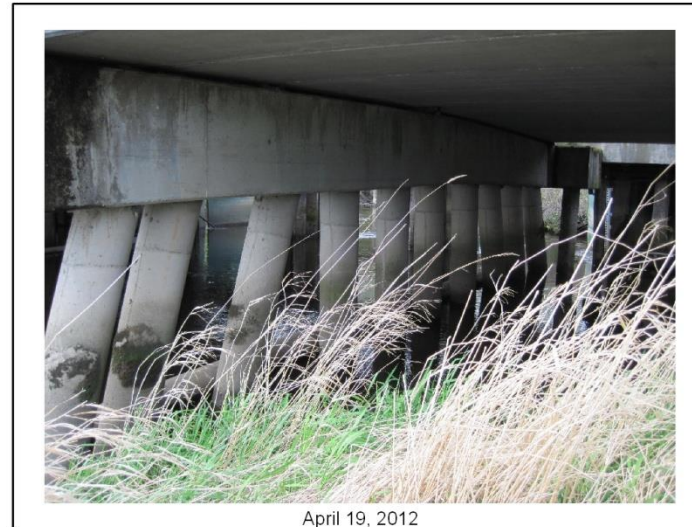
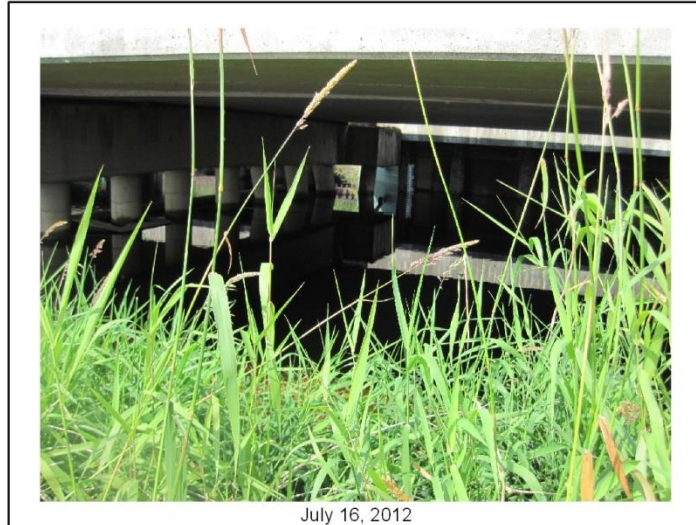
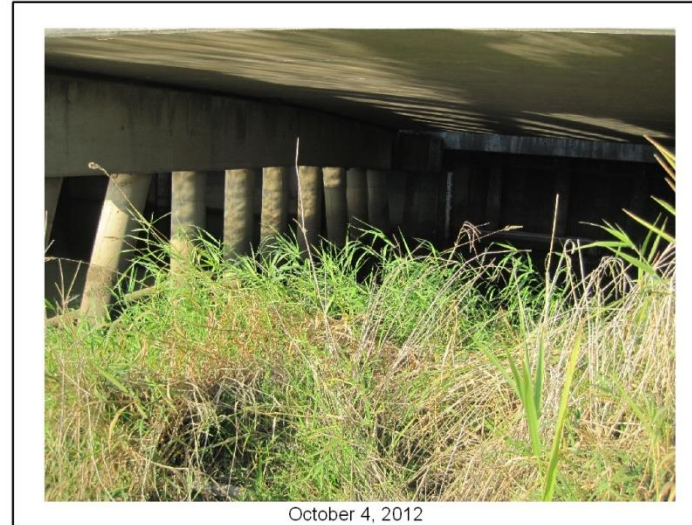
FS02 Photograph 1: Taken from the north bank of Fisher Slough at the highway bridge looking at the upstream side of floodgates.

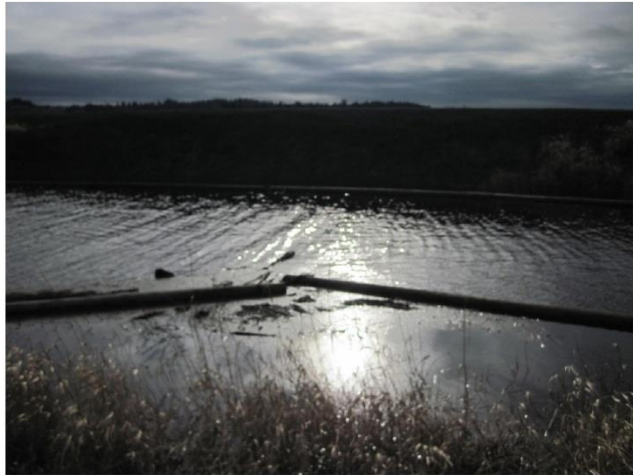
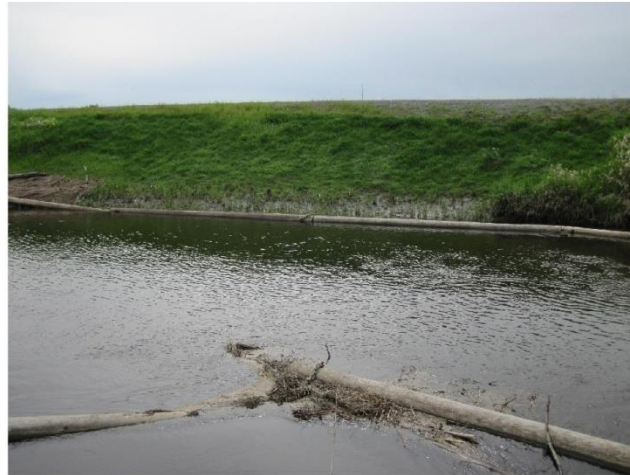
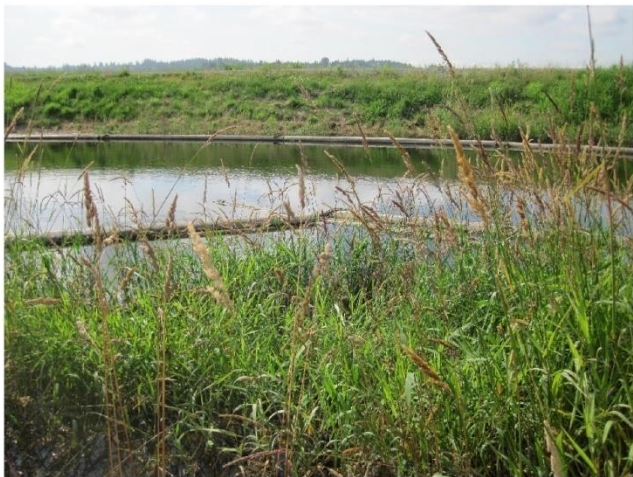
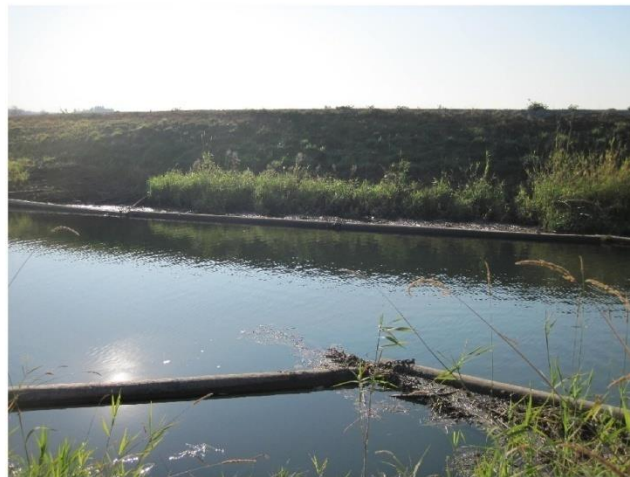
FS02 Photograph 2: Taken from the north bank of Fisher Slough at the highway bridge looking southwest.

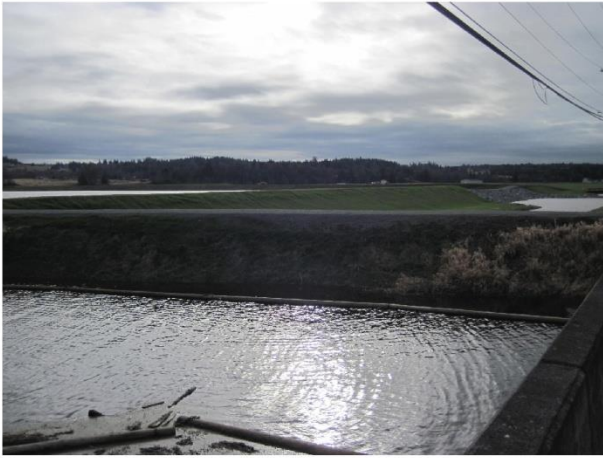
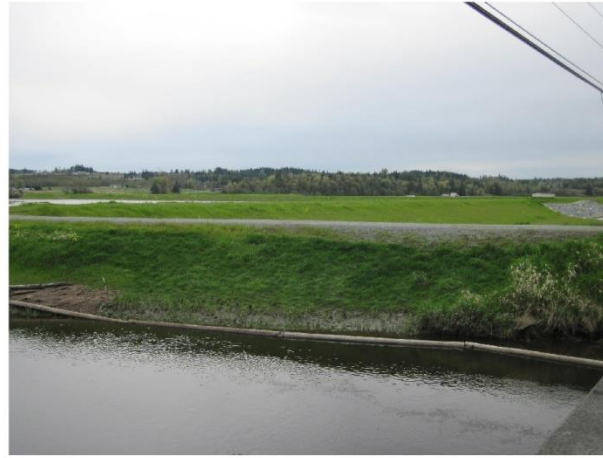
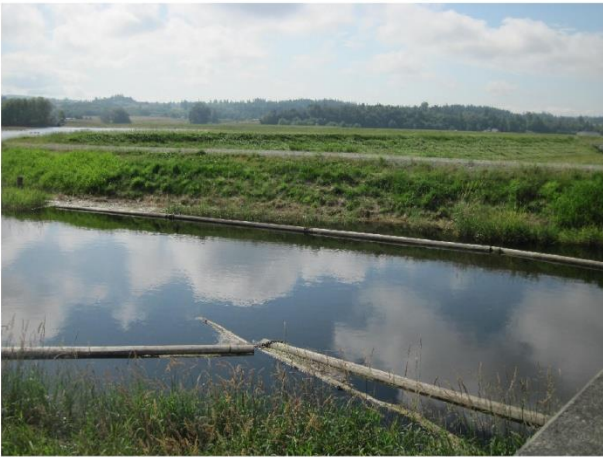
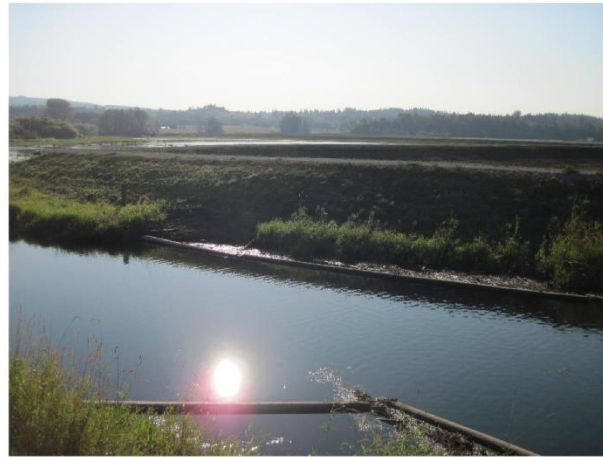
FS02 Photograph 3: Taken from the north bank of Fisher Slough at the highway bridge looking southwest at the new crossing for Big Ditch, the new south levee, and Smith A.

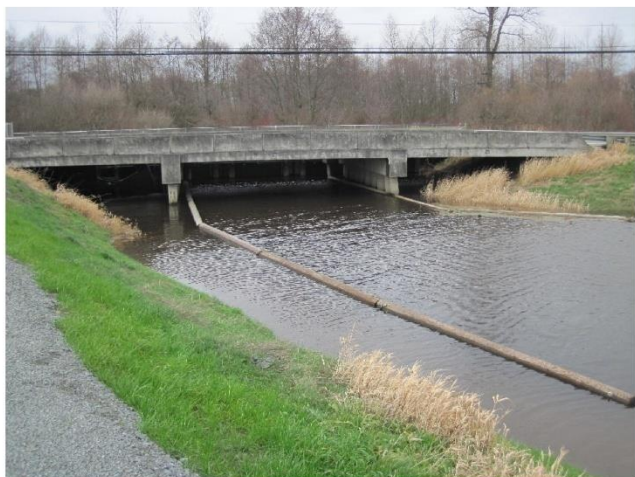
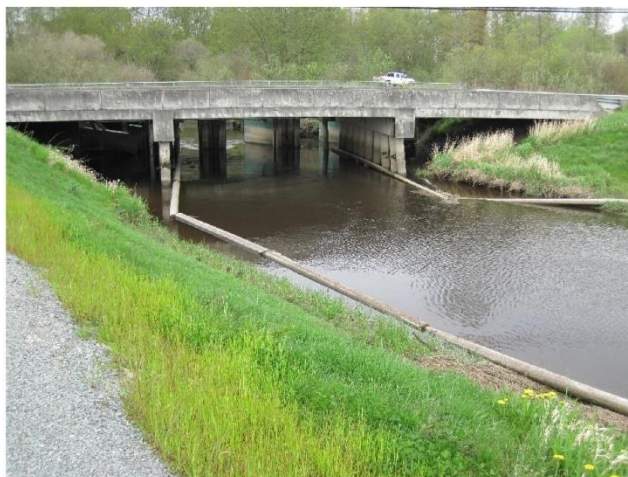
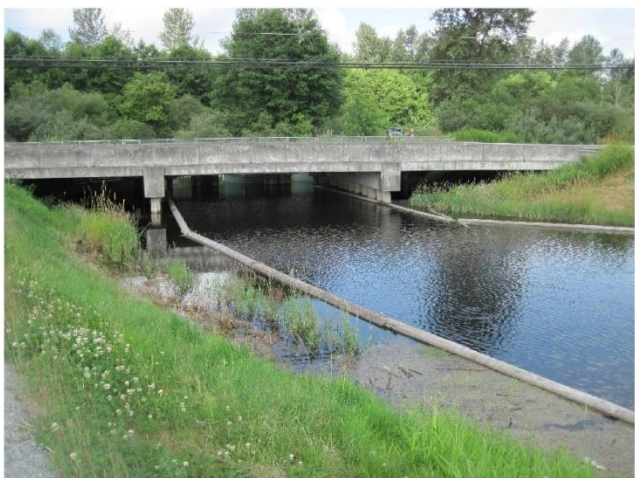
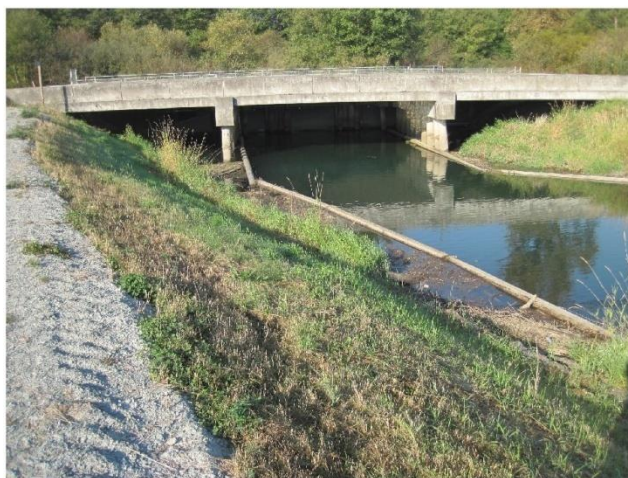
FS03 Photograph 1: Taken from the south levee of Fisher Slough looking at the upstream side of floodgates.

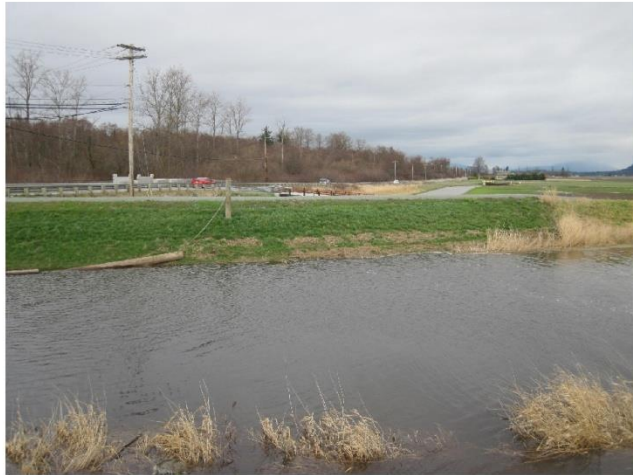
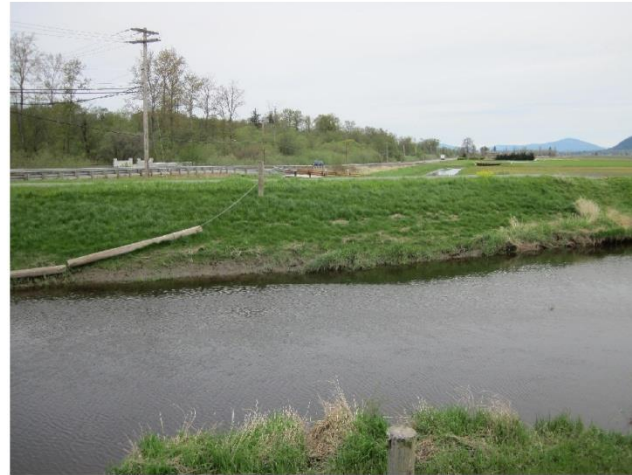
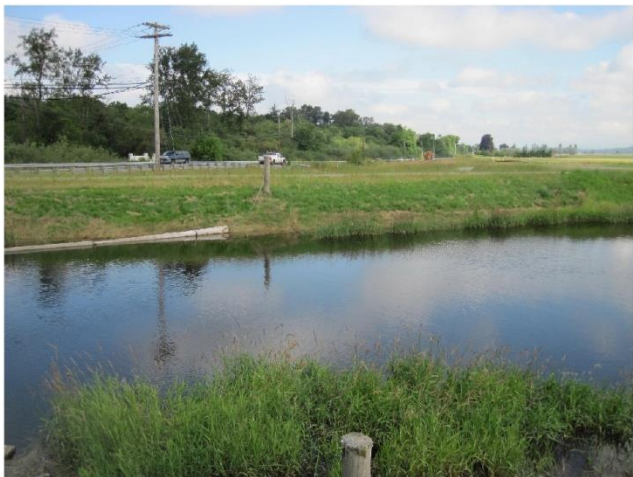
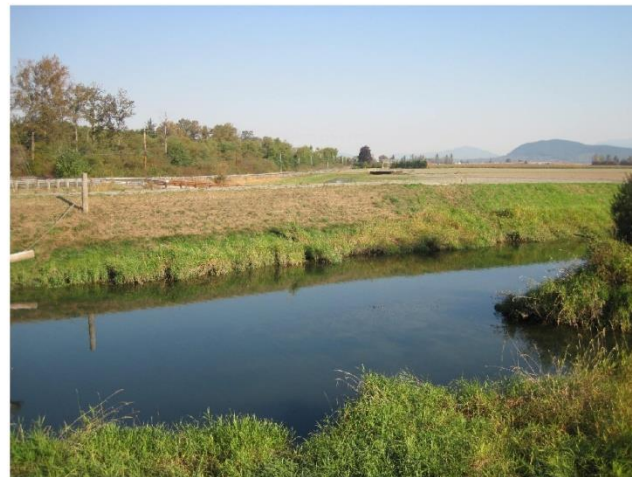
FS03 Photograph 2: Taken from the south levee of Fisher Slough looking northward at north levee.

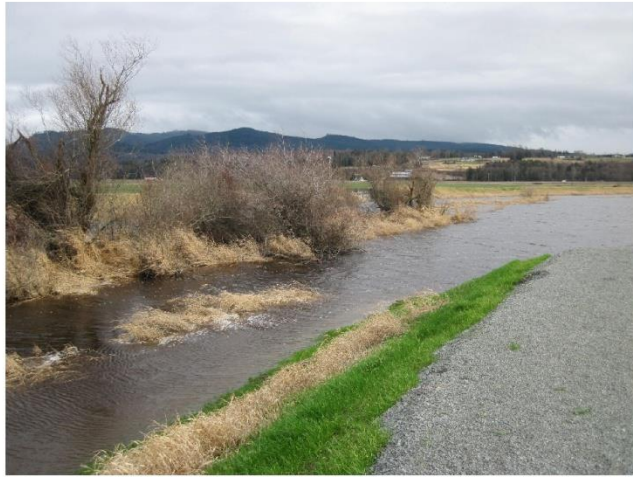
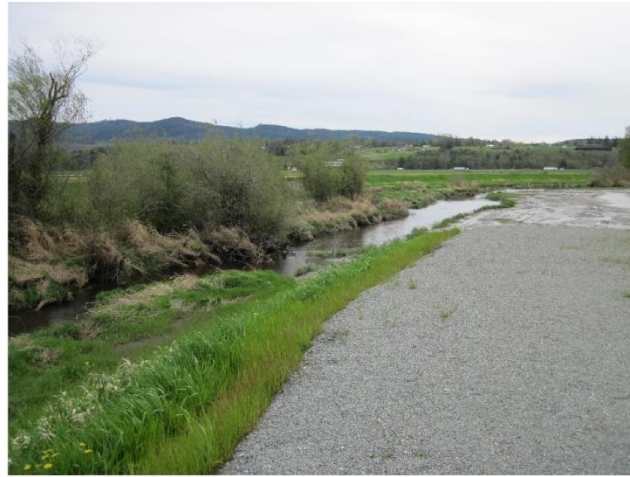
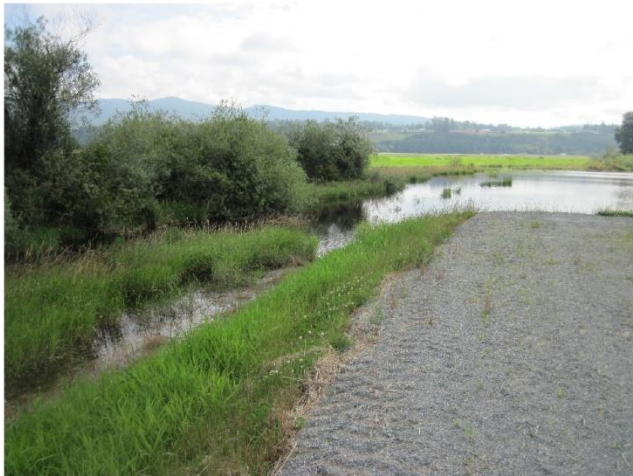
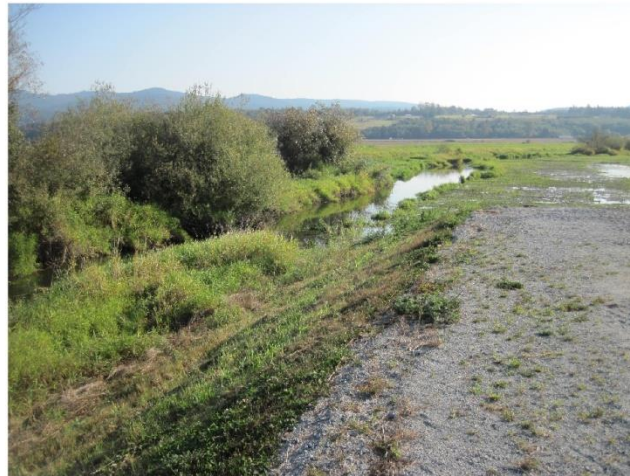
FS03 Photograph 3: Taken from the south levee of Fisher Slough looking eastward at Fisher Slough.

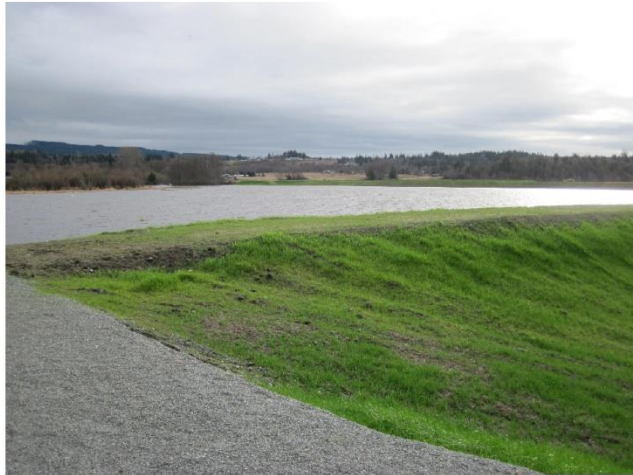
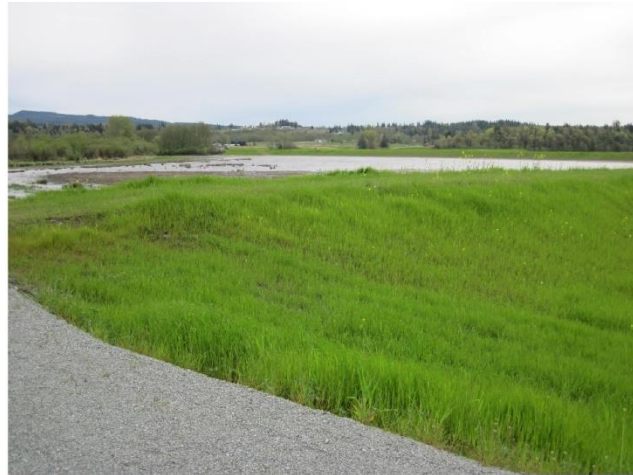
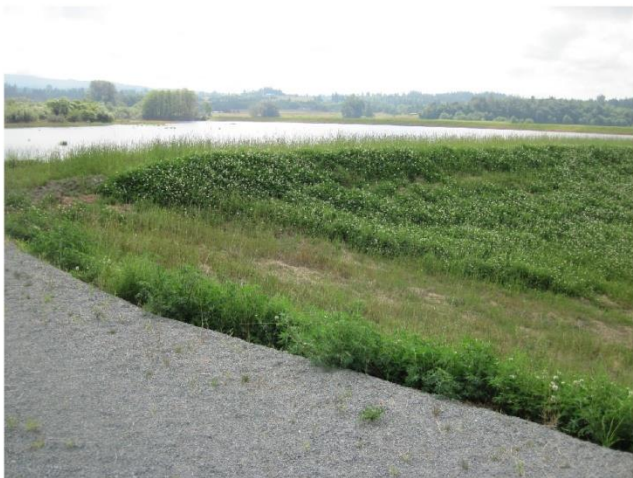
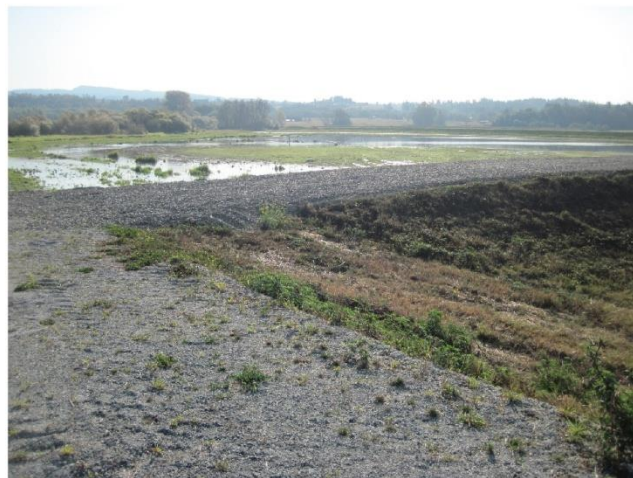
FS03 Photograph 4: Taken from the south levee of Fisher Slough looking southeast at Smith A.

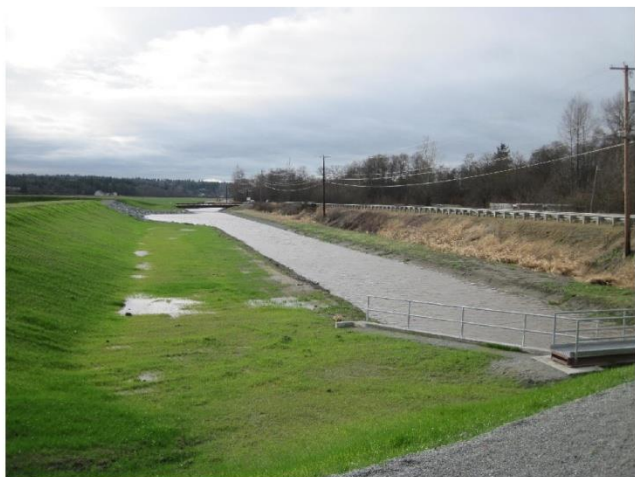
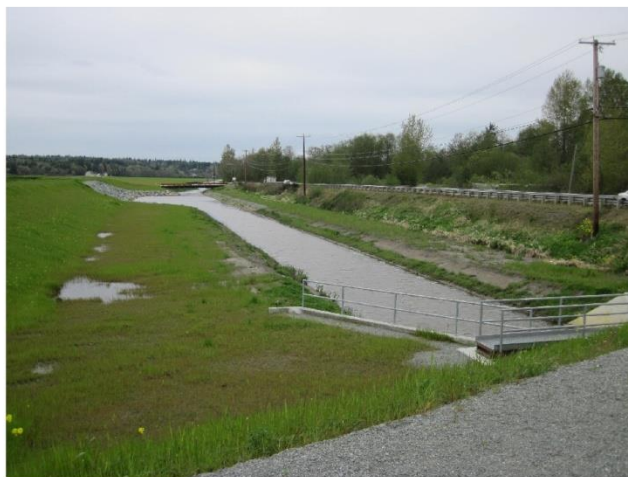
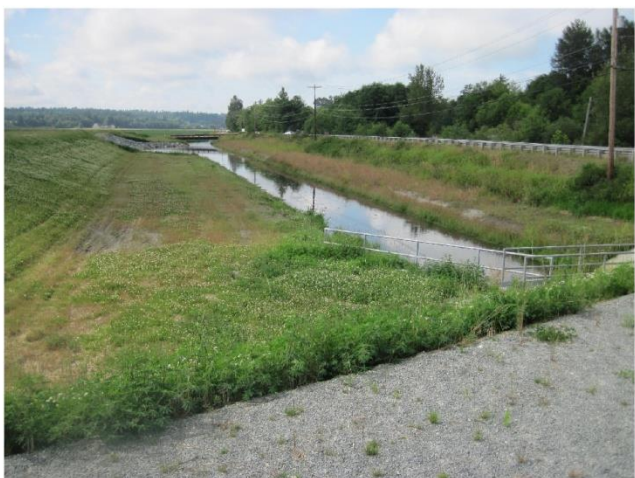
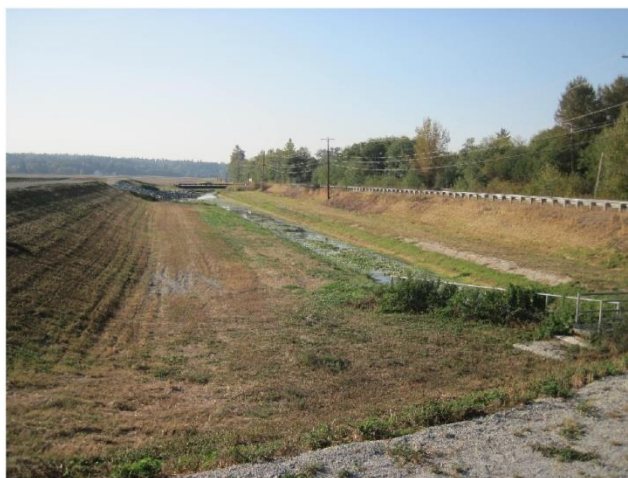
FS03 Photograph 5: Taken from the south levee of Fisher Slough looking south at the new Big Ditch.

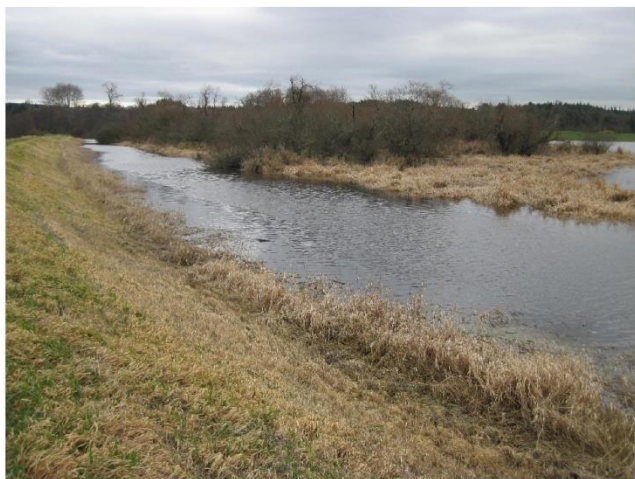
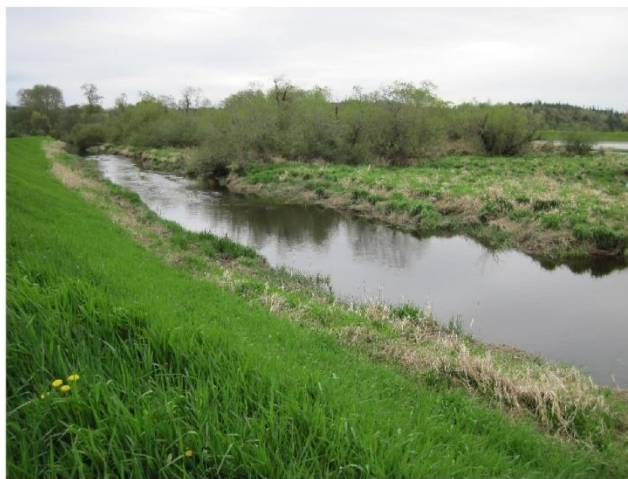
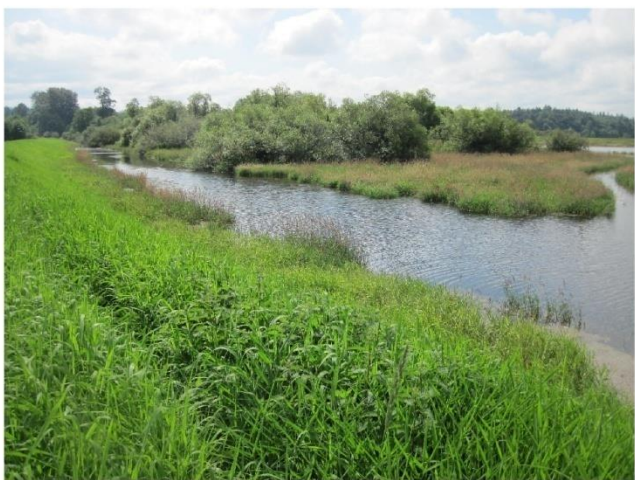
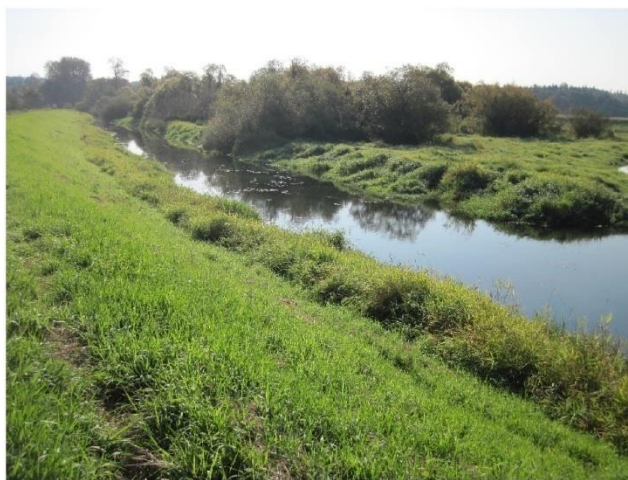
FS04 Photograph 1: Taken from the north levee of Fisher Slough looking southeast at the second marsh island and Fisher Slough.

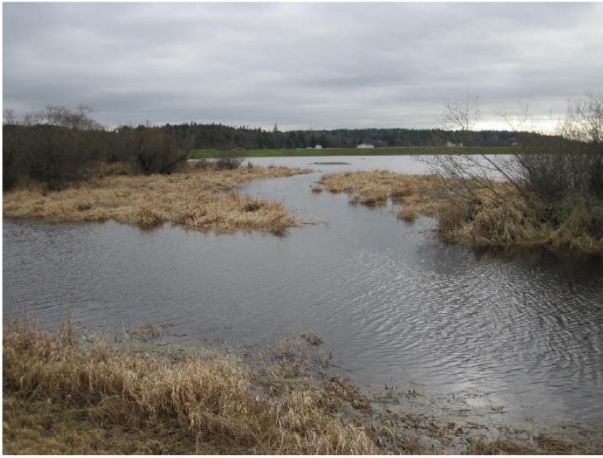
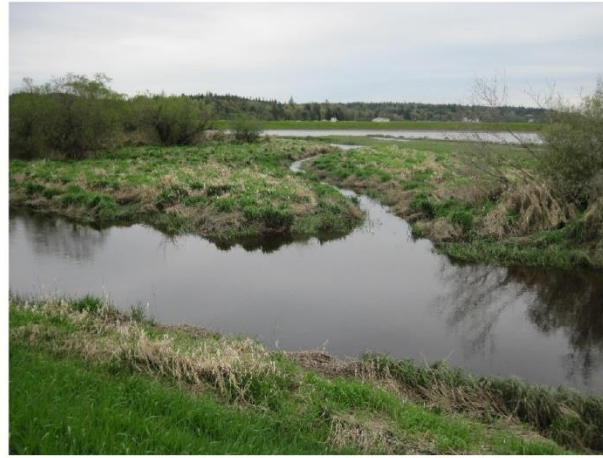
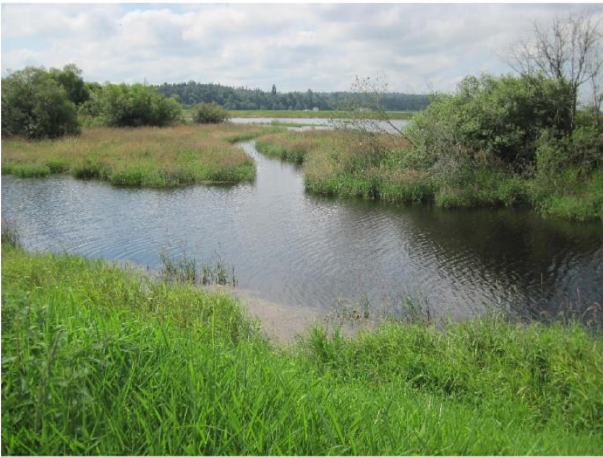
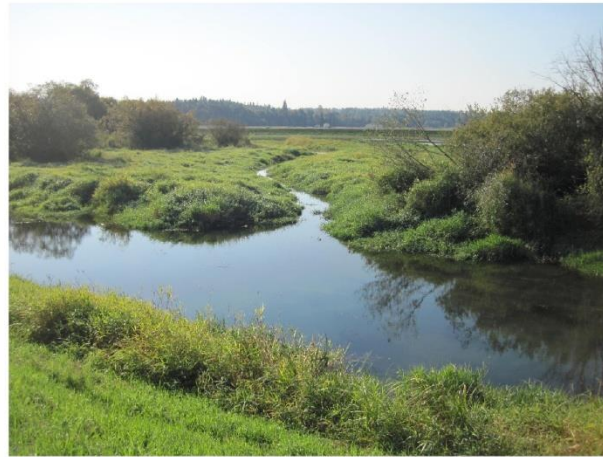
FS04 Photograph 2: Taken from the north levee of Fisher Slough looking upstream at the marsh islands and channel, with Smith A in the background.

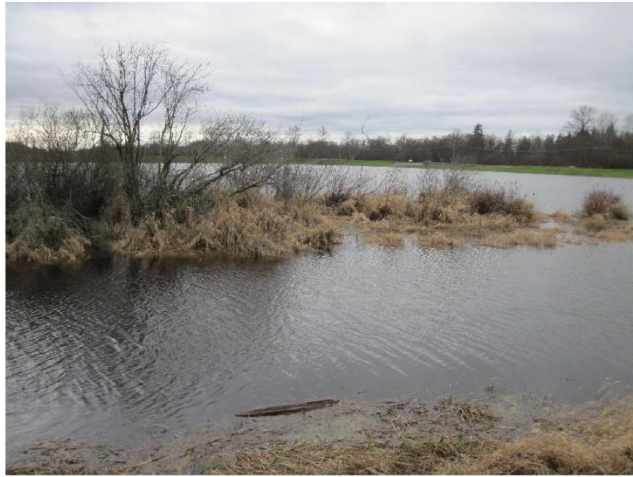
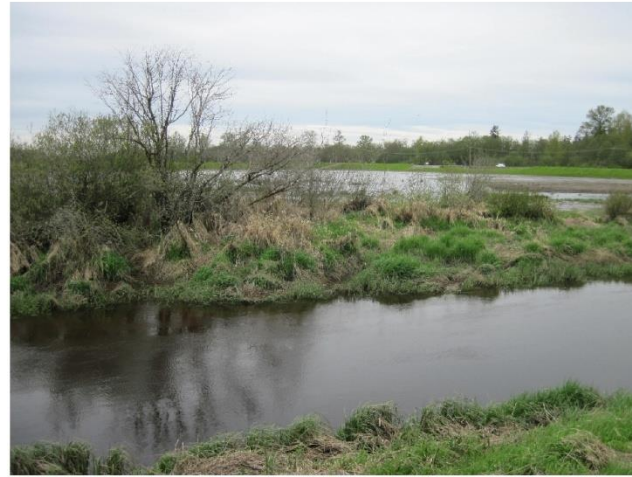
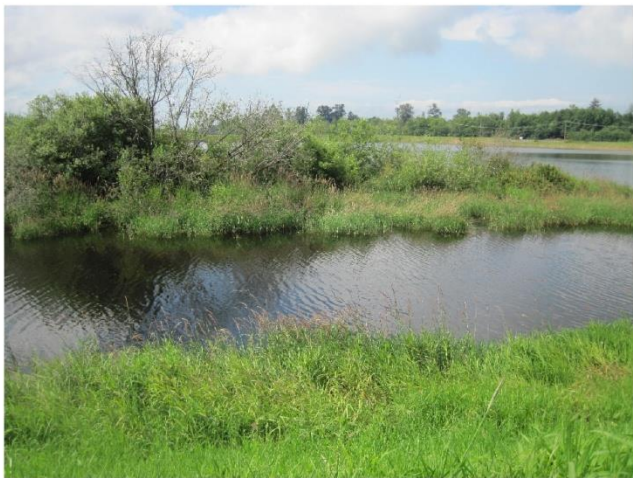
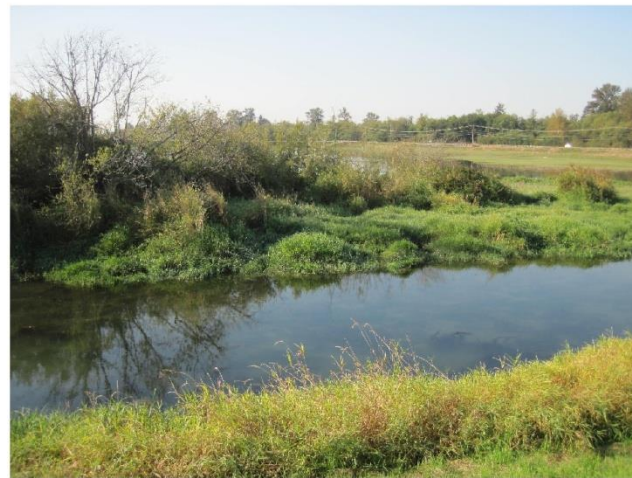
FS04 Photograph 3: Taken from the north levee of Fisher Slough looking southwest at the middle marsh island and Smith A.
