# Fisher Slough Tidal Marsh Restoration

## 2012 Monitoring Report

Skagit River System Cooperative, LaConner, WA

May 2013

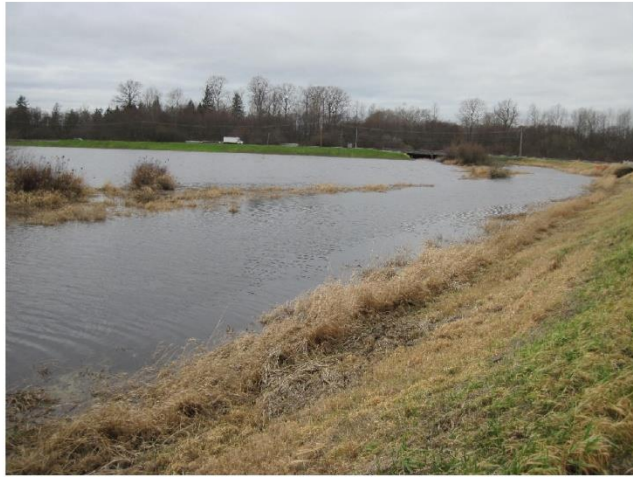
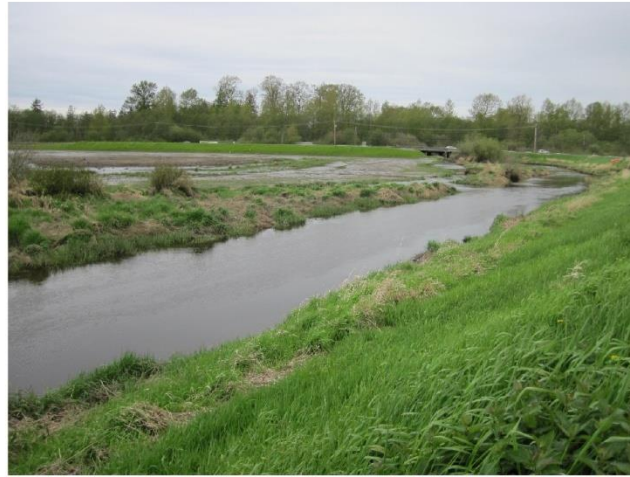
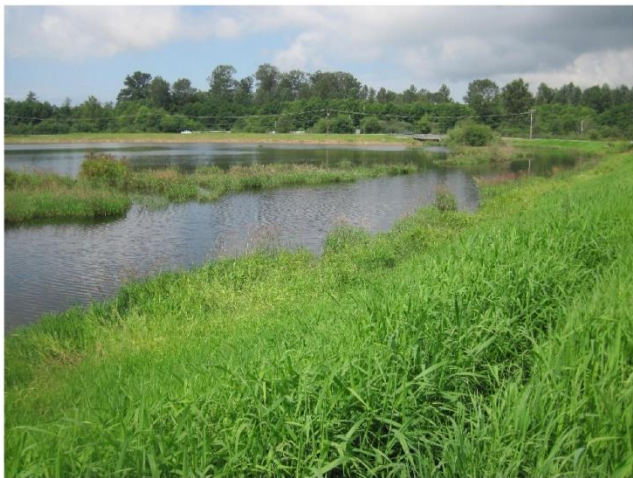
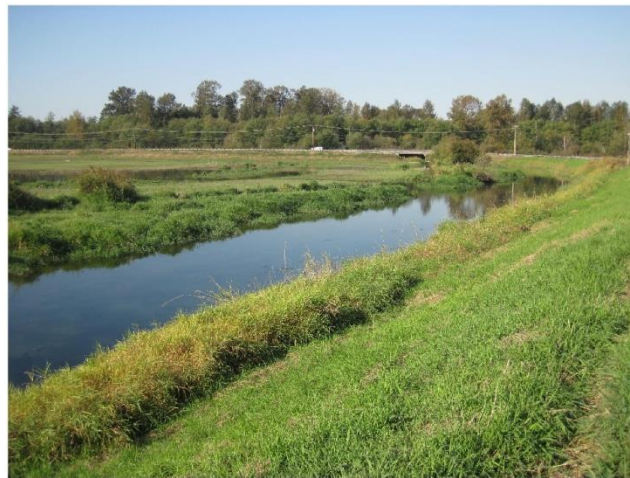
FS04 Photograph 4: Taken from the north levee of Fisher Slough looking downstream at the marsh islands and Fisher Slough.

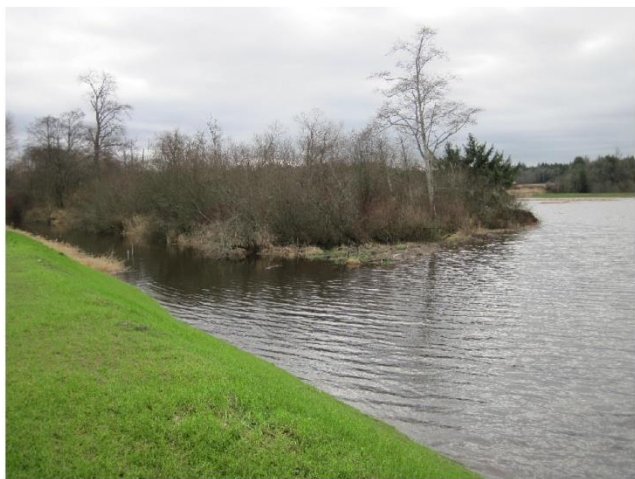
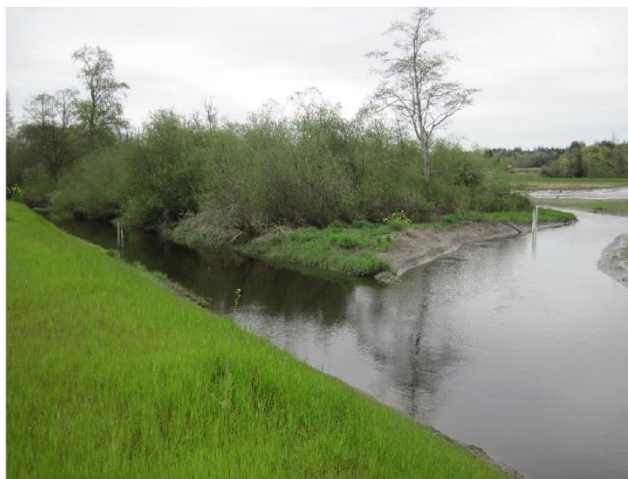
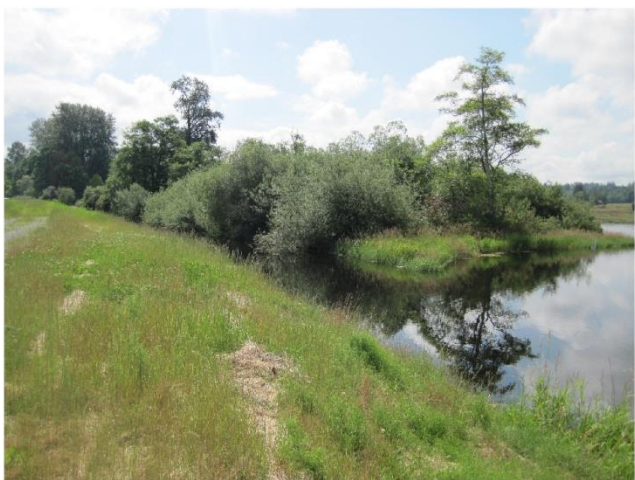
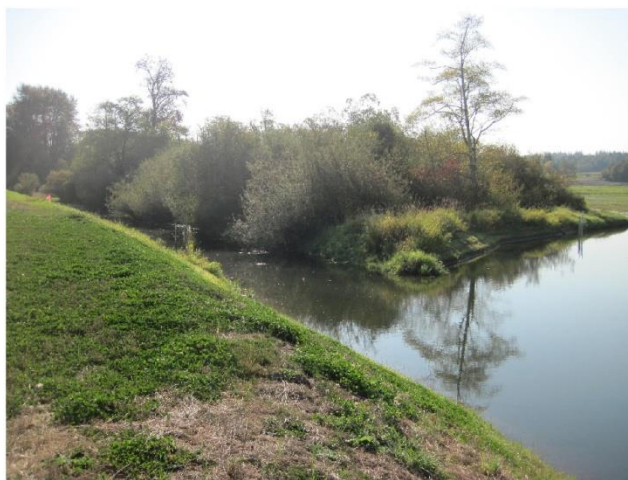
FS05 Photograph 1: Taken from the north levee of Fisher Slough at the historic Big Ditch Crossing looking upstream at Fisher Slough.

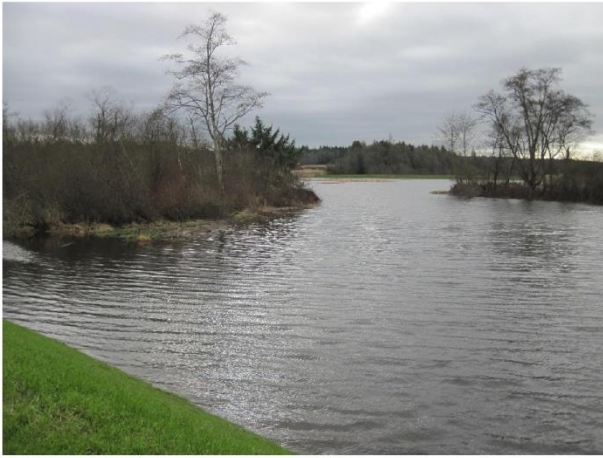
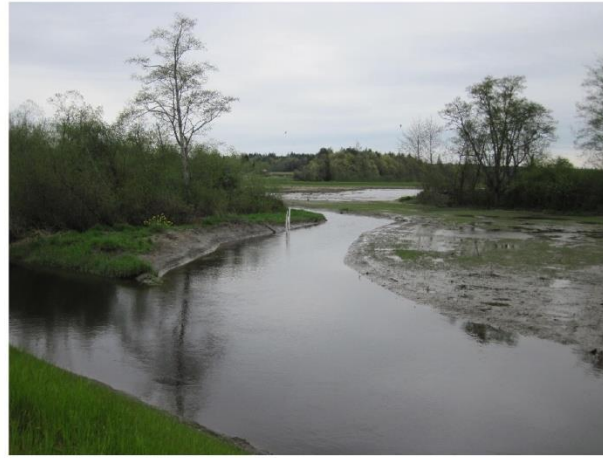
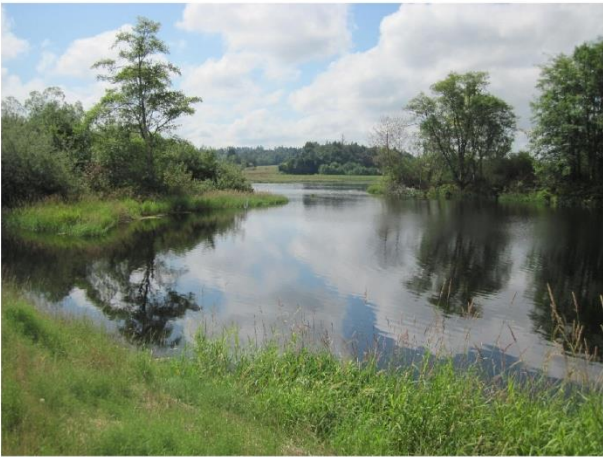
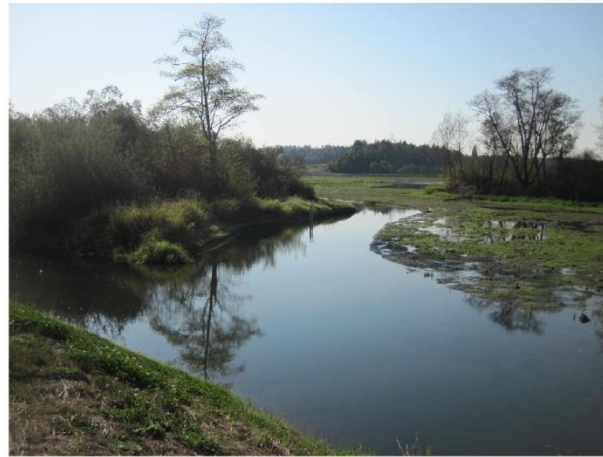
FS05 Photograph 2: Taken from the north levee of Fisher Slough at the historic Big Ditch Crossing looking southward at the downstream end of main tidal channel realignment.

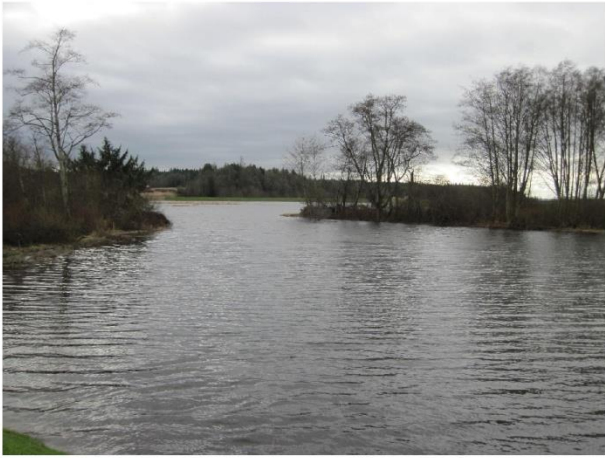
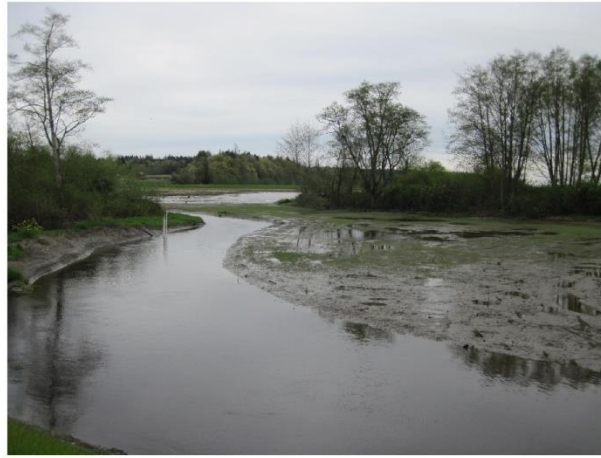
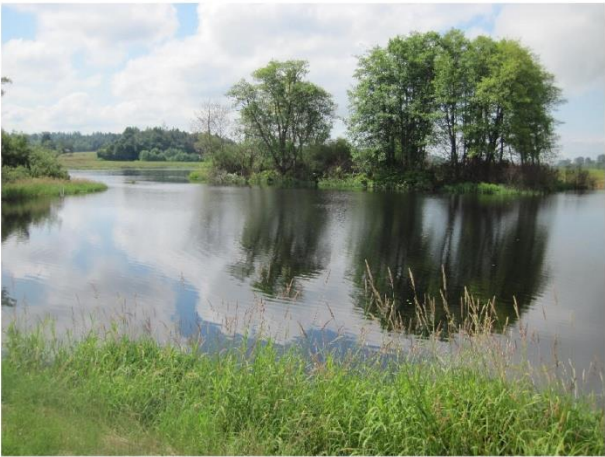
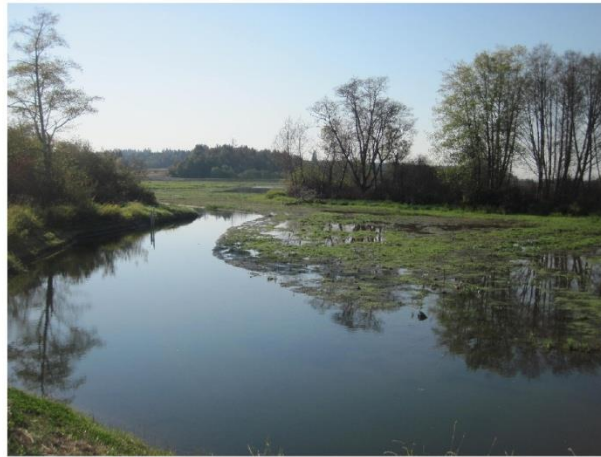
FS05 Photograph 3: Taken from the north levee of Fisher Slough at the historic Big Ditch Crossing looking southward. The historic crossing structure can be seen January through July.

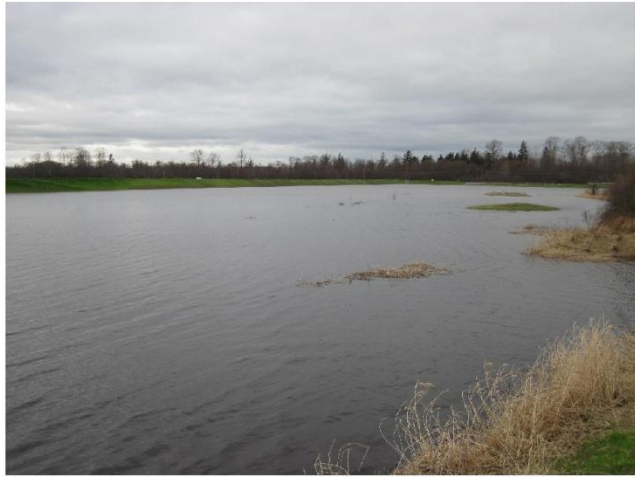
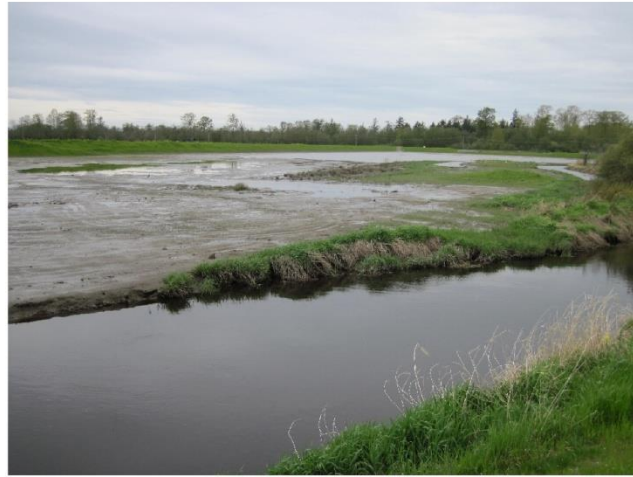
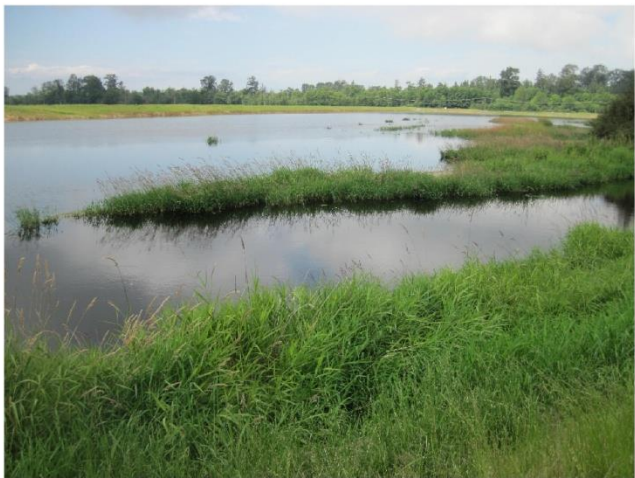
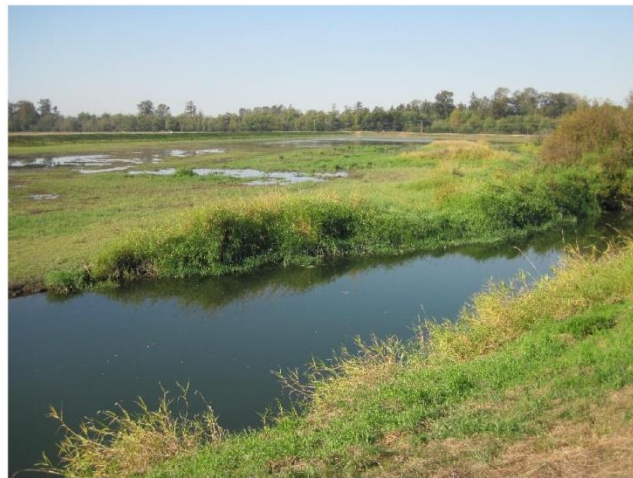
FS05 Photograph 4: Taken from the north levee of Fisher Slough at the historic Big Ditch Crossing looking westward at Fisher Slough and Smith A.

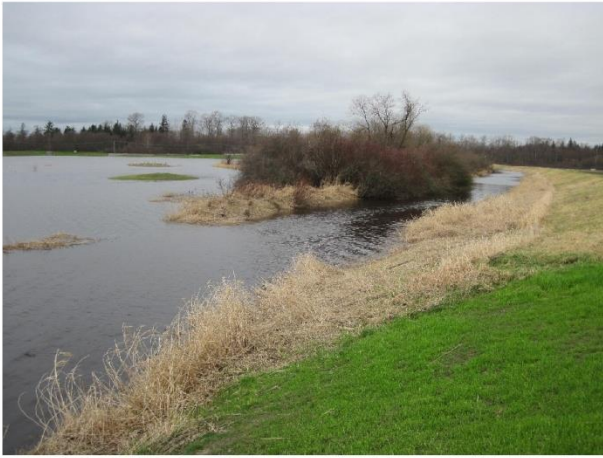
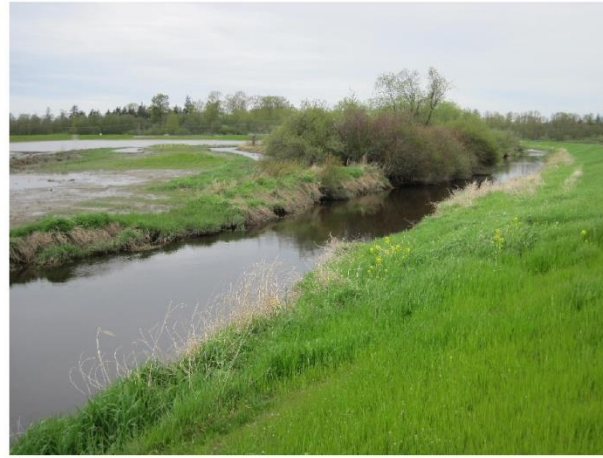
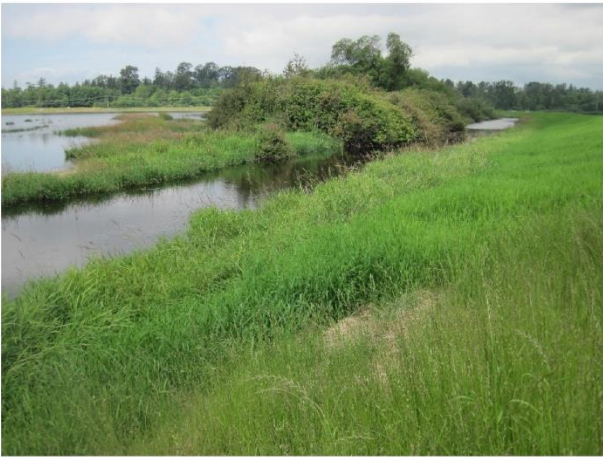
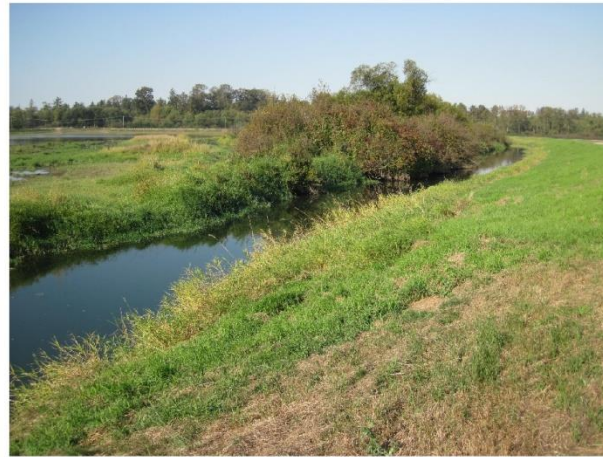
FS05 Photograph 5: Taken from the north levee of Fisher Slough at the historic Big Ditch Crossing looking downstream at Fisher Slough and Smith A.

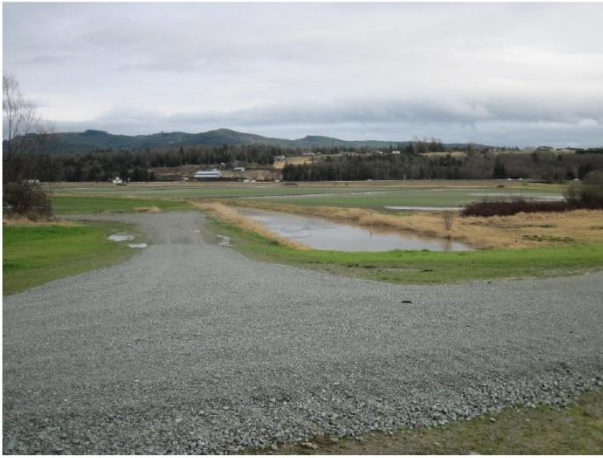
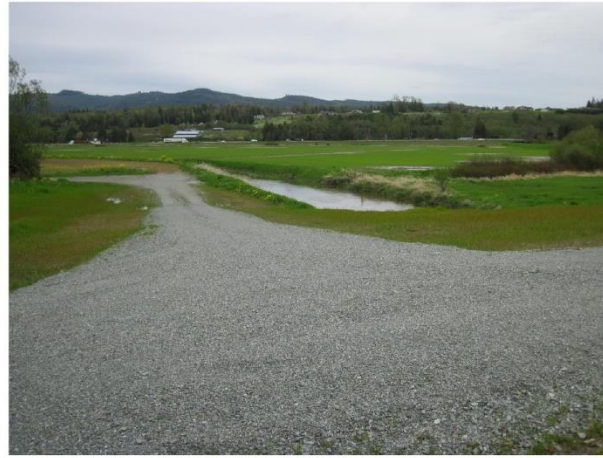
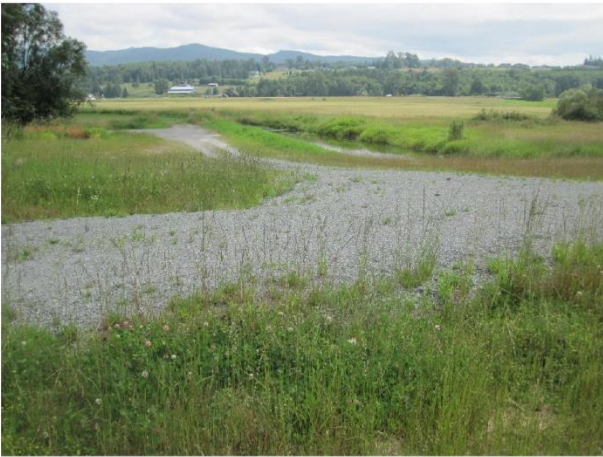
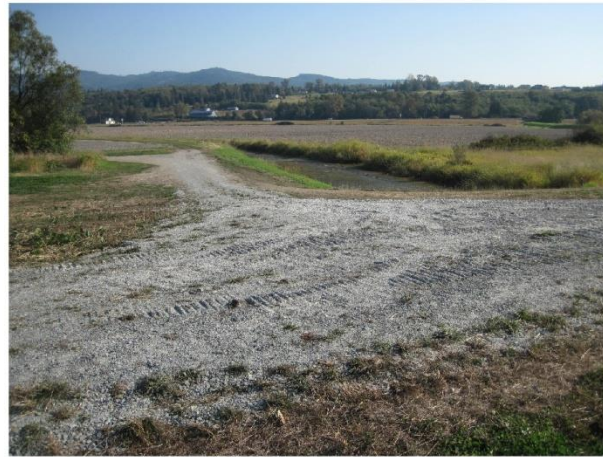
FS05 Photograph 6: Taken from the north levee of Fisher Slough at the historic Big Ditch Crossing looking northeastward at the remnant of the historic Big Ditch, upstream of Fisher Slough crossing.

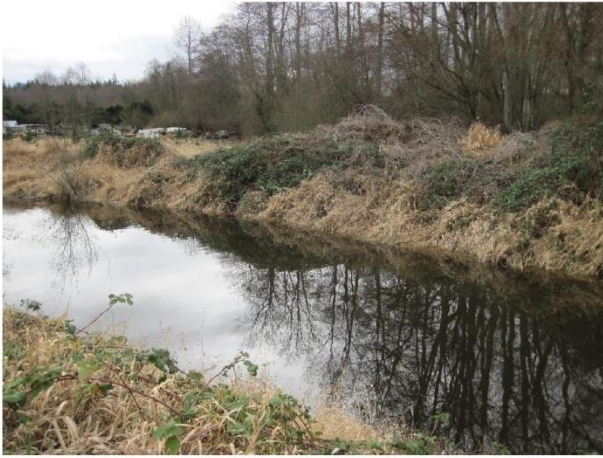
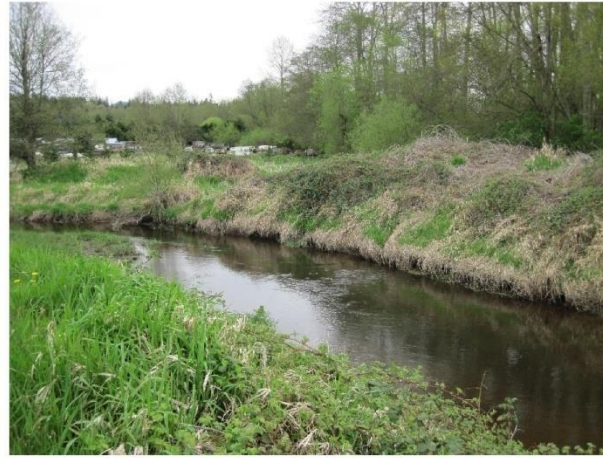
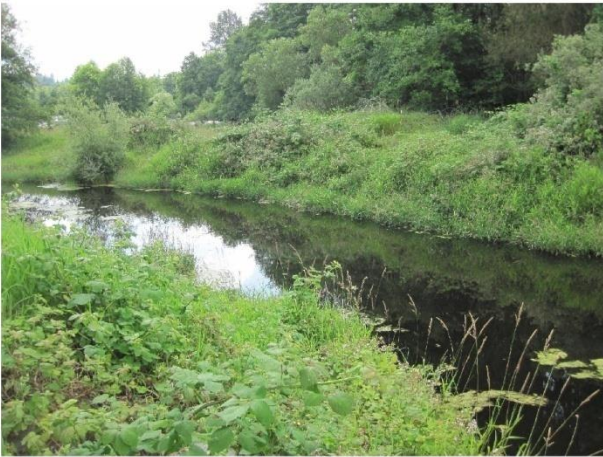
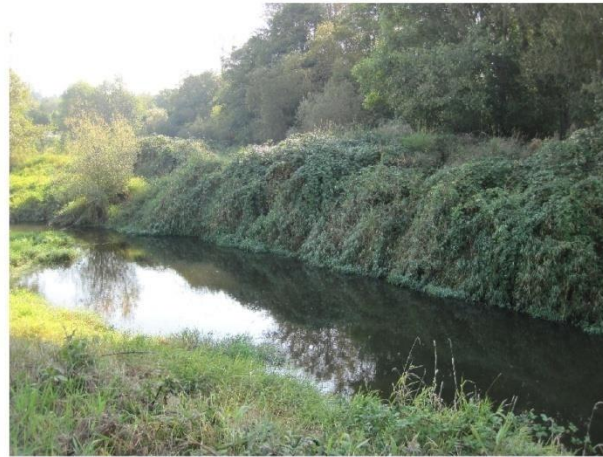
FS06 Photograph 1: Taken from the eastern end of the north levee, near an old shed and gate structure looking upstream at Carpenter Creek/Fisher Slough and the upstream end of the new main tidal channel realignment.

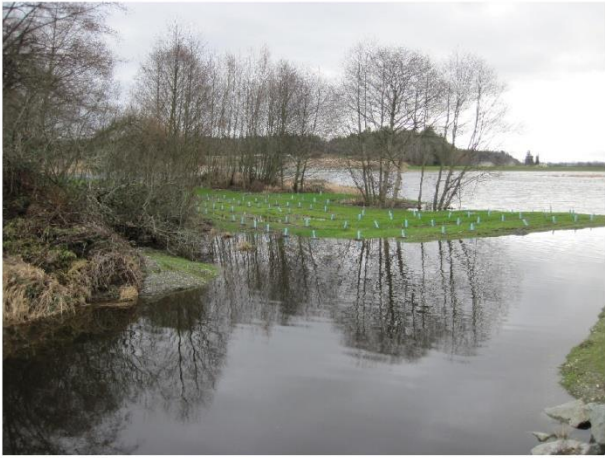
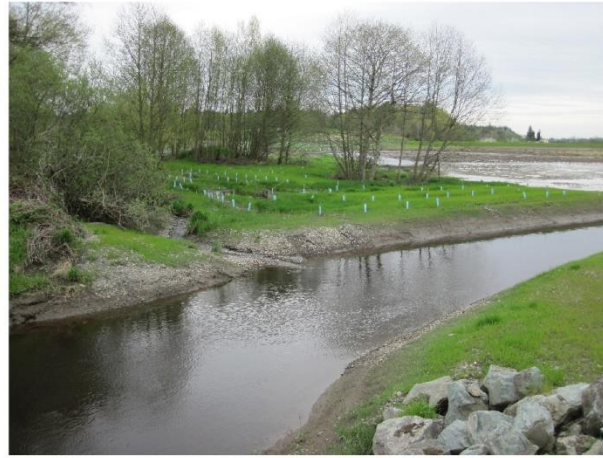
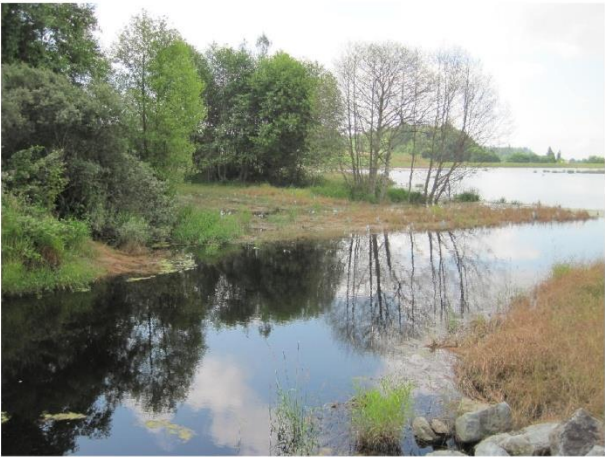
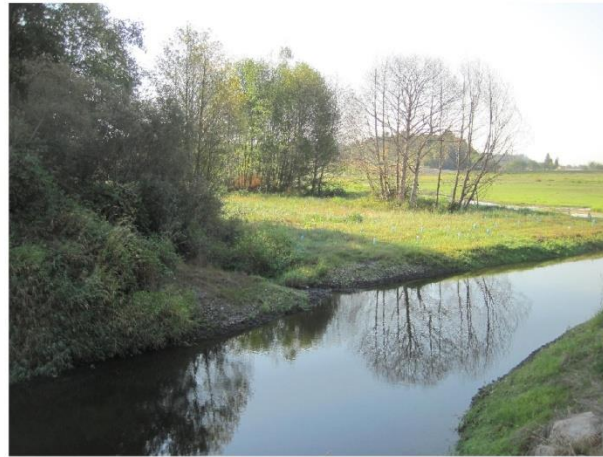
FS06 Photograph 2: Taken from the eastern end of the north levee, near an old shed and gate structure looking southward at Fisher Creek mouth.

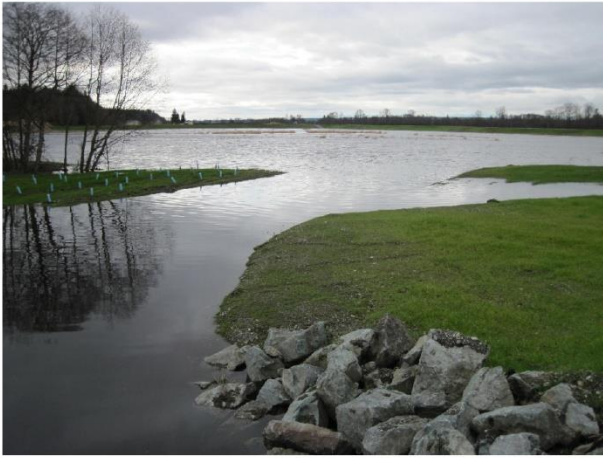
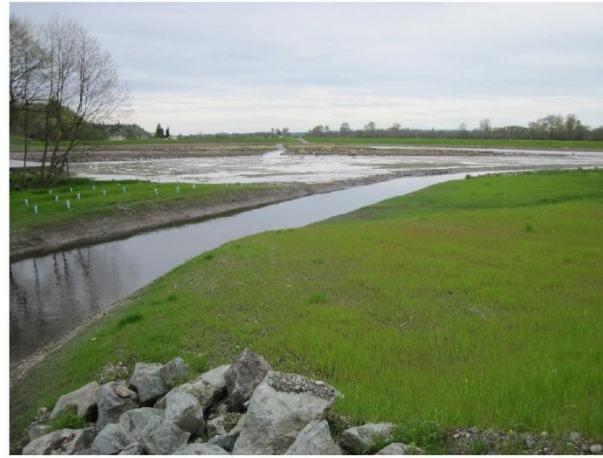
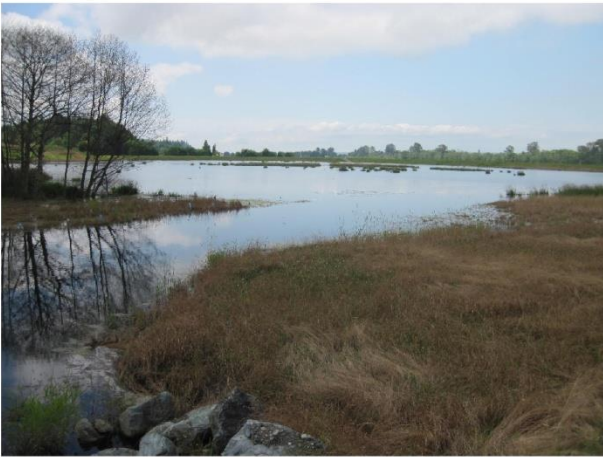
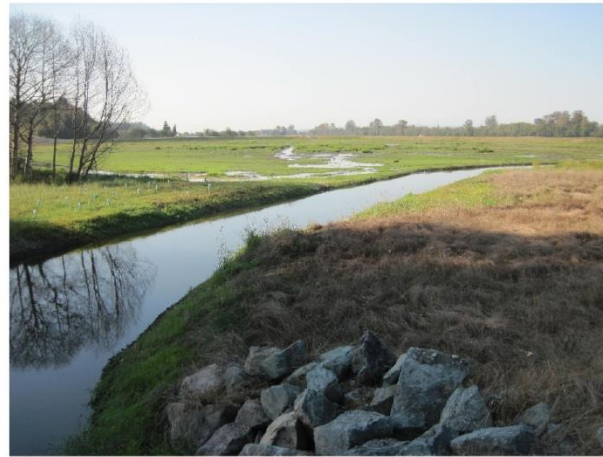
FS06 Photograph 3: Taken from the eastern end of the north levee, near an old shed and gate structure looking southwestward at Fisher Slough and Smith B.

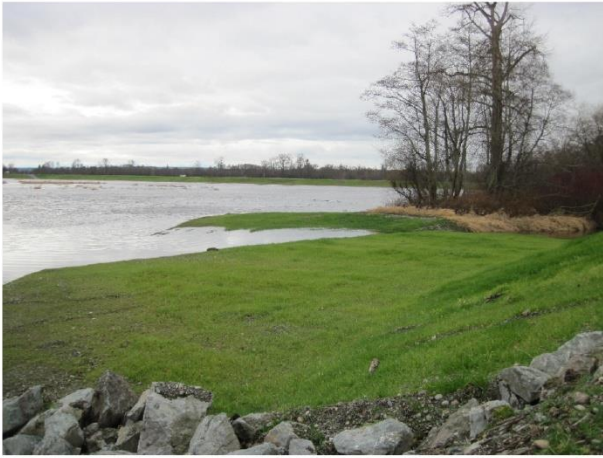
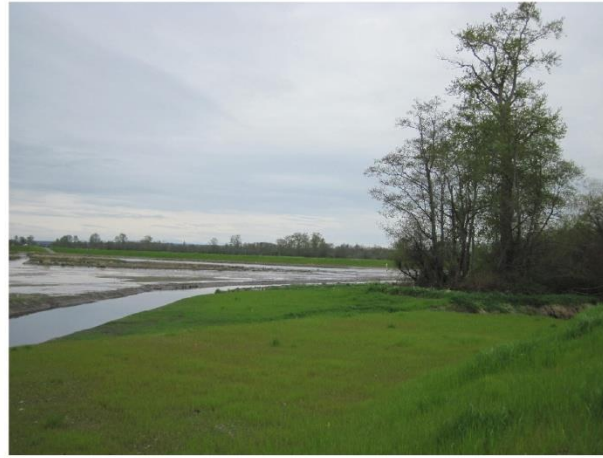
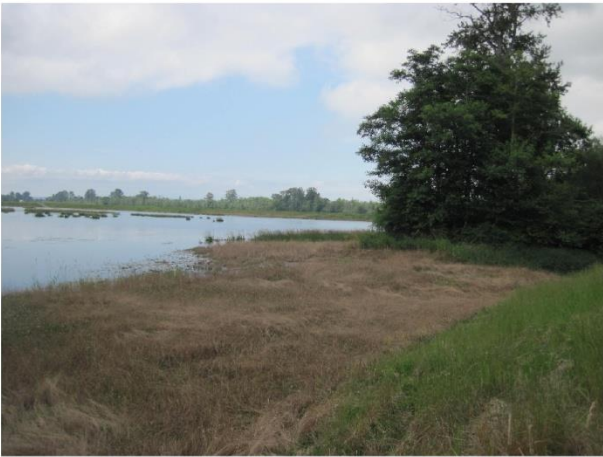
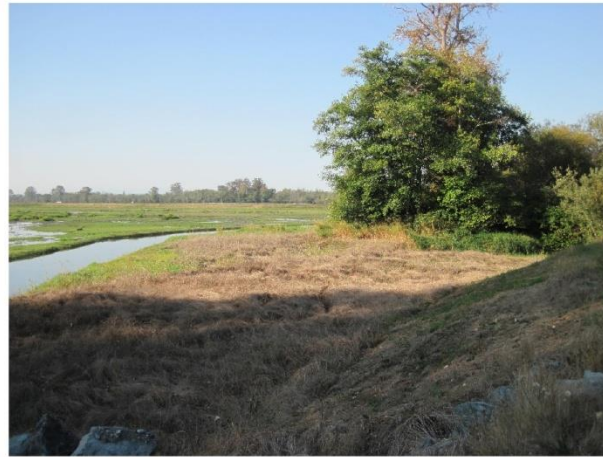
FS06 Photograph 4: Taken from the eastern end of the north levee, near an old shed and gate structure looking downstream at the historic south levee (gone by October), and Fisher Slough.

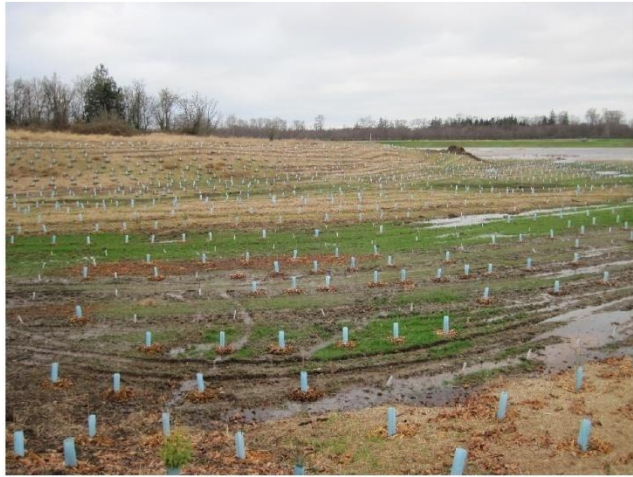
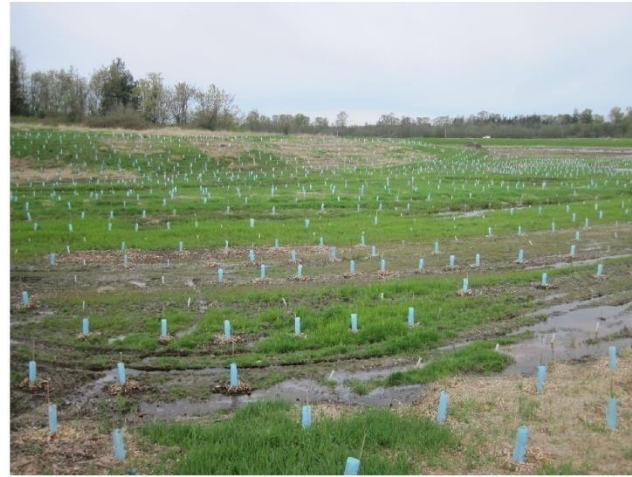
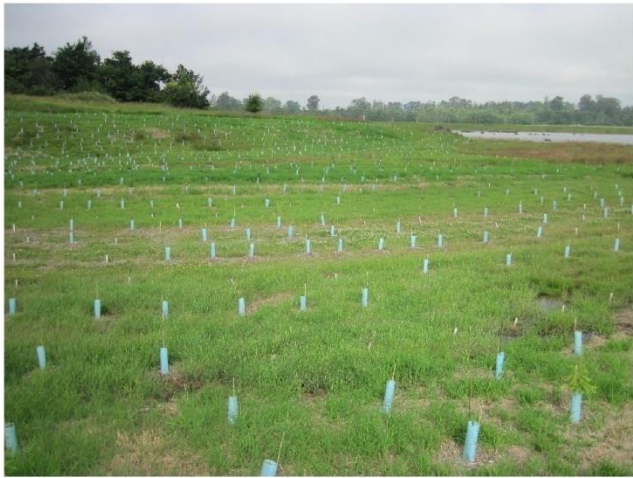
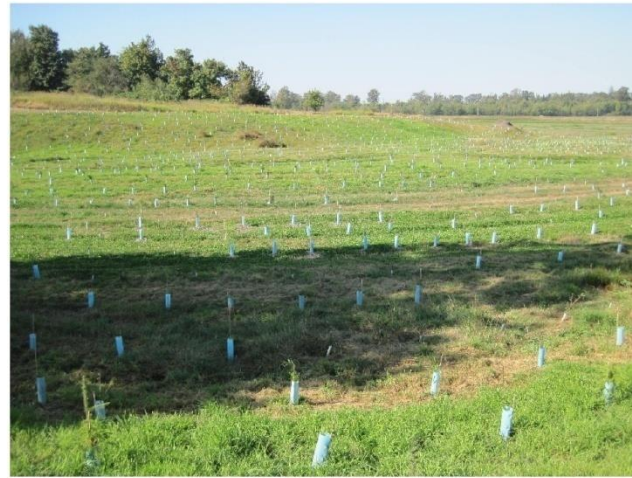
FS07 Photograph 1: Taken from near the southern edge of the Moyer property, east of Little Fisher Creek looking west.

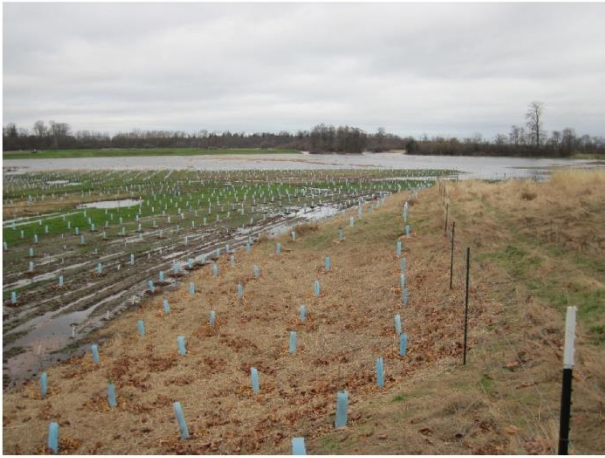
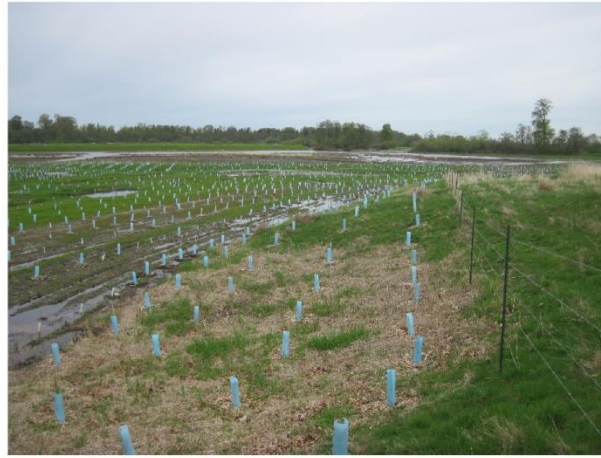
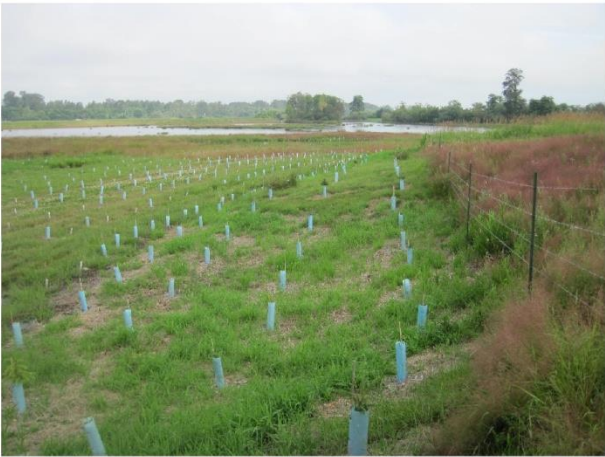
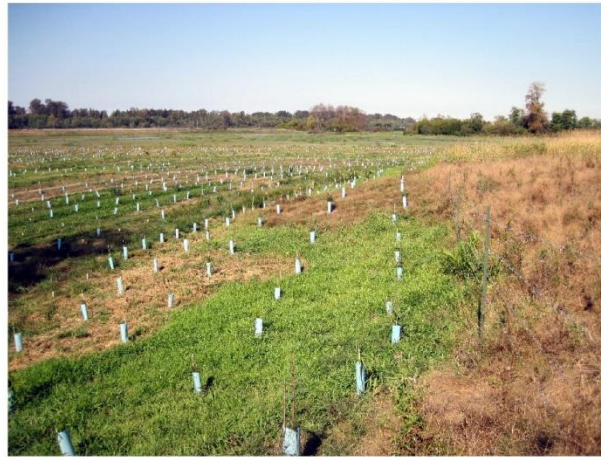
FS07 Photograph 2: Taken from near the southern edge of the Moyer property, east of Little Fisher Creek looking northwest with Smith B in background.

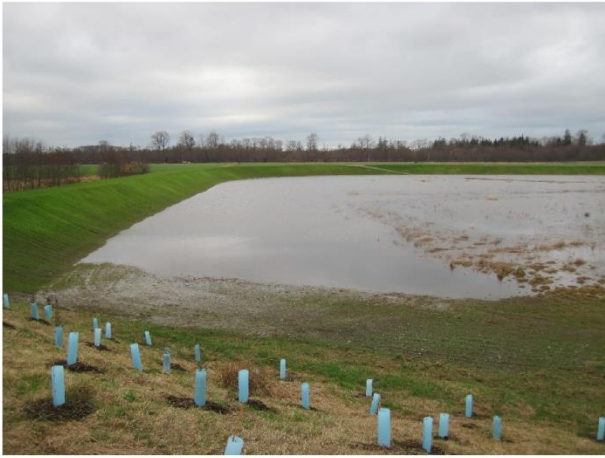
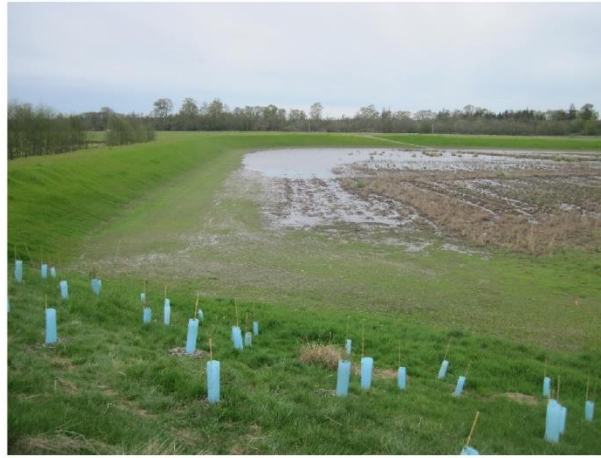
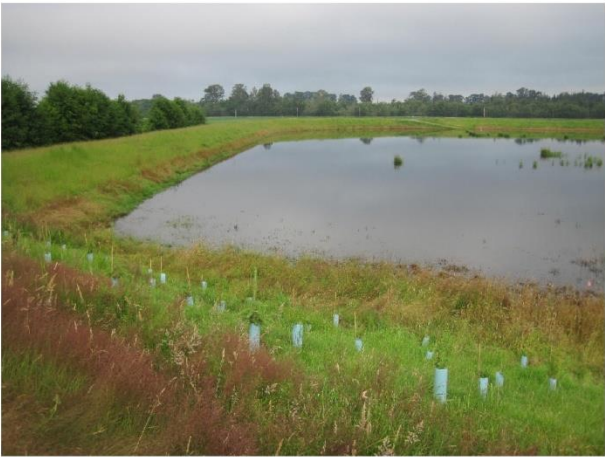
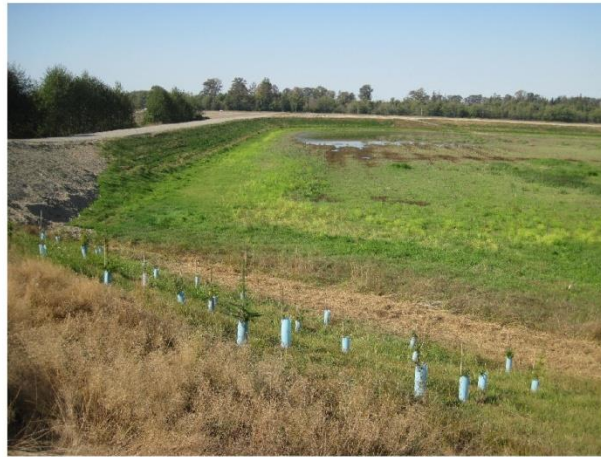
FS08 Photograph 1: Taken from the southeast corner of Smith B, on the hillslope where the new levee ties into the Moyer property looking west-southwest at Smith B.

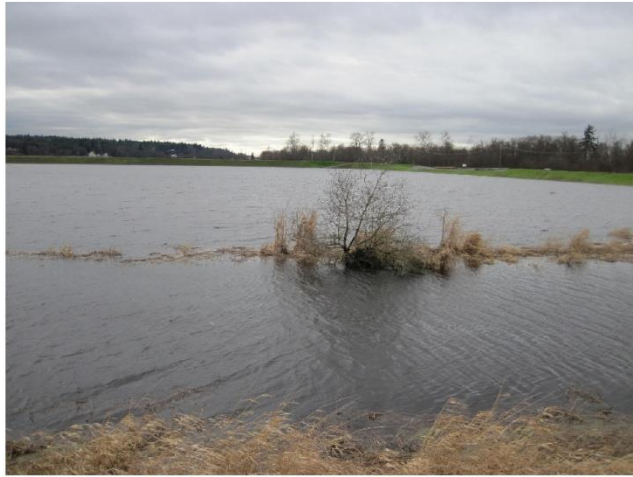
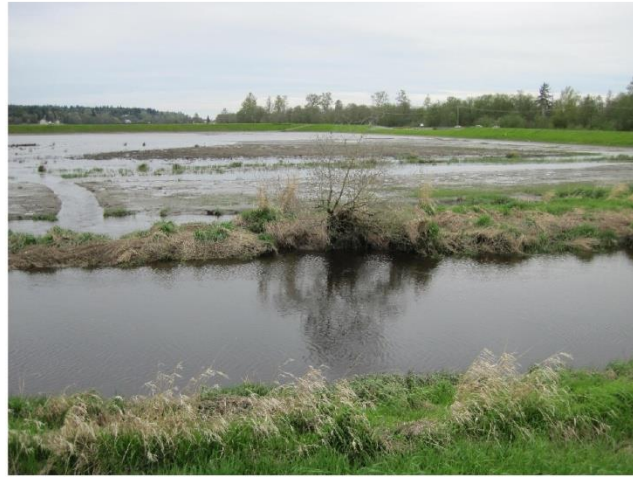
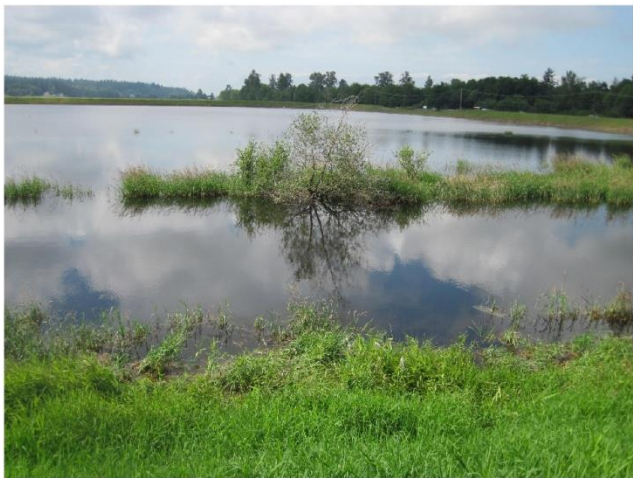
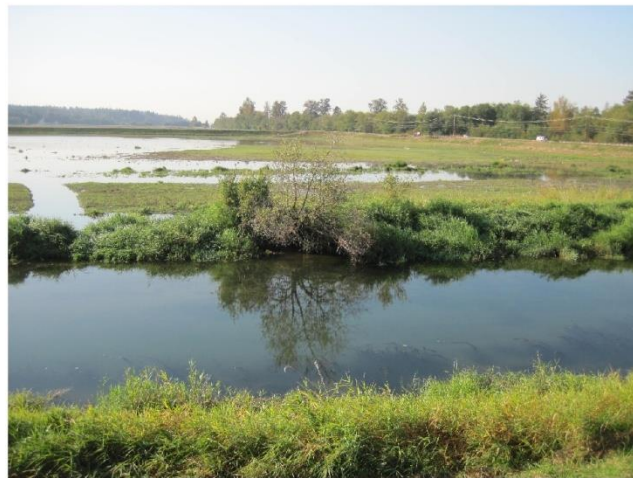
SF12 Photograph 3: Taken on the north dike near the flood return structure, looking southwest across the channel to Smith A.

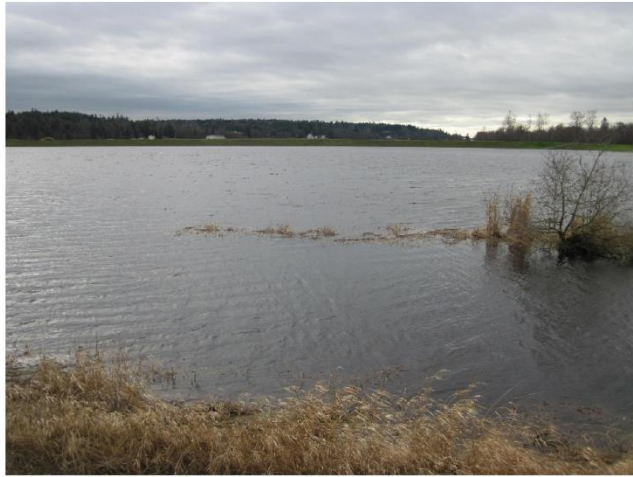
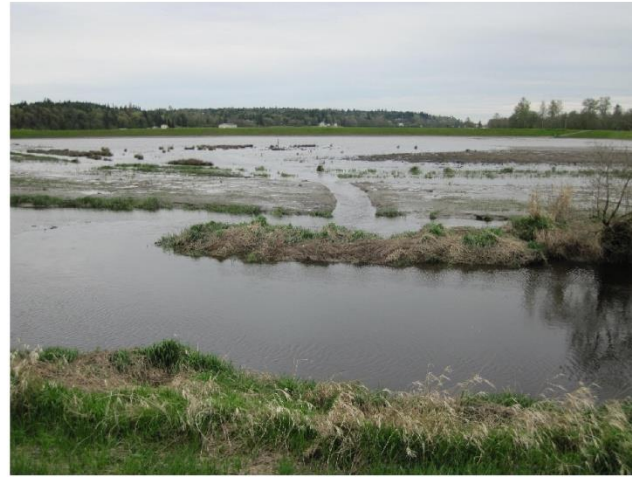
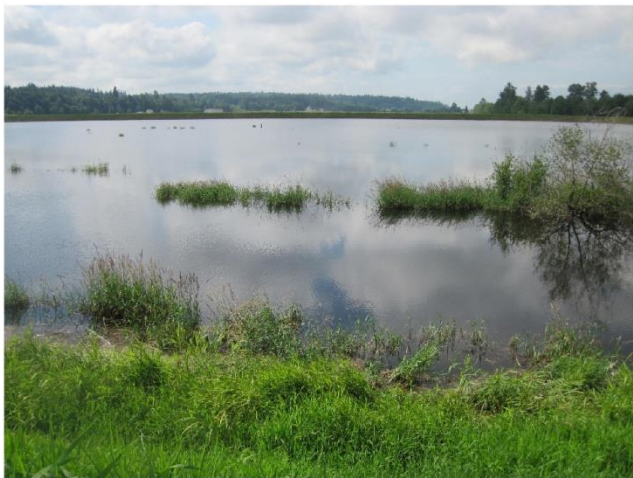
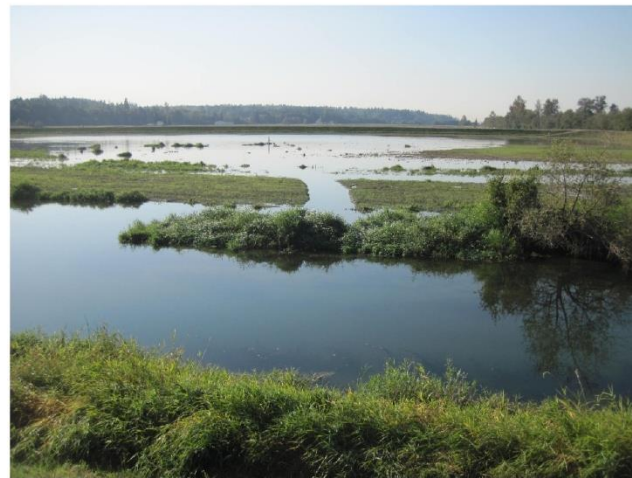
SF12 Photograph 4: Taken on the north dike near the flood return structure, looking southwest across the channel to Smith A.

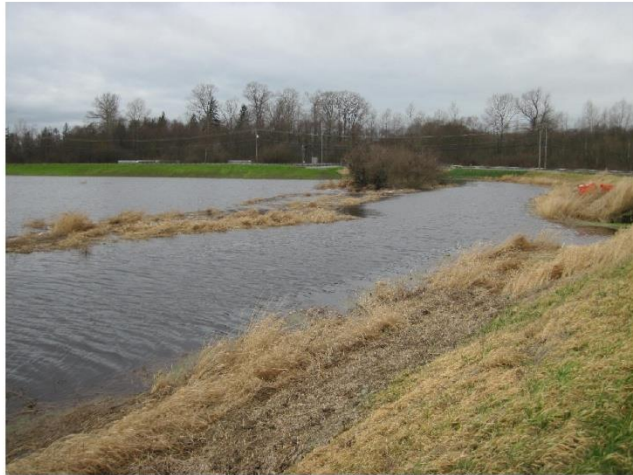
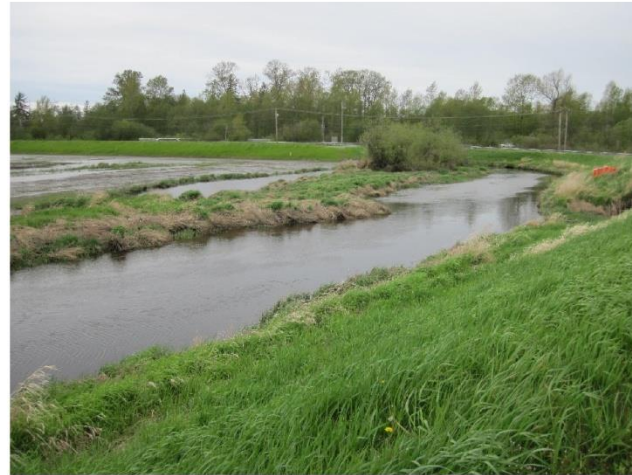
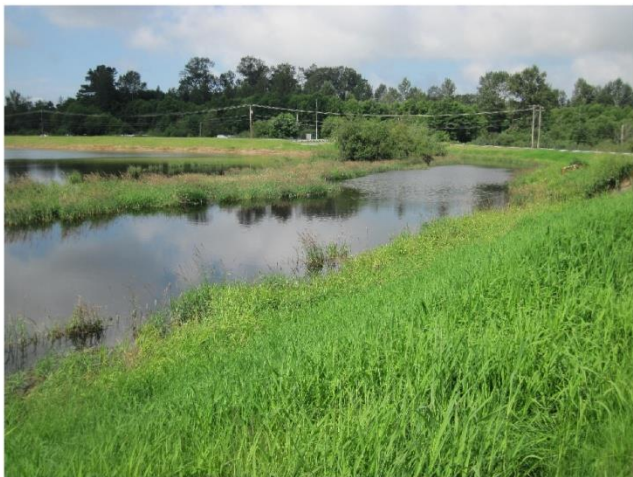
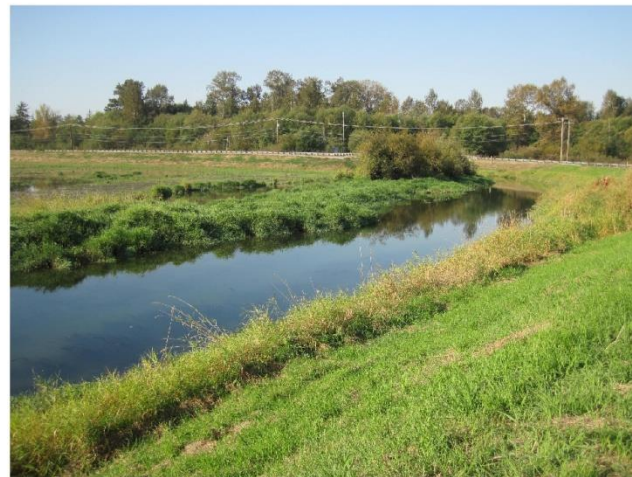
SF12 Photograph 5: Taken on the north dike near the flood return structure, looking west towards Pioneer Highway.
