## **Agenda**

**Site: W5 Degraded Forest (1.42 acres) “The Conifer Plantation”**

**Site: W1 Degraded Woodland (0.93 Acres)**

### **Site: P1 Weedy Patch (1.57 acres) “The Mother Garden”**

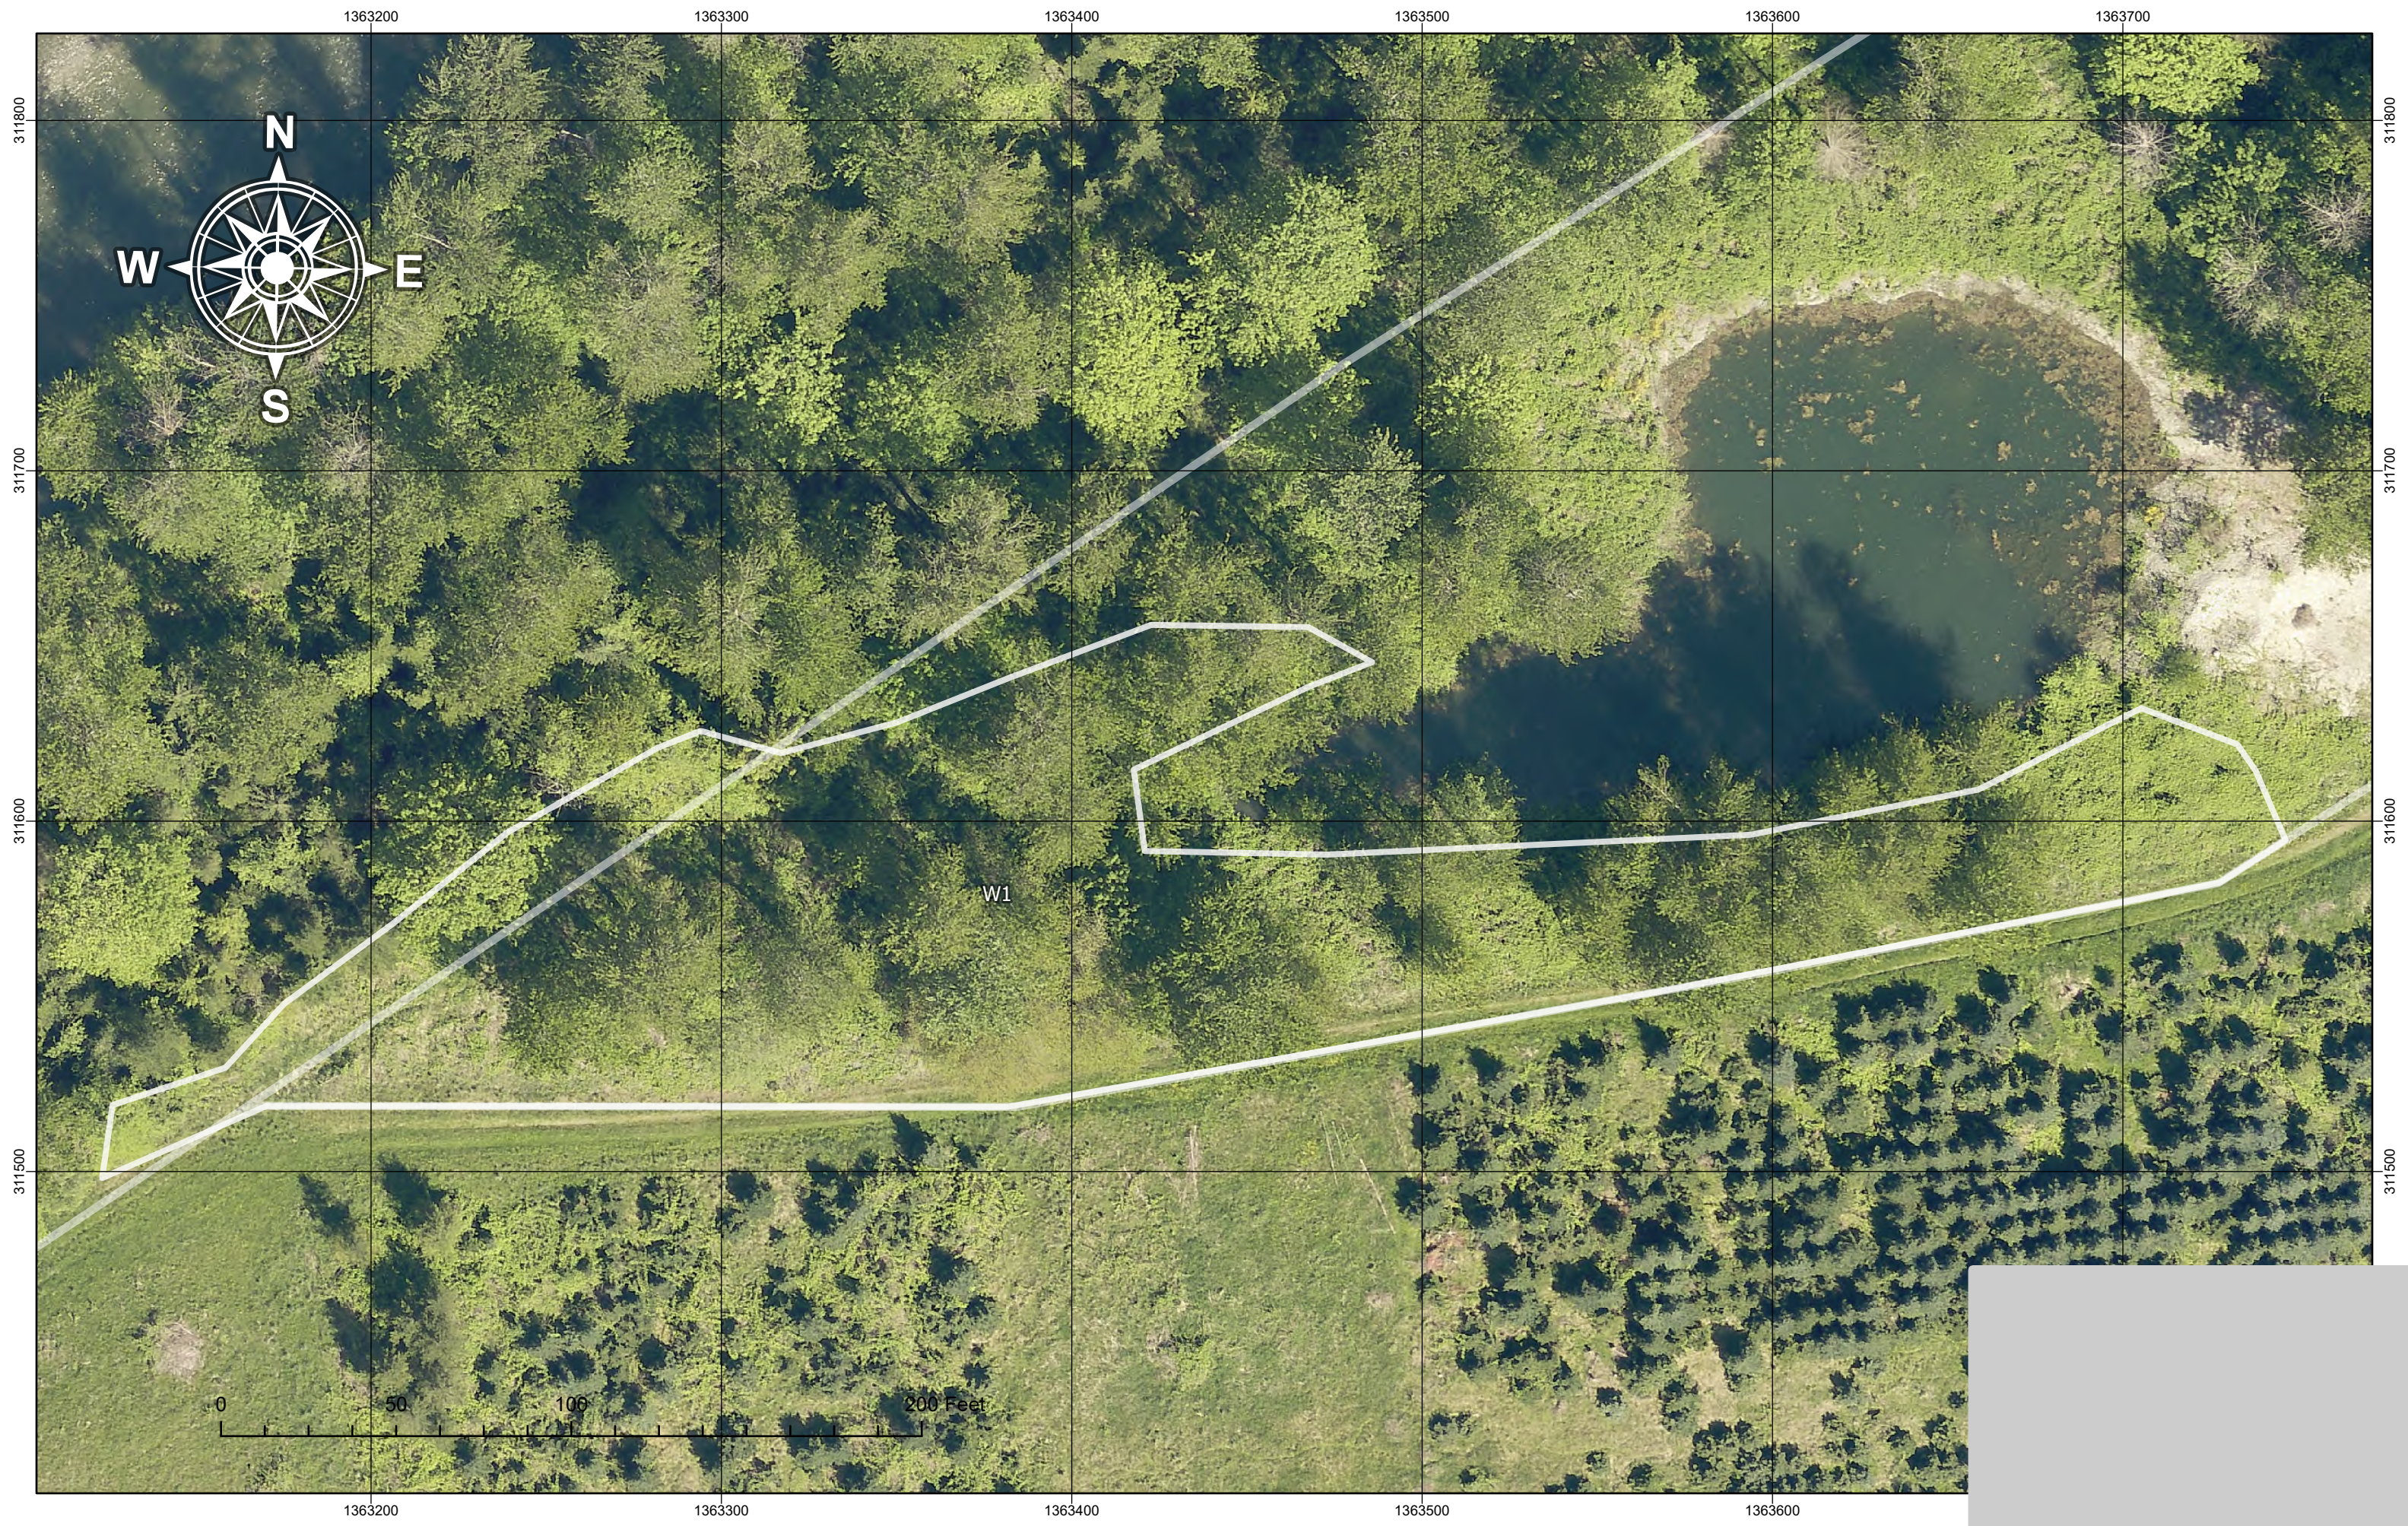
W1

**Landform & Water:** The unit is mostly flat and located 150' south of the Skykomish mainstem and surrounds an old gravel pit (GP1) to the east and a swale (S2) to the northeast. County models suggest the site has limited inundation during 10-year flood events. The gravel pit and gravel layers observed in our test pit suggest portions of this unit were likely a historical river channel. Surface soils are silty suggesting infrequent inundation deposits fine materials indicating a low energy flood environment. DEMs indicate water level matches river levels likely connected by unconstrained shallow groundwater. The old gravel pit pond and swale likely backwaters during floods, but may serve as an exit location during very high flood events. The old gravel pit (GP1) has approximately 1:1.5 slopes along most its perimeter.

**Forests & Biota:** Trees in the western 1/3 of the unit are predominantly softwoods (spruce, Douglas-fir, western red cedar) with a closed canopy (perhaps 4-8" DBH) transitioning to hard woods (cherry, cottonwood, big leaf maple) for the remaining 2/3 on the south and east along the road and around the gravel pit pond (GP1). These hardwoods are a closed deciduous canopy dominated by cottonwood (perhaps 8-15" DBH) with some maple in the understory and a patch of cherry along the edge and part of the interior. The understory is a mix of salmonberry and blackberry. The uncommon species manroot is climbing the blackberry along the southern forest edge. Other species noted in the unit are red-osier dogwood, lady fern, snowberry, salmonberry, Canadian thistle, butterfly bush, Nootka rose and burdock. Evidence of some beaver presence was found as a freshly chewed stick floating in the gravel pit pond. The gravel pit pond largely lacks a fringe of emergent vegetation due to the slope. Small fish (appx 2") have been observed along the shore, but no known investigation into species inhabiting the water has been conducted. Beaver or otter trails have been found between the river and the pond. Two white-tail deer were flushed from the deciduous forest, and the blackberry fringe does not appear to limit interior deer browse.

**Soil Conditions:** NRCS soils surveys suggest Pilchuck, however one test pit found gravel layer starting at around 18" down, with surface soils predominately silt, with some fine-grained sand and little clay, more similar to a **Sultan** soil, which is consistent with mapped soils south of the unit. Roots were found to about 12" depth. The duff layer was 6"+ consisting of Himalayan blackberries litter and unidentifiable organic matter, with a 2-3" dark A-horizon.

- Avoid impacts to manroot population (potential seed source for very uncommon species?)
- Increase the production and diversity of useful materials from native understory to support restoration and ethnobotanical education.
- Enhance the sunny southern edge of the site for production of materials requiring higher levels of sun exposure.

- Consider future enhancement of the gravel pit wetlands (likely cut/fill to form emergent zone).
- Integrate snowberry propagule harvest as part of trail management?
- Prevent tree encroachment into the farm road.
