EFFECTIVENESS MONITORING OF  
SOUTH FORK NOOKSACK INSTREAM HABITAT PROJECTS,

SUMMER 2011

Nooksack Indian Tribe  
Natural Resources Department

July 11, 2012

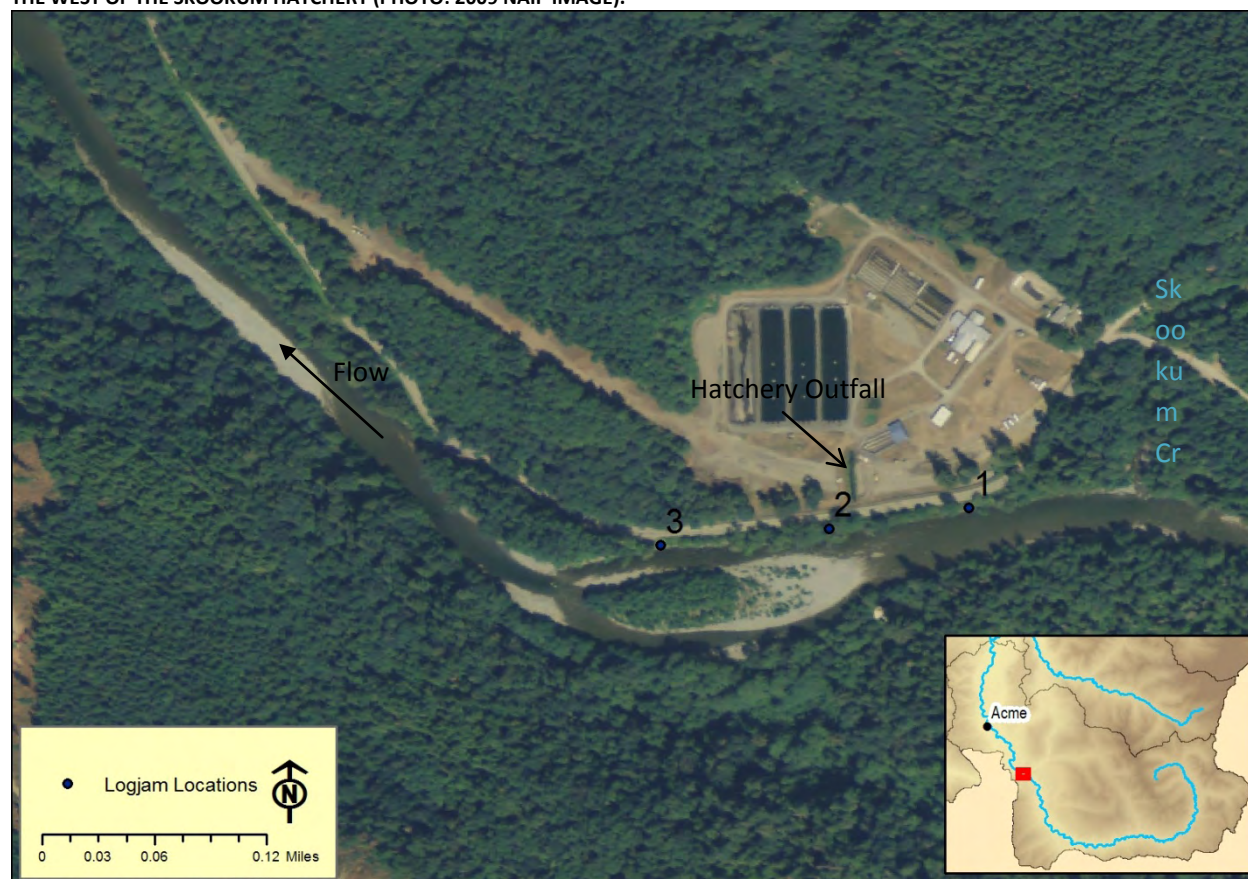
FIGURE 5: SKOOKUM PROJECT SHOWING LOGJAM LOCATIONS AND STRUCTURE NUMBERS. THE ROAD SETBACK CORRIDOR IS VISIBLE TO THE WEST OF THE SKOOKUM HATCHERY (PHOTO: 2009 NAIP IMAGE).

Logjams #2 and #3 lie in a side channel that runs along the base of the terrace. Logjam #2 is forming a small secondary pool with wood cover in the side channel immediately downstream of the outfall from the Skookum Hatchery. Logjam #3 also lies in a run along the same side channel. The structure is providing a small amount of cover, but has no local scour associated with it. Both structures are set into the bank, providing increased bank resistance to the slowly eroding terrace. None of the structures have resulted in a deep scour pool as intended, likely due to being set deeply into the terrace. Continued erosion of the terrace may expose more of the structures to the flow of the river and lead to deeper local scour, although the erosion rate has historically been slow due in part to the location near the point of inflection on the inside of a bend in the South Fork.

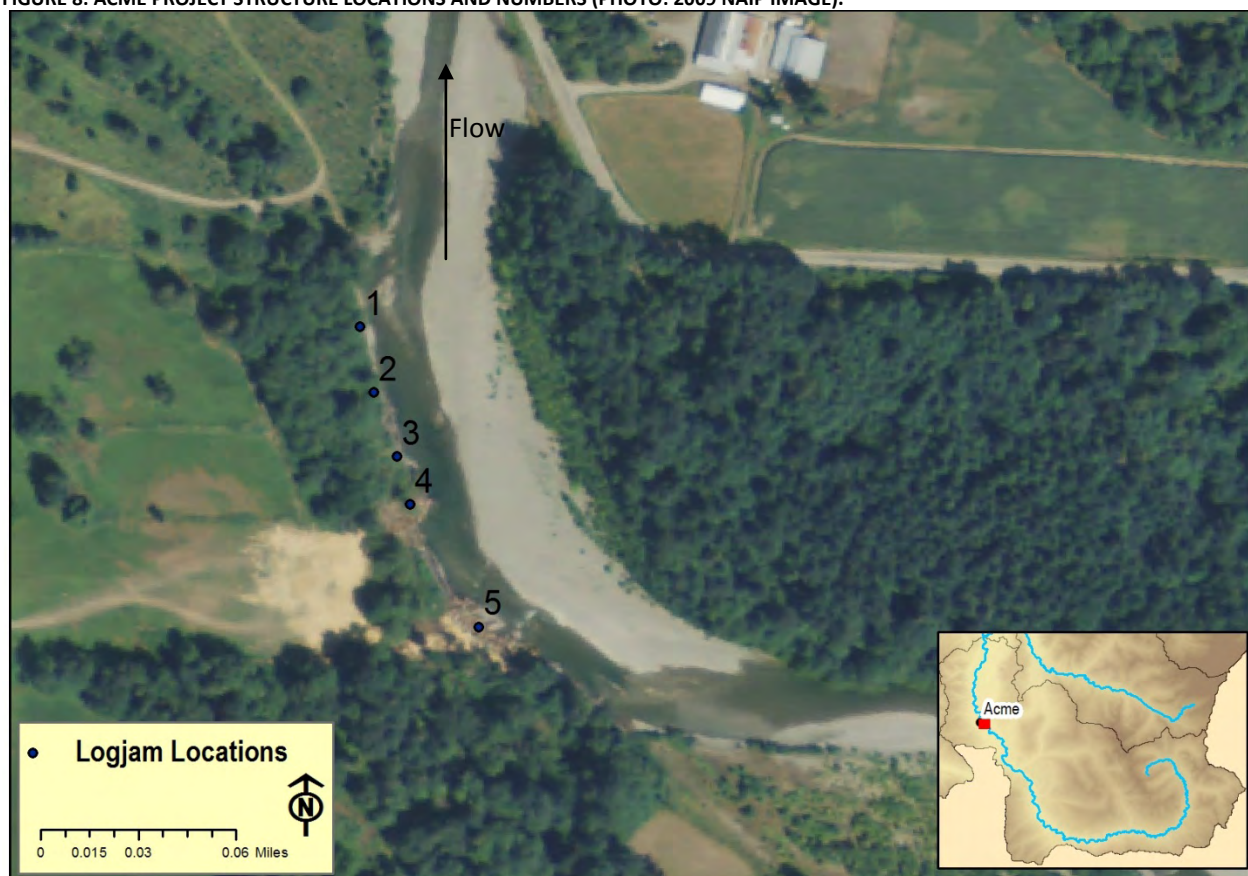
FIGURE 8: ACME PROJECT STRUCTURE LOCATIONS AND NUMBERS (PHOTO: 2009 NAIP IMAGE).

Logjam #3 lies at the divergence of a side channel that was historically separated from the South Fork by a high bank and which contained the flow of Landingstrip Creek. Recent migration by the South Fork reclaimed the side channel and captured Landingstrip Creek which now enters the South Fork at jam #4. Logjam #3 was constructed by excavation to place footer logs with subsequent log layers being interlaced with and cabled to driven pilings and rock ballast. This structure forms a secondary pool in the mainstem run that is connected to the pool formed by Logjam #2, with only a slight tail-out separating the two. The apex structure splits moderate to high flow into the Landingstrip side channel. This structure also protects the upstream end of the island separating the side channel from the main flow of the river.

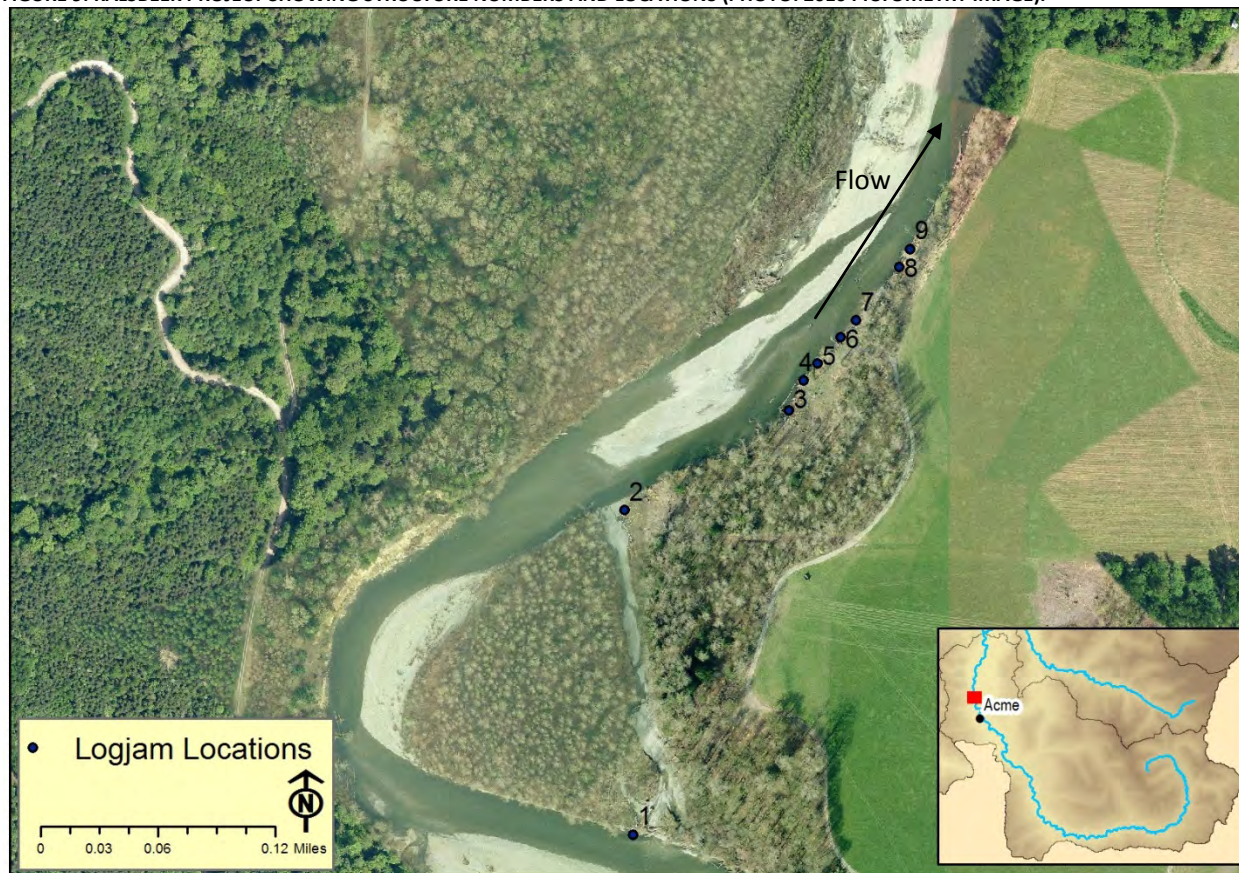
FIGURE 9: KALSBECK PROJECT SHOWING STRUCTURE NUMBERS AND LOCATIONS (PHOTO: 2010 PICTOMETRY IMAGE).

The two upstream-most bank structures (#4 and #5) each form a secondary pool in a long flat water section of the South Fork. Bank structures #6 and #7 were located close enough together that they were essentially the same structure and were associated with the same pool. The same was true for structures #8 and #9, which were tied together into one structure with placed logs. None of these bank structures has accumulated any woody material. All of these structures provide protection from erosion to the adjacent floodplain.

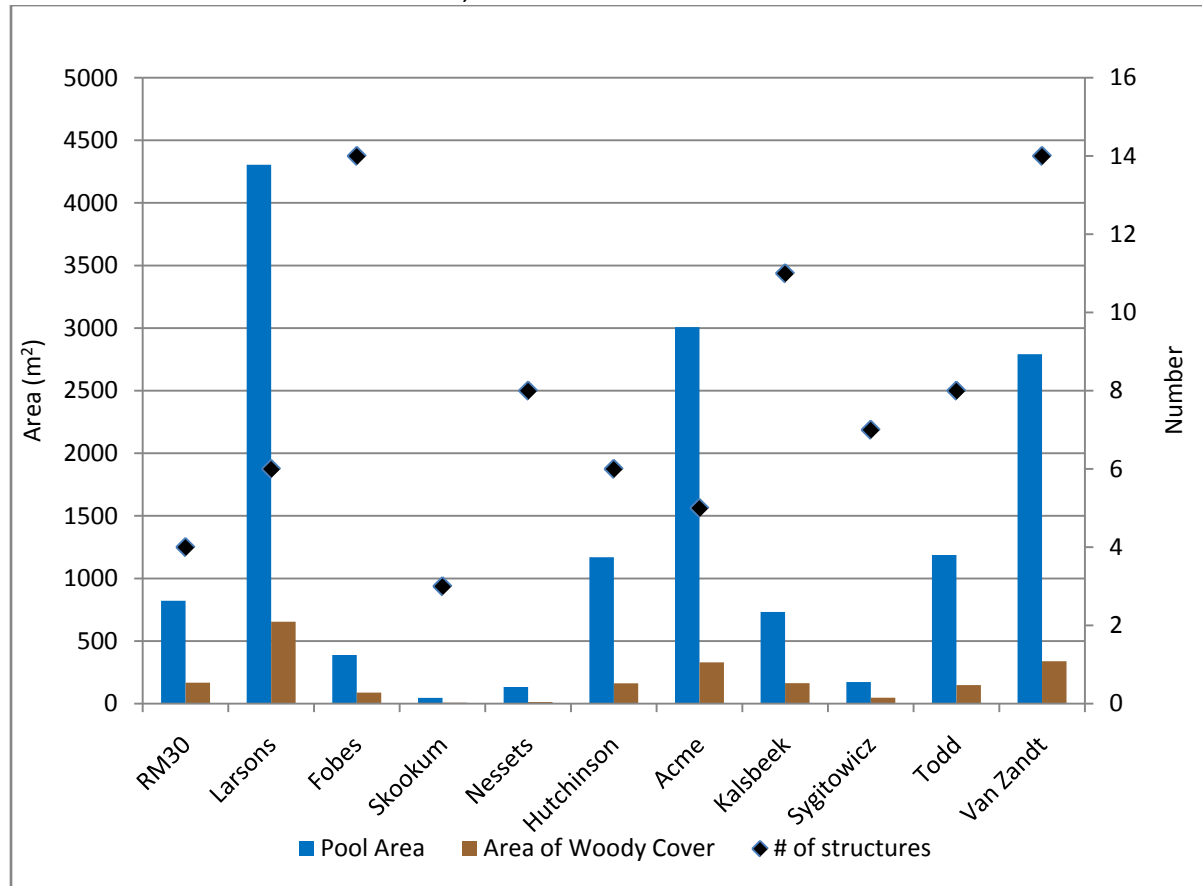
FIGURE 14: CUMULATIVE NUMBER OF STRUCTURES, POOL AREA AND COVER AREA FOR EACH PROJECT

The three projects that yielded the greatest area of wood-formed pools and cover were the Larson's Bridge, Acme and Van Zandt projects (Figure 14; Table 14). For the Larson's Bridge and Acme projects, this was accomplished by a few (5 to 6) structures forming very large pools. In the case of the Acme Project, one pool was approximately 2385m<sup>2</sup> in area, accounting for nearly 80% of the pool area in the project reach, and 16% of the total South Fork project-formed pool area (Table 15). This was also the case in the Larson's Reach where one pool accounted for 1960m<sup>2</sup>, which represented 45% of the reach area and 13% of the total project-formed pool area.

While pool area and cover area are related at the project reach scale, at the individual structure level they are not (Figure 15). Structures that create larger pools do not provide the most instream cover area. This could imply that these should be separated as objectives at the structure level, and the engineering designs should be directed toward the individual objectives as necessary. At the reach scale, the three most effective projects at creating pools and cover were the Larson's Bridge, Acme and Van Zandt projects, while the four least effective were Skookum, Nasset, Sygitowicz, and Fobes (Figure 14; Table 14).

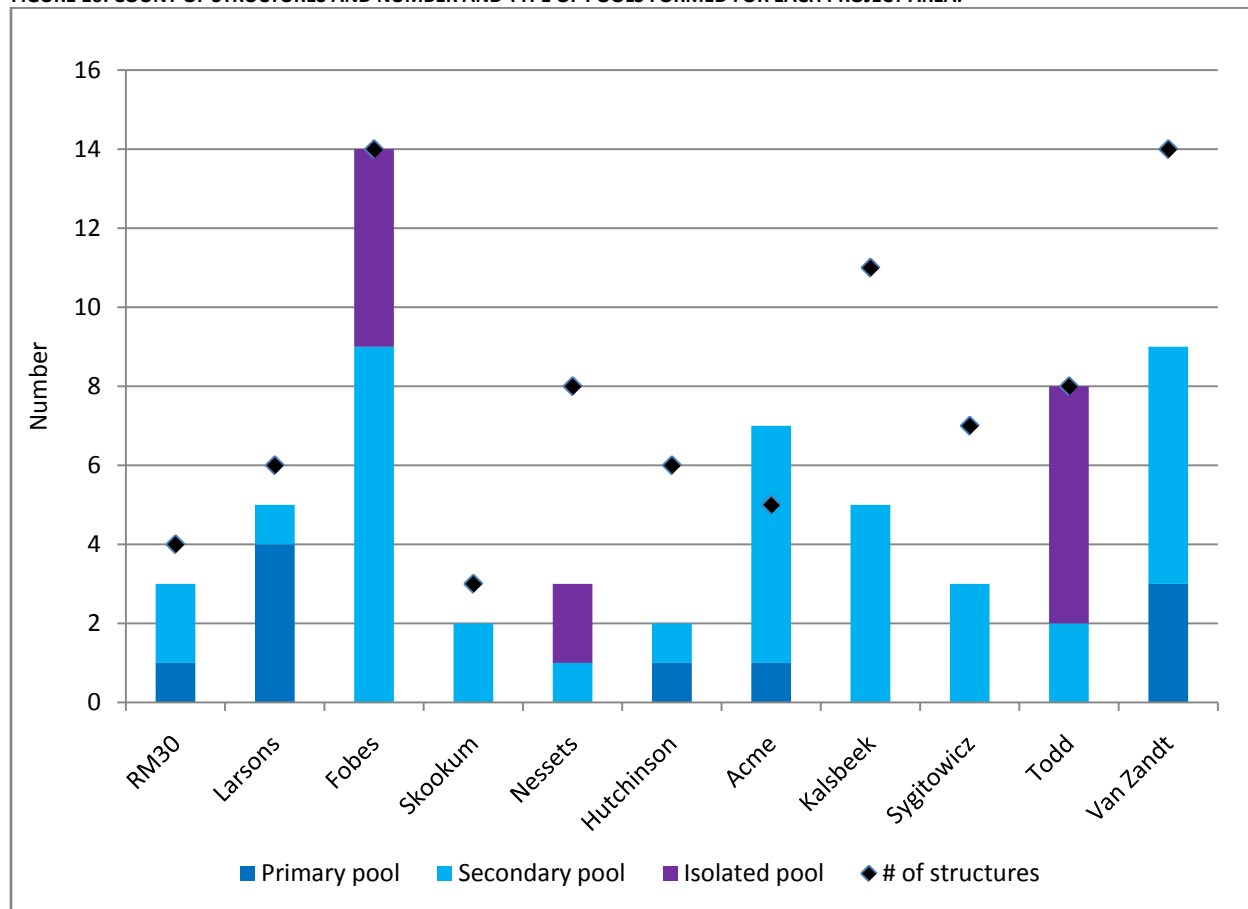
FIGURE 16: COUNT OF STRUCTURES AND NUMBER AND TYPE OF POOLS FORMED FOR EACH PROJECT AREA.

The different projects also created different types of pools: primary (comprising greater than half of the channel width), secondary (comprising less than half of the channel width), and isolated (not interacting with the flow at the time of the survey) (Figure 16). Because primary pools are large (average area = 975 m<sup>2</sup>) and deep (average= 2.2 m residual depth), they provide the highest quality holding and rearing habitat and were the focus for restoration projects in the South Fork. However, only ten of the eighty-

three structures formed primary pools (Table 14). These ten structures were distributed among five projects, with the Larson's Bridge Project accounting for four of the ten and the Van Zandt Project accounting for three of the ten pools. Since over half (44 of 83) of the structures were completed in 2010 and have seen only two events that have exceeded the bank-full stage (December 12, 2010 and January 17, 2011), it is likely that more primary pools will be formed through time.

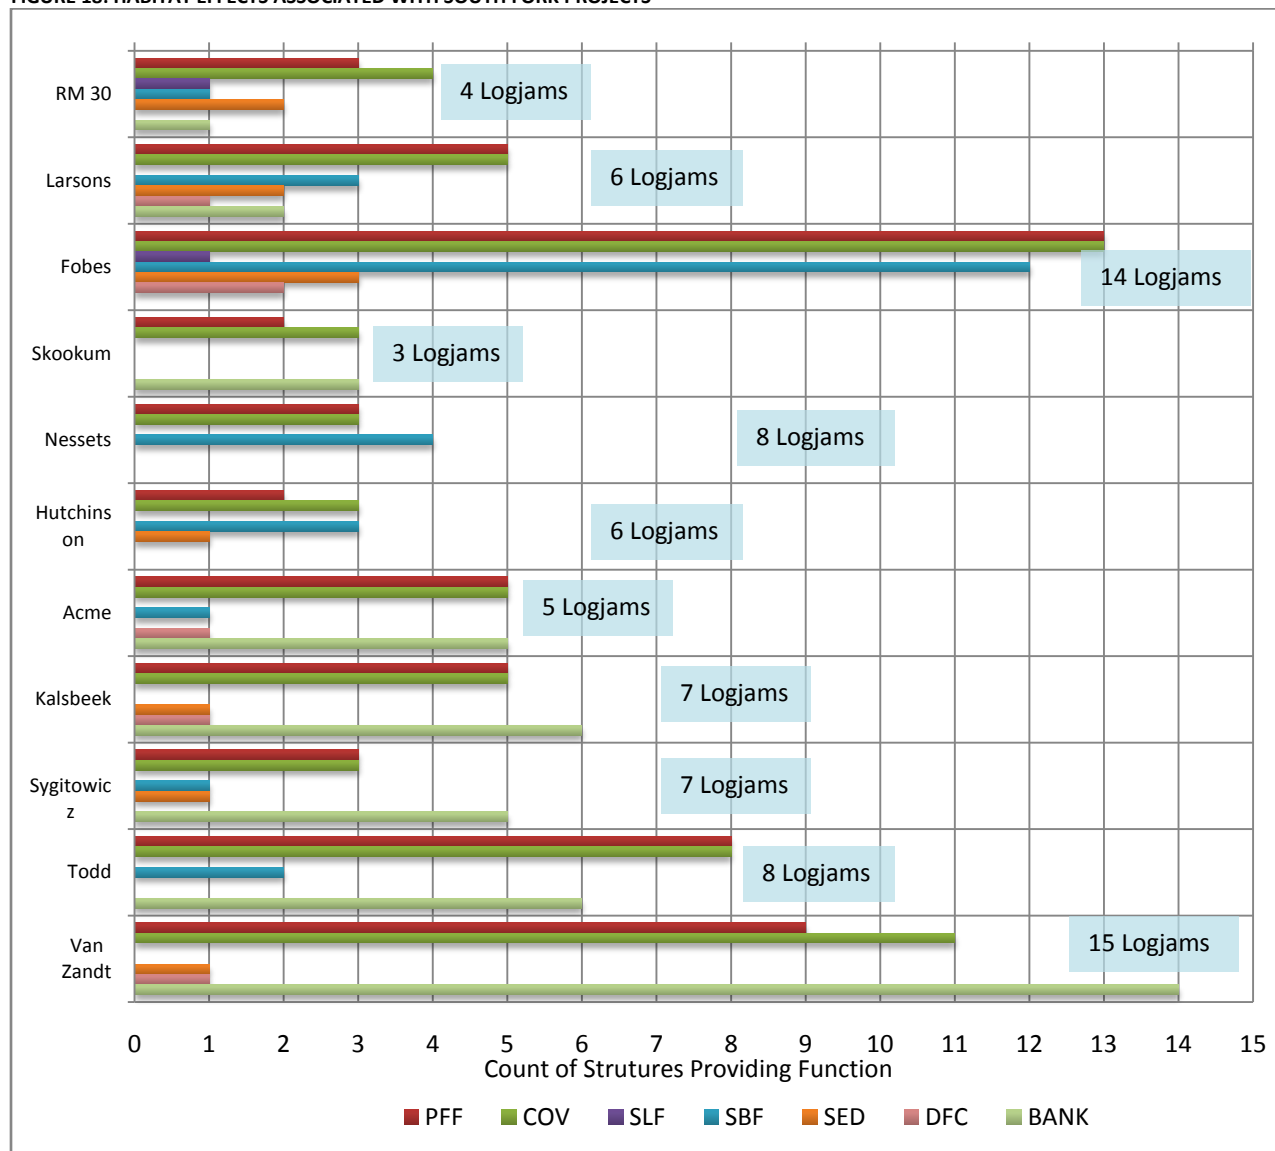
**FIGURE 18: HABITAT EFFECTS ASSOCIATED WITH SOUTH FORK PROJECTS**

In addition to measuring pool and cover area and pool depth, several other habitat effects were noted when present. These included splitting the low or bank-full flow, sediment sorting, causing channel avulsion, deflecting the channel, or protecting a stream bank. While all projects shared the goal of creating deep pools with cover, other habitat effects varied based on the channel type and engineering design of the project (Figure 18). In reaches where the South Fork Nooksack is more incised and confined by terraces and high floodplain, many of the structures are built into the bank. This is the case in the Van Zandt, Todd, Sygitowicz, Kalsbeek, Acme and Skookum projects. In two instances, the River Mile 30 and Larson's Bridge projects, the structures were designed to protect the bank at the toe of an active landslide. In less confined reaches, the structures are situated on bars and are splitting the bank-full channel. Examples of these project reaches include the Hutchinson, Nessel and Fobes projects.

Projects were generally more effective at producing site-scale effects, such as pool formation and bank protection, rather than reach-scale effects, such as channel deflection or flow splitting. While only three projects had a stated objective of protecting a bank, nearly all projects included structures that would

slow channel migration. Only two projects, Fobes and RM 30, have resulted in the formation of a secondary low flow channel and neither of these projects specifically identified side channel formation as a goal. For the two projects, Larson's Bridge and Kalsbeek, that did include low flow side channel formation as an objective, no logjam-induced side channel formation was observed.

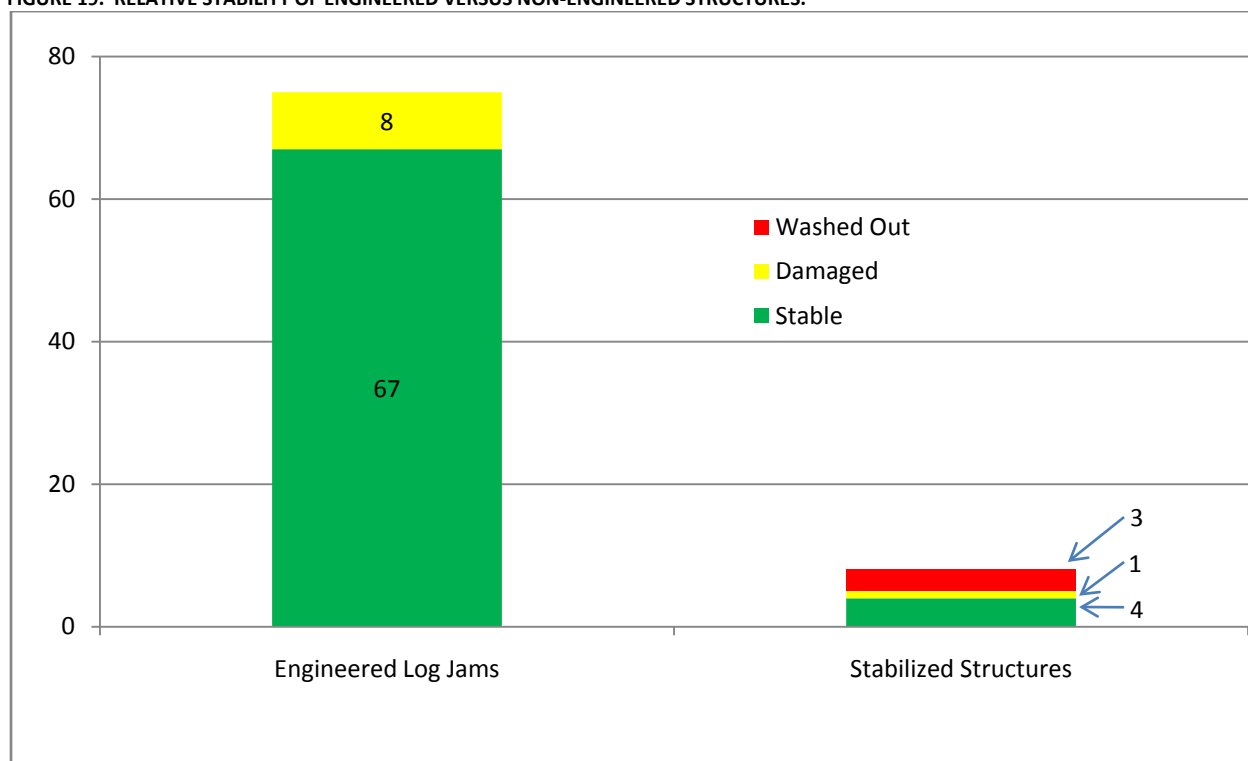
FIGURE 19. RELATIVE STABILITY OF ENGINEERED VERSUS NON-ENGINEERED STRUCTURES.

In terms of contribution to the working habitat target of 30 stable log jams/mile (WRIA 1 SRB 2005), constructing new engineered log jams has proven to be more effective than stabilizing existing structures (i.e. without engineering design). Almost all of the projects (10 of 11) implemented engineered designs, and most (89%) engineered structures have been stable since construction. Of the 75 engineered structures built, 8 have sustained minor damage (primarily loss of ballast; one structure lost key pieces; Figure 19). For the project that involved stabilization of existing structures (Nesset), 3 of 8 structures stabilized have washed out and an additional structure has lost pilings. Of the 4 remaining, 2 have not interacted with the channel so evaluation of stability is premature.

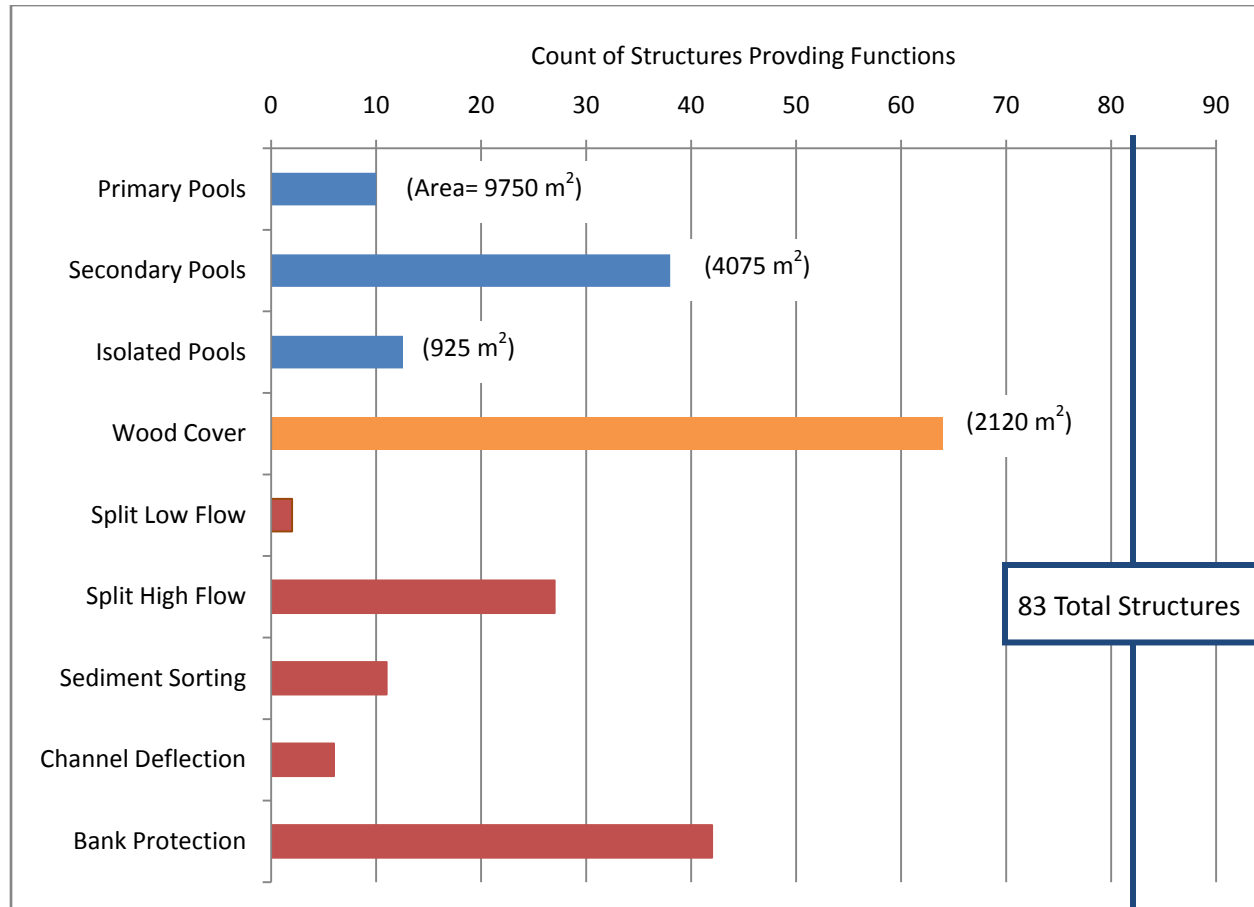
FIGURE 20: CUMULATIVE HABITAT FUNCTIONS OF SOUTH FORK LOGJAMS.

The cumulative results of the eleven logjam projects show that the structures have been most effective at scouring pools, providing woody cover and protecting banks from erosion (Figure 20). Out of the 83 structures, only 10 formed primary pools (Table 14). These were located in 5 of the 11 projects, with the Larson's Bridge and Van Zandt Projects accounting for 7 of the 11 pools. Jam-formed secondary (38 structures) and isolated pools (13 structures) were common; secondary pools provide a limited amount of habitat at low flow, while pools that are isolated at low flow can actually be sources of mortality for juvenile salmonids that get trapped therein due to dewatering, high temperatures, and high rates of predation. Deep pools were uncommon, with only fifteen pools in the low-flow channel (i.e. excluding

Sediment sorting was a project objective of both the Larson's Bridge and RM 30 projects, where limited spawning was occurring due to a lack of suitable spawning gravel. In both of these instances, sediment deposition and bar formation was associated with structures. Sediment sorting was more common in projects in the unconfined reaches of the upper watershed (Larson's Bridge, Fobes and RM 30) than in the lower watershed. These three projects accounted for 7 of the 11 structures that were associated with sediment sorting.
