# Fir Island Farm Estuary Restoration Project

## Lessons Learned

Washington State Department of Fish and Wildlife

# Fir Island Farm: Estuary Restoration Project Overview

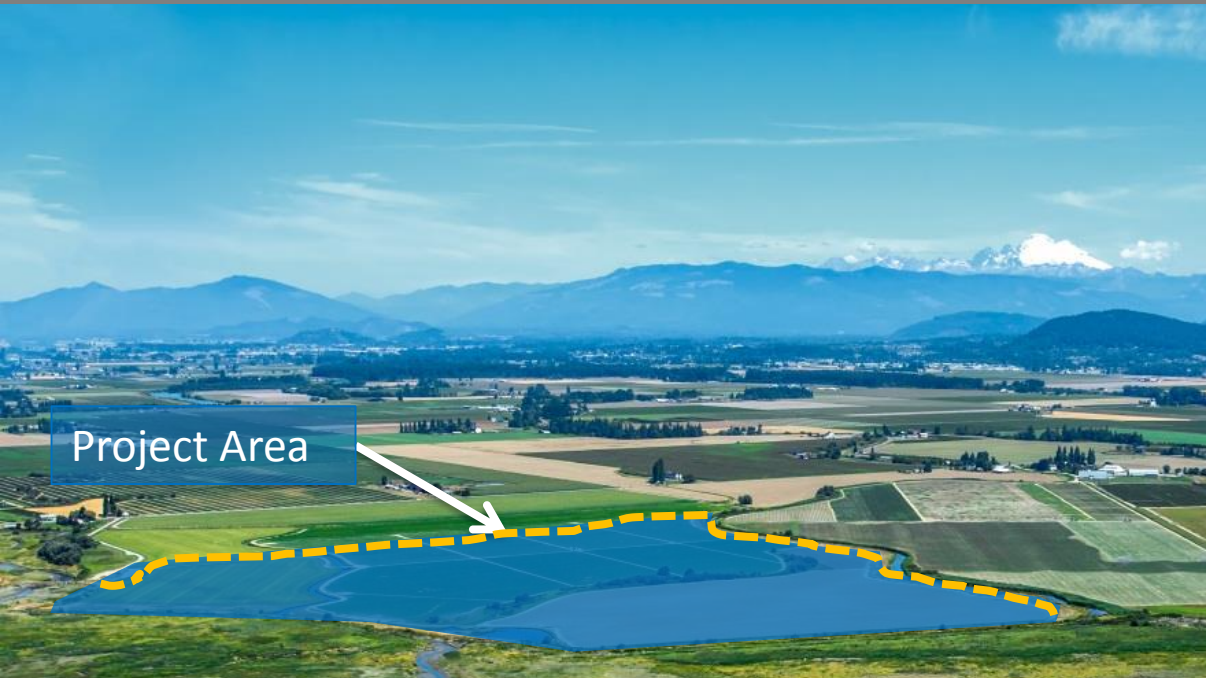
- Restored 132 acres of estuary habitat
- Constructed 5,800 feet of setback dike designed to improve coastal resiliency
- Completed pump station, tidegates and outfall structure

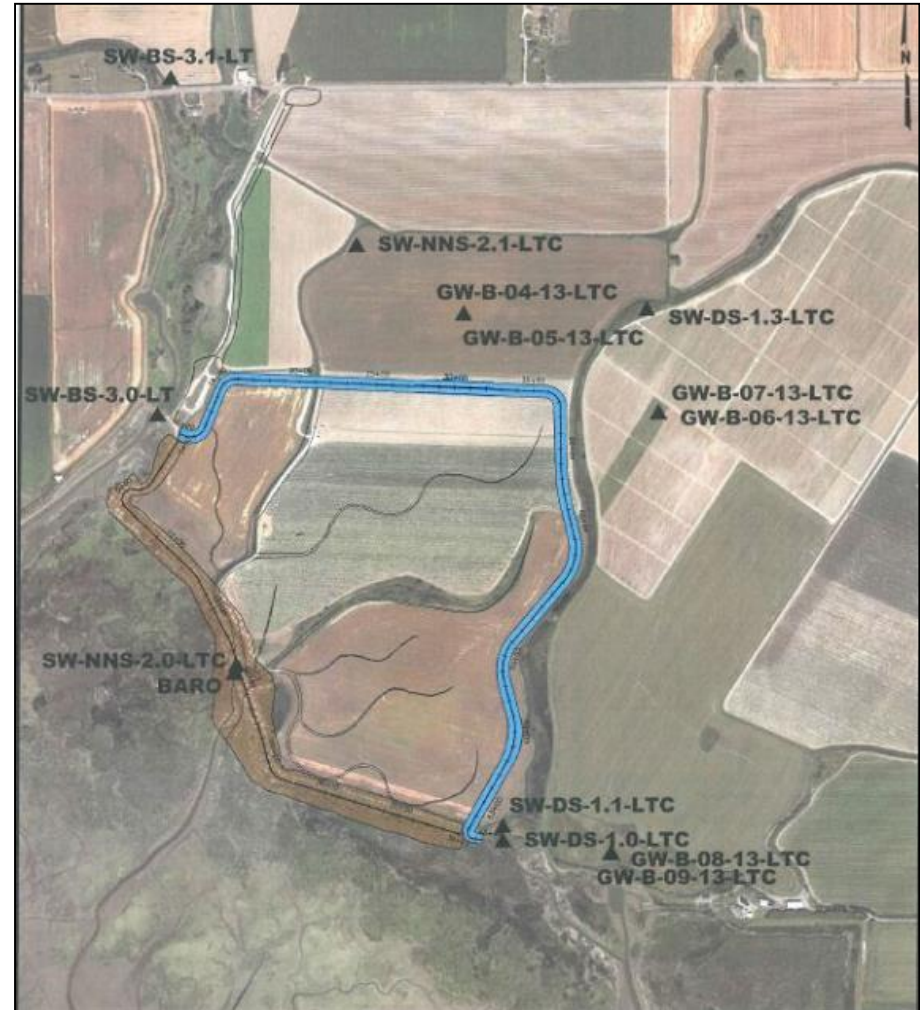
- Site specific water Levels let us better understand how much in-water work would be required during the breach.
- Allowed for better coordination with Ecology for WQ compliance
- Allowed for better cost estimating
- Protected us from a large dewatering claim

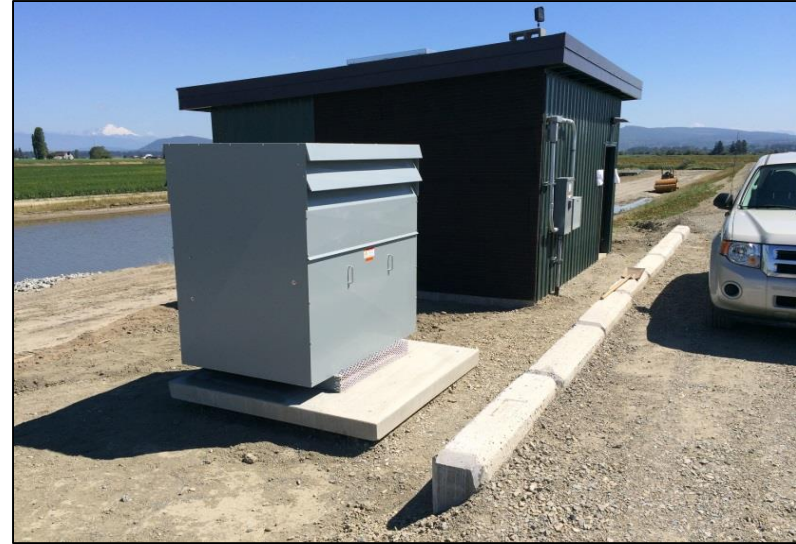
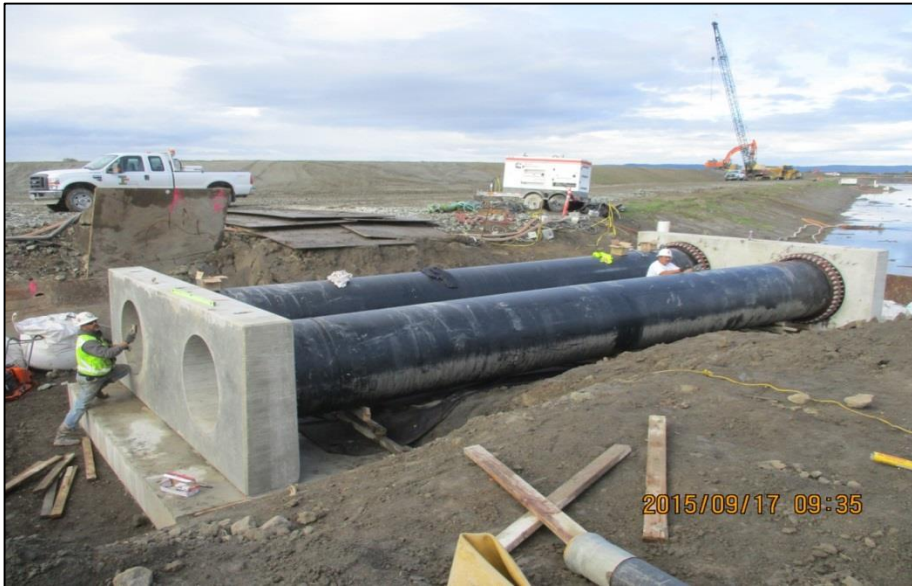
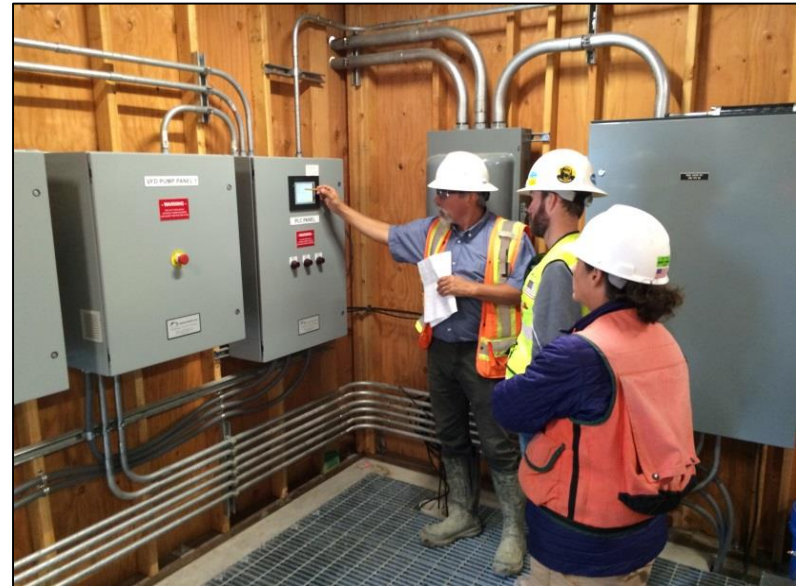
- Pump Station
  - Three 3,000 gpm pumps
  - Cost = 1.2 M/appx. 14% overall construction cost
- Tidegates
  - 6 tidegates (three new tidegates)
  - Cost = 1.1M/appx. 13% overall construction cost

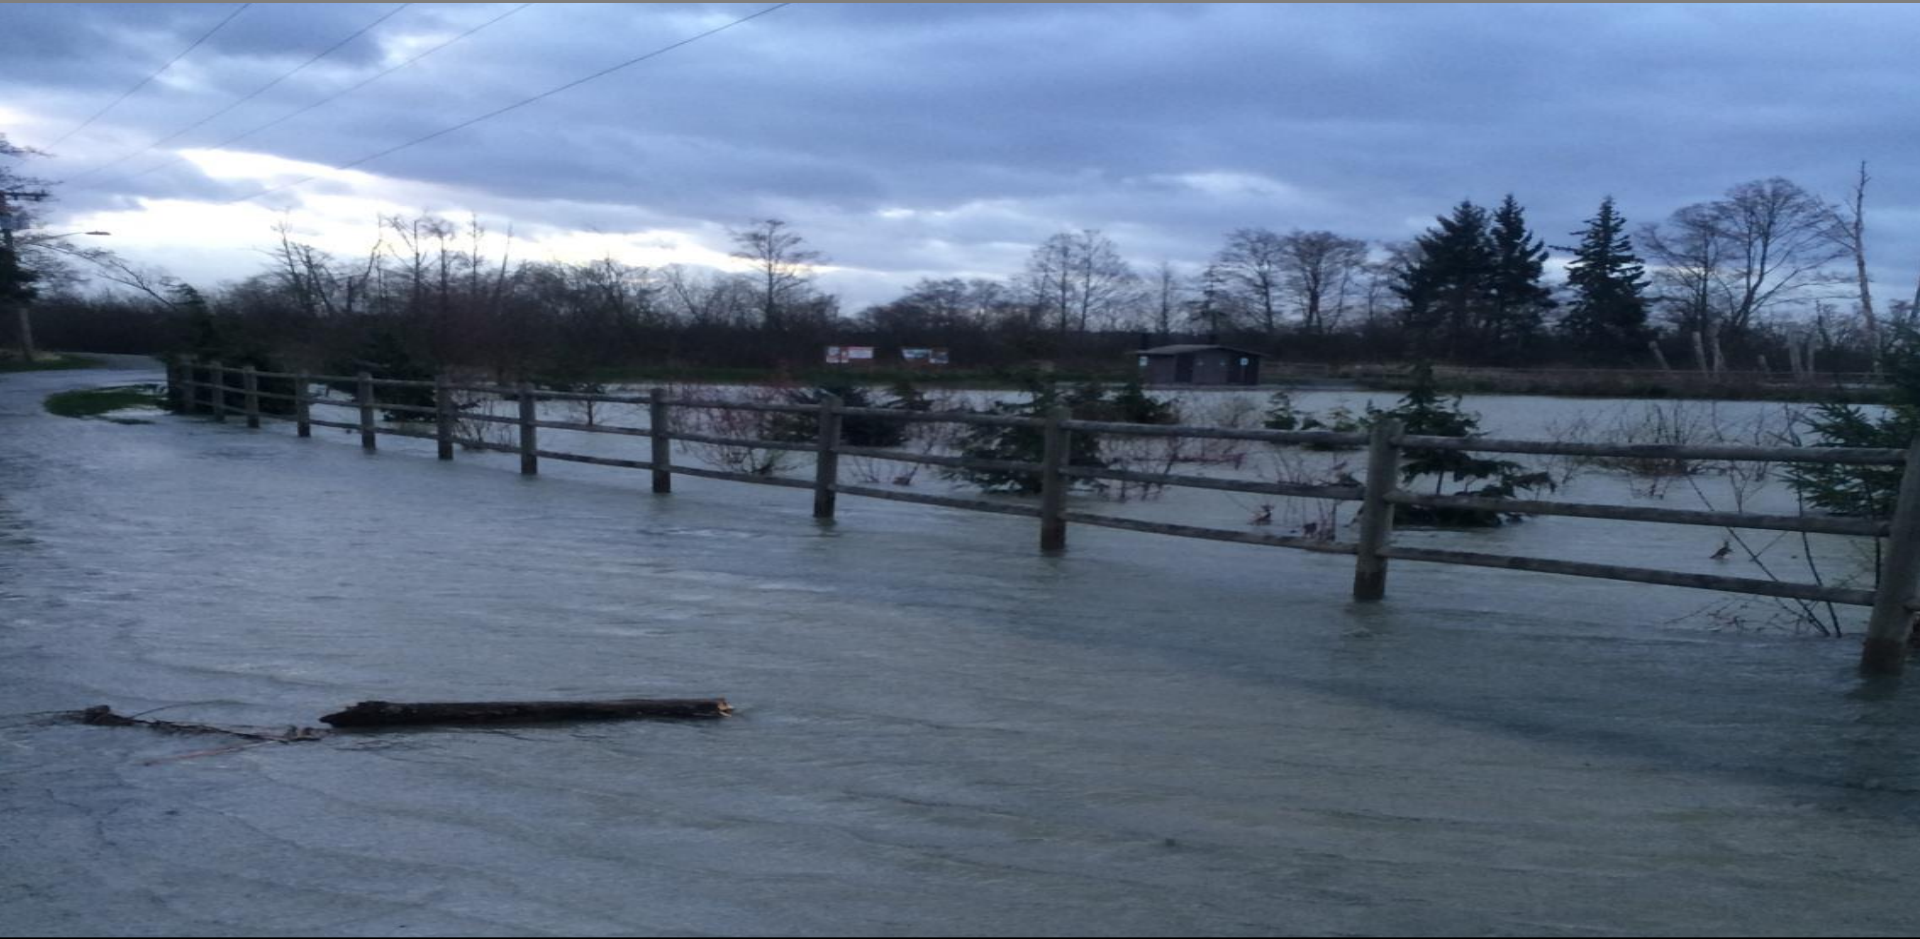
- Understand the current levee system, what level of protection is currently provided
  - This is not always as simple as matching an elevation
- Understand current engineering analysis and design standards
- Understand existing deficiencies on the site- You can't just push existing problems on to adjacent landowners

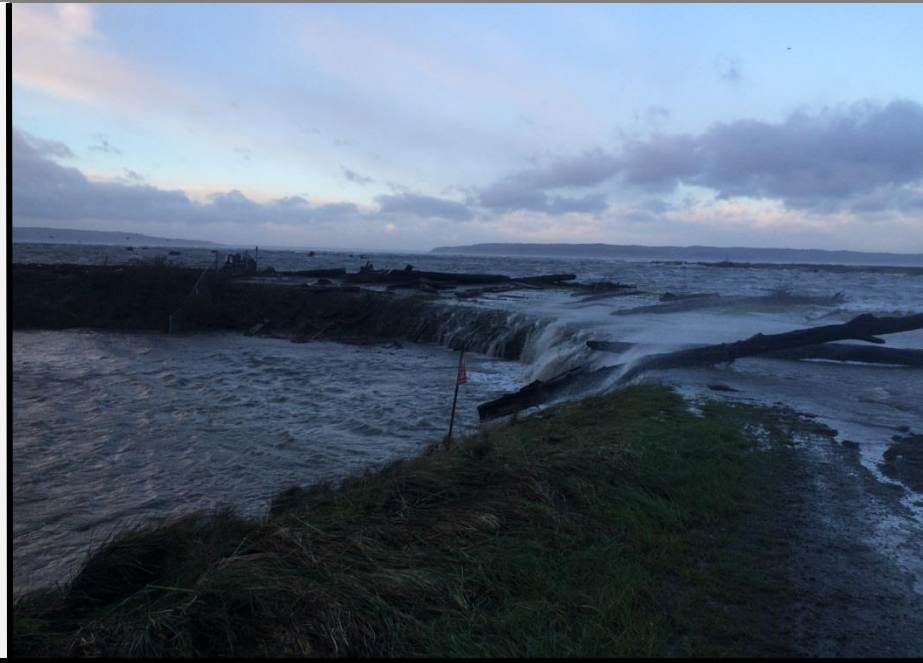
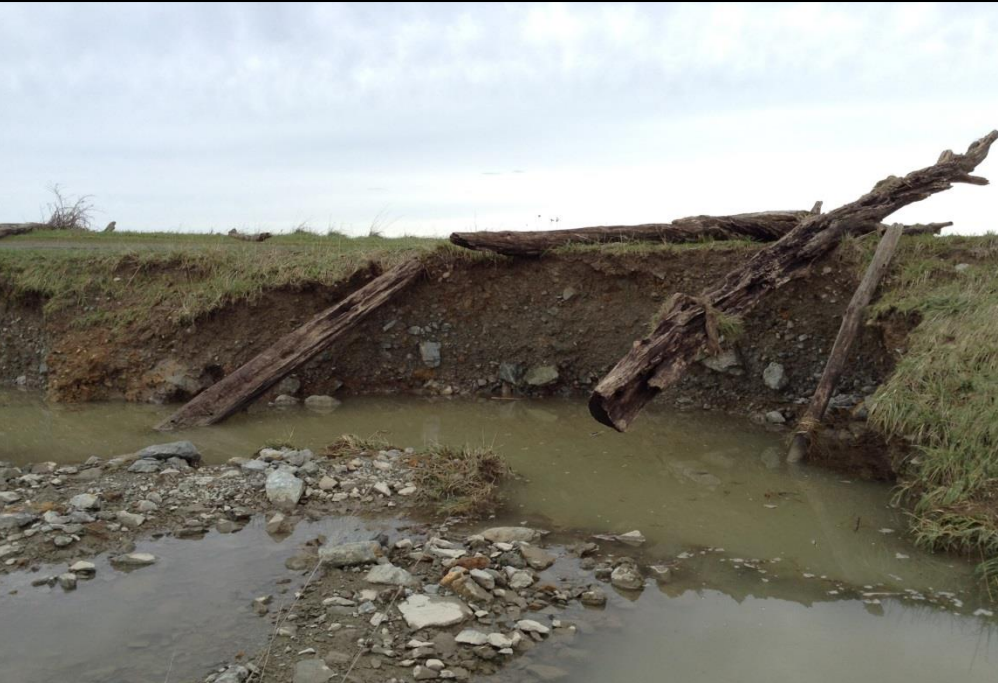
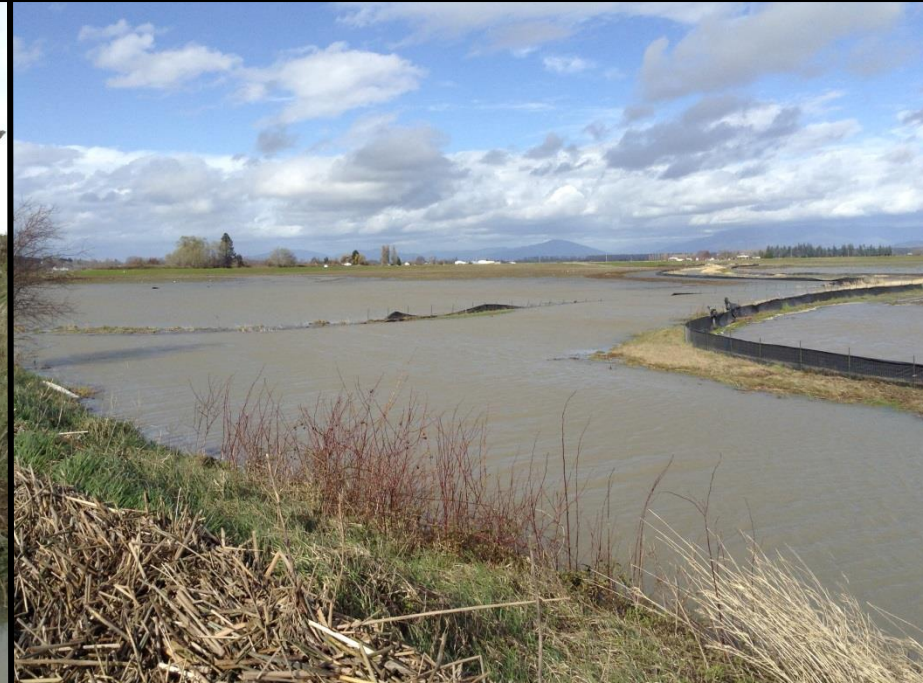
- Between Year 1 and Year 2 construction the existing dike was overtopped
- Dike is approximately 2-ft higher than existing dike
  - Will withstand large storm events without damage
  - Small percentage of the overall project cost

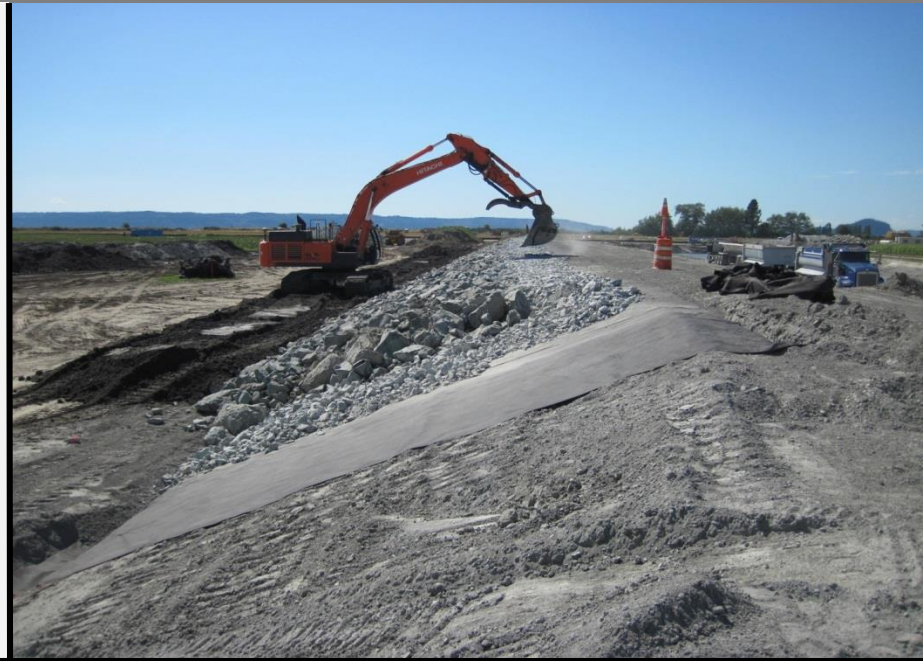
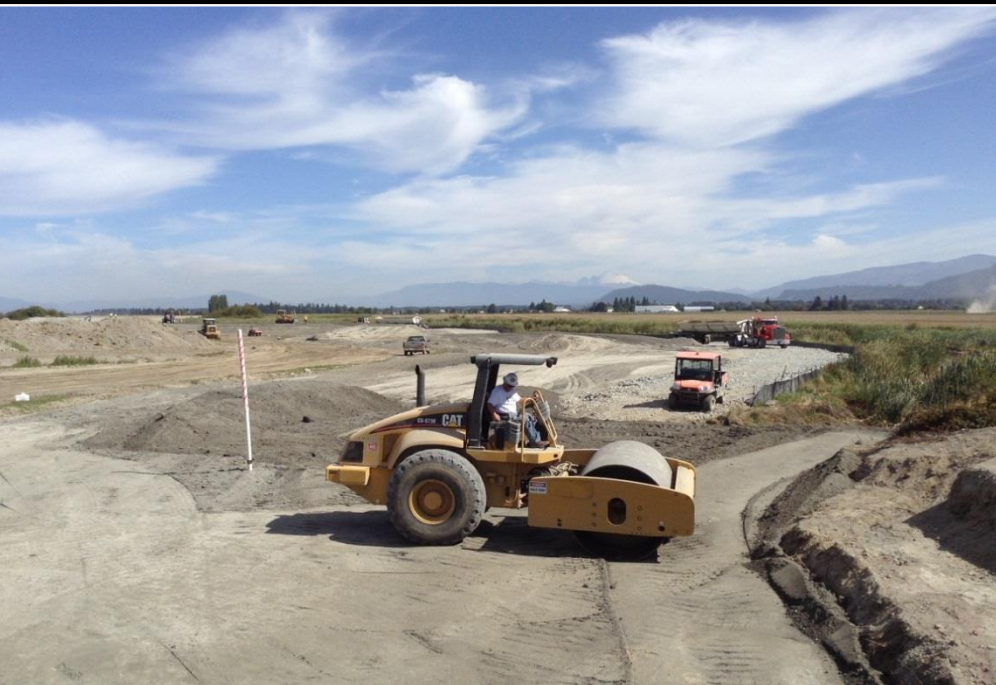
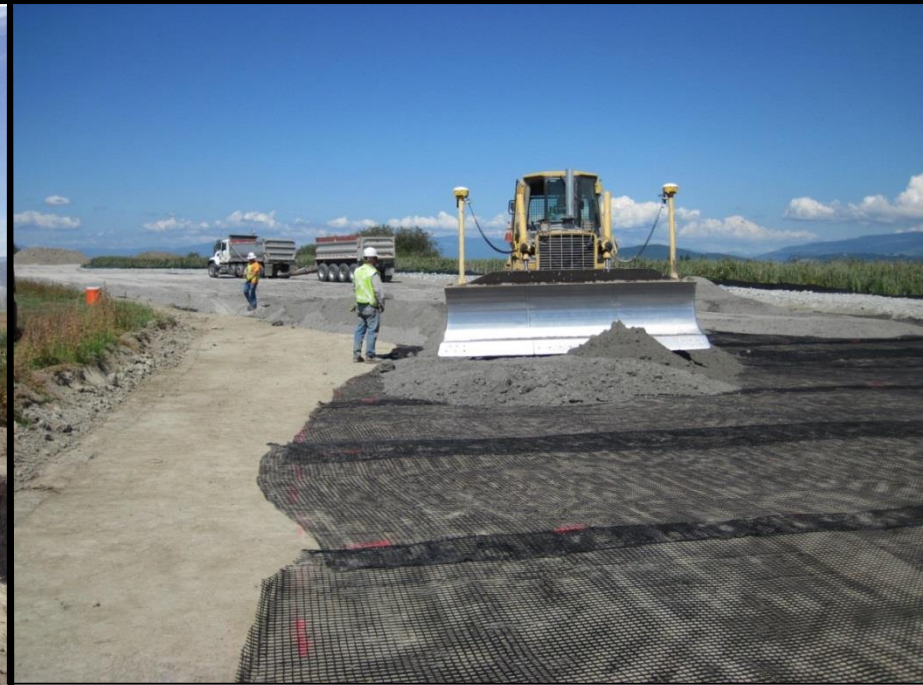
- It's hard to construct 5,800 LF of dike in one summer
  - 80 to 90 workers on site
  - Averaged about 4,000 tons of dike material each day – roughly 28 trucks running 1-hour round trips for 10-hours a day
  - Material is very weather sensitive

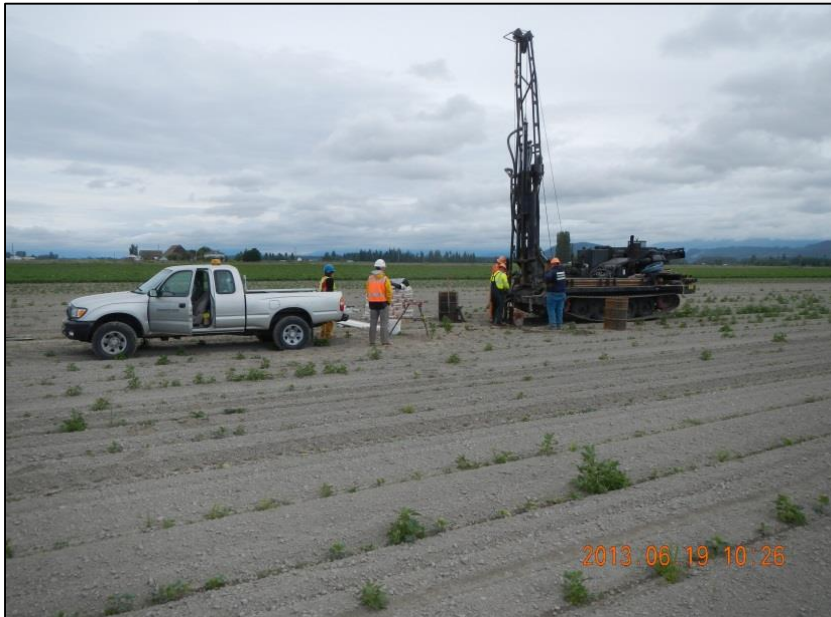
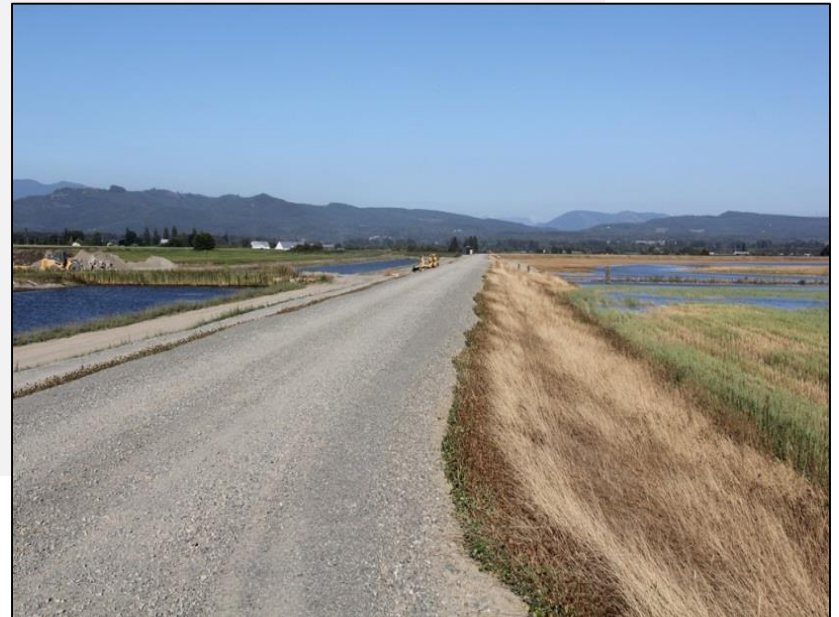
- Geotechnical investigation predicted 5 to 7 inches of settlement occurring over 20 years' time
- Settlement monitoring stations were installed along the entire length of the dike
  - Measure the top of the dike select fill
  - Top layer of gravel does not “count” for protection
