# **Canyon Creek Alluvial Fan Risk Assessment**

**Final Report  
September 2003**

Whatcom County Flood Control Zone District

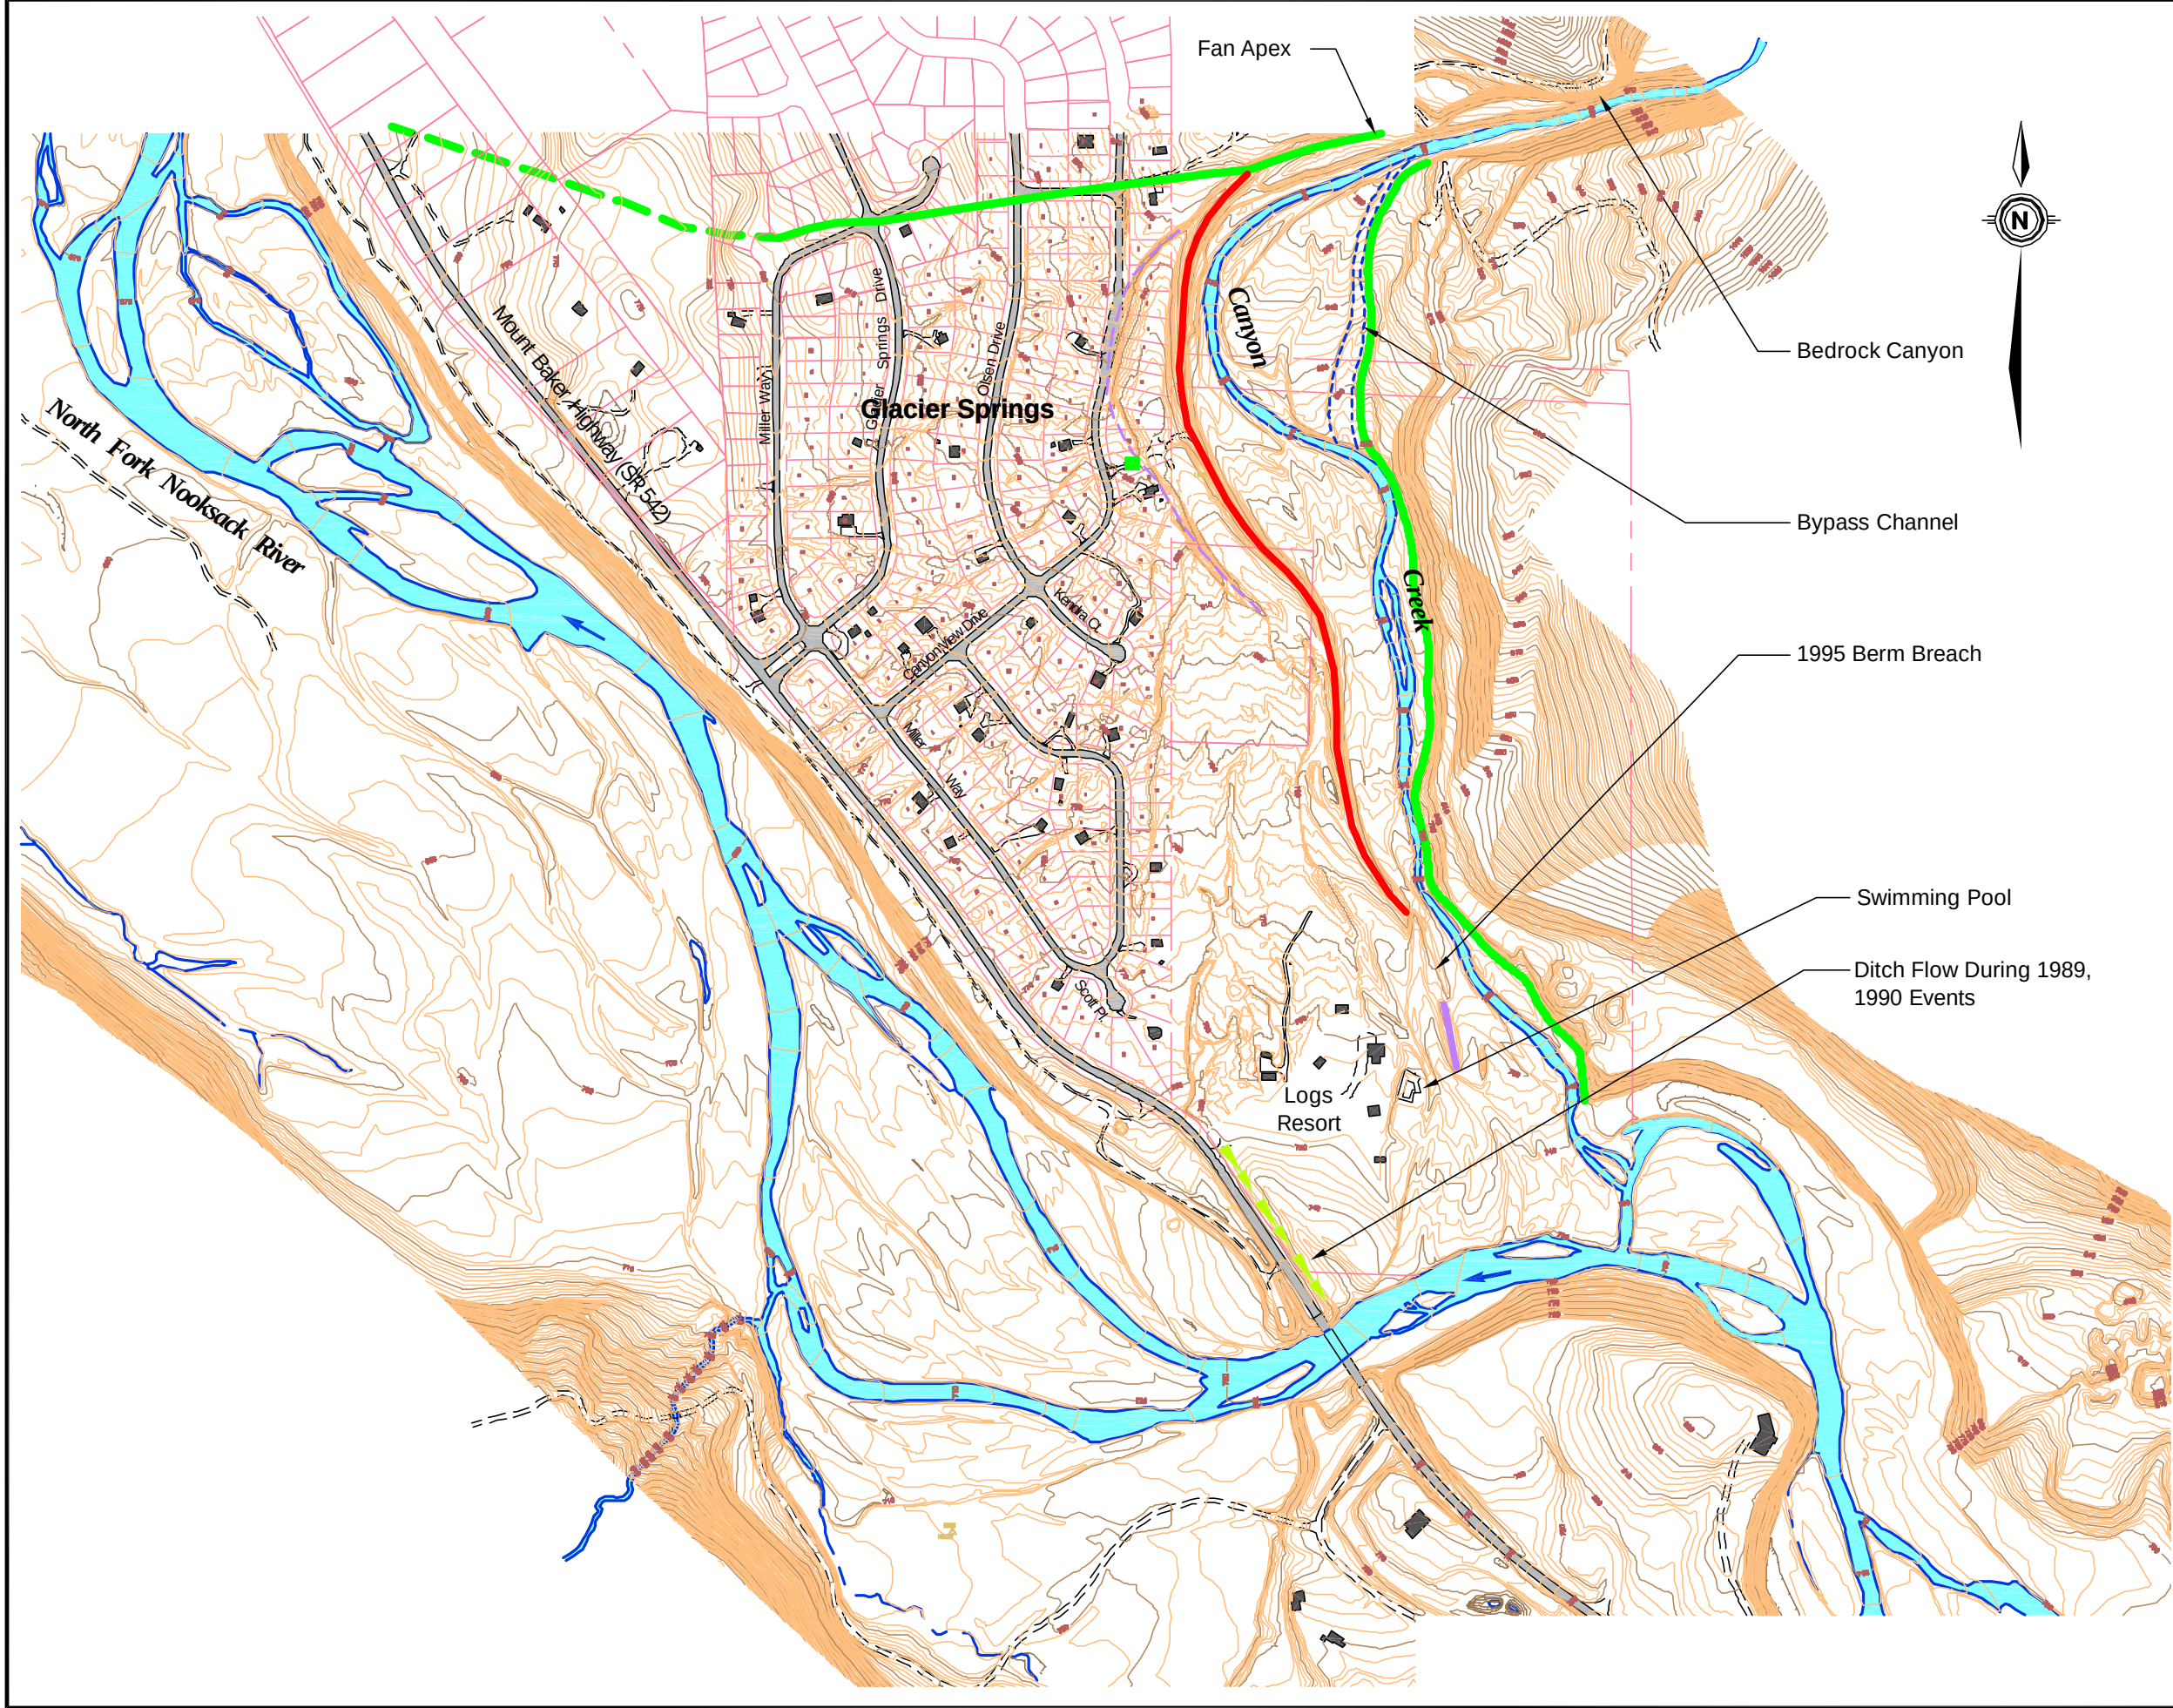
| Canyon Creek Alluvial<br>Fan Risk Assessment<br>Whatcom County Flood Control<br>Zone District | |
|---|---|
| <b>Figure 1-3</b> | |

| Canyon Creek Alluvial<br>Fan Risk Assessment<br>Whatcom County Flood Control<br>Zone District | |
|---|---|
| <b>Legend</b> <ul style="list-style-type: none"><li>Armoured Berm</li><li>Berm</li><li>Property Line</li><li>Former Shepherd Residence</li><li>Limit of 1989,1990 Bank Erosion</li><li>Fan Boundary</li></ul> | |

Below the riprapped section, the berm was extended downstream a further 450 ft (137 m) to provide additional protection to the Logs Resort. However, this section of the berm was not armoured (Figure 1-3). The proposed berm on the left bank in the lower reaches was eliminated as a contract item because it was felt that the existing natural bank provided adequate flow deflection. Elimination of the left berm also provided additional area for sediment deposition during peak flow events.

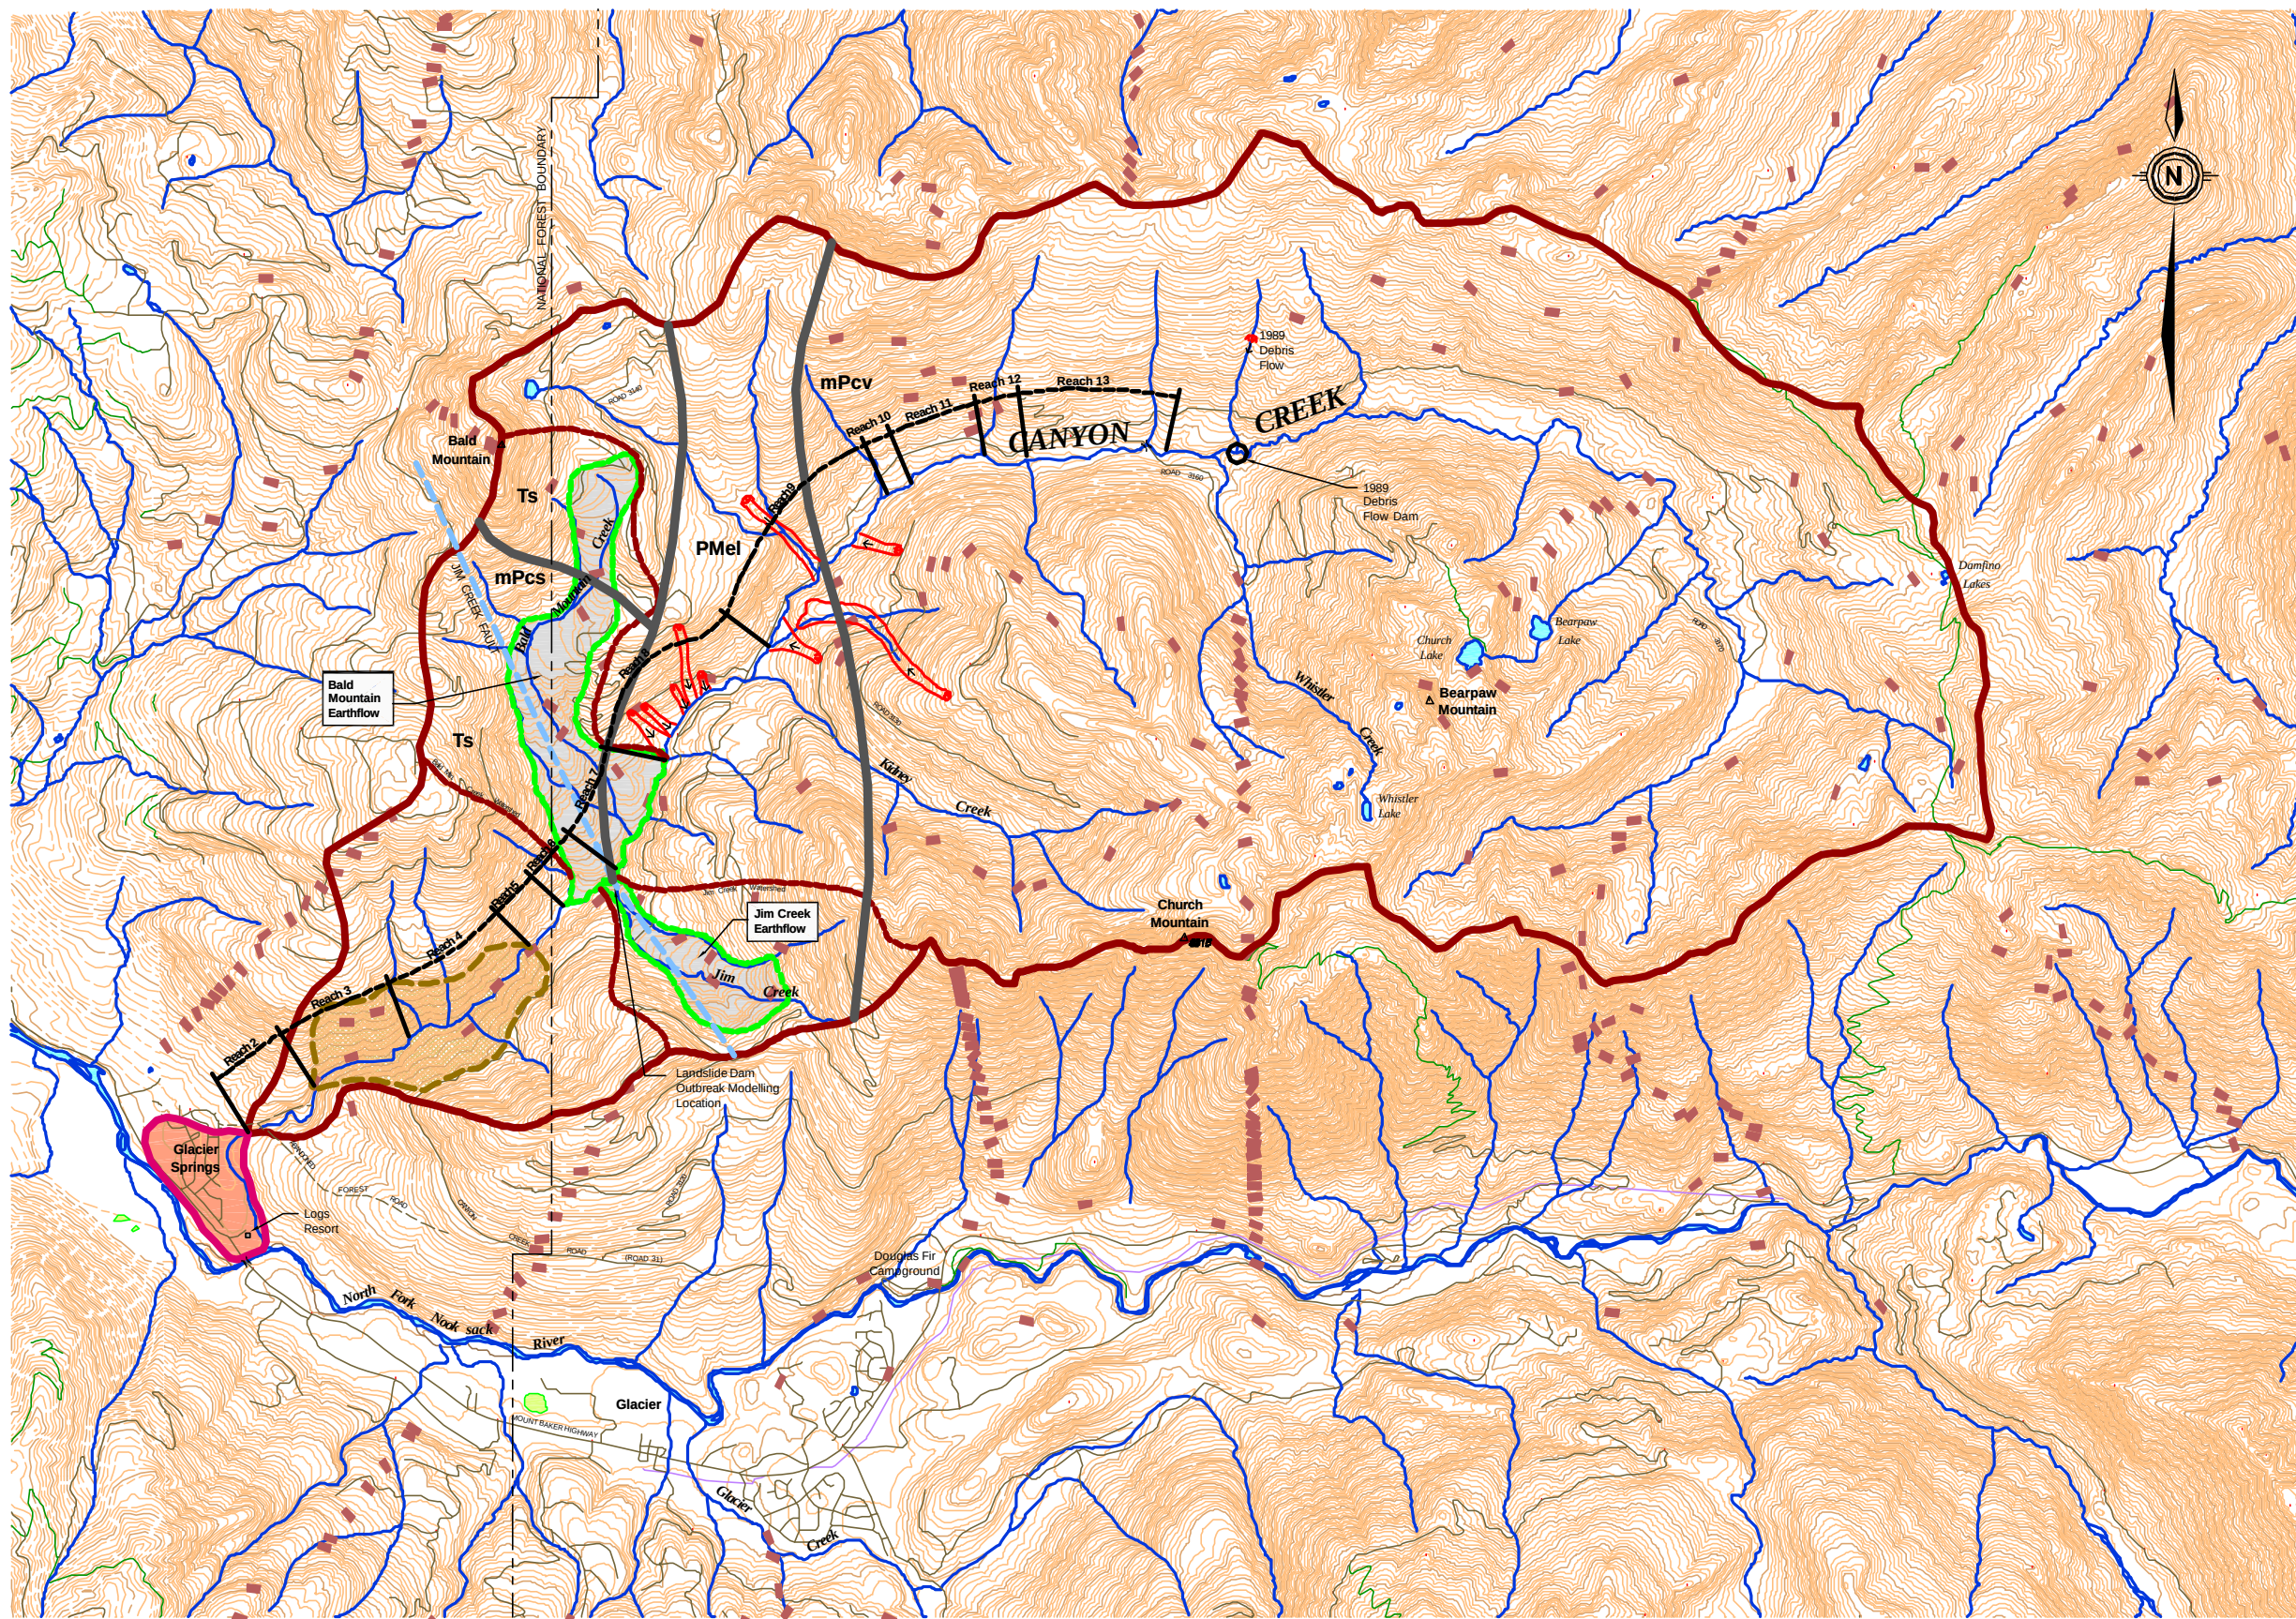
Canyon Creek Alluvial Fan Risk Assessment  
Overview Map of Canyon Creek Watershed

This section should be read in conjunction with Appendix B (photographs), Appendix C (watershed description), Appendix D (aerial photograph analysis), Appendix E (environmental resource values), Figure 2-1 (a geomorphic map of the watershed), and Figure 2-2 (a 2001 air photo of the Canyon Creek fan).

Within a 500-year return period, debris floods exceeding the 1989 event are considered probable. Approximately 3 miles upstream of the fan apex, two large landslides (the Jim Creek earthflow and the Bald Mountain earthflow) are situated on opposite sides of the main valley (Figure 2-1). Both earthflows are active and contribute significant volumes of sediment to the creek (Appendix C). The Jim Creek earthflow is in an extensional phase with active loss of toe support by the undercutting action of Canyon Creek. Based on tension cracks observed above the exposed face, a dam height of up to 100 ft (30 m) is thought to be possible by rotational or block failures. Although not observed in historic time, a failure of this magnitude is thought to be possible within a 500-year return period. To determine the peak discharge associated with a 100 ft (30 m) high dam, various dam outbreak scenarios were modelled using the hydraulic model FLDWAV (Appendix G).

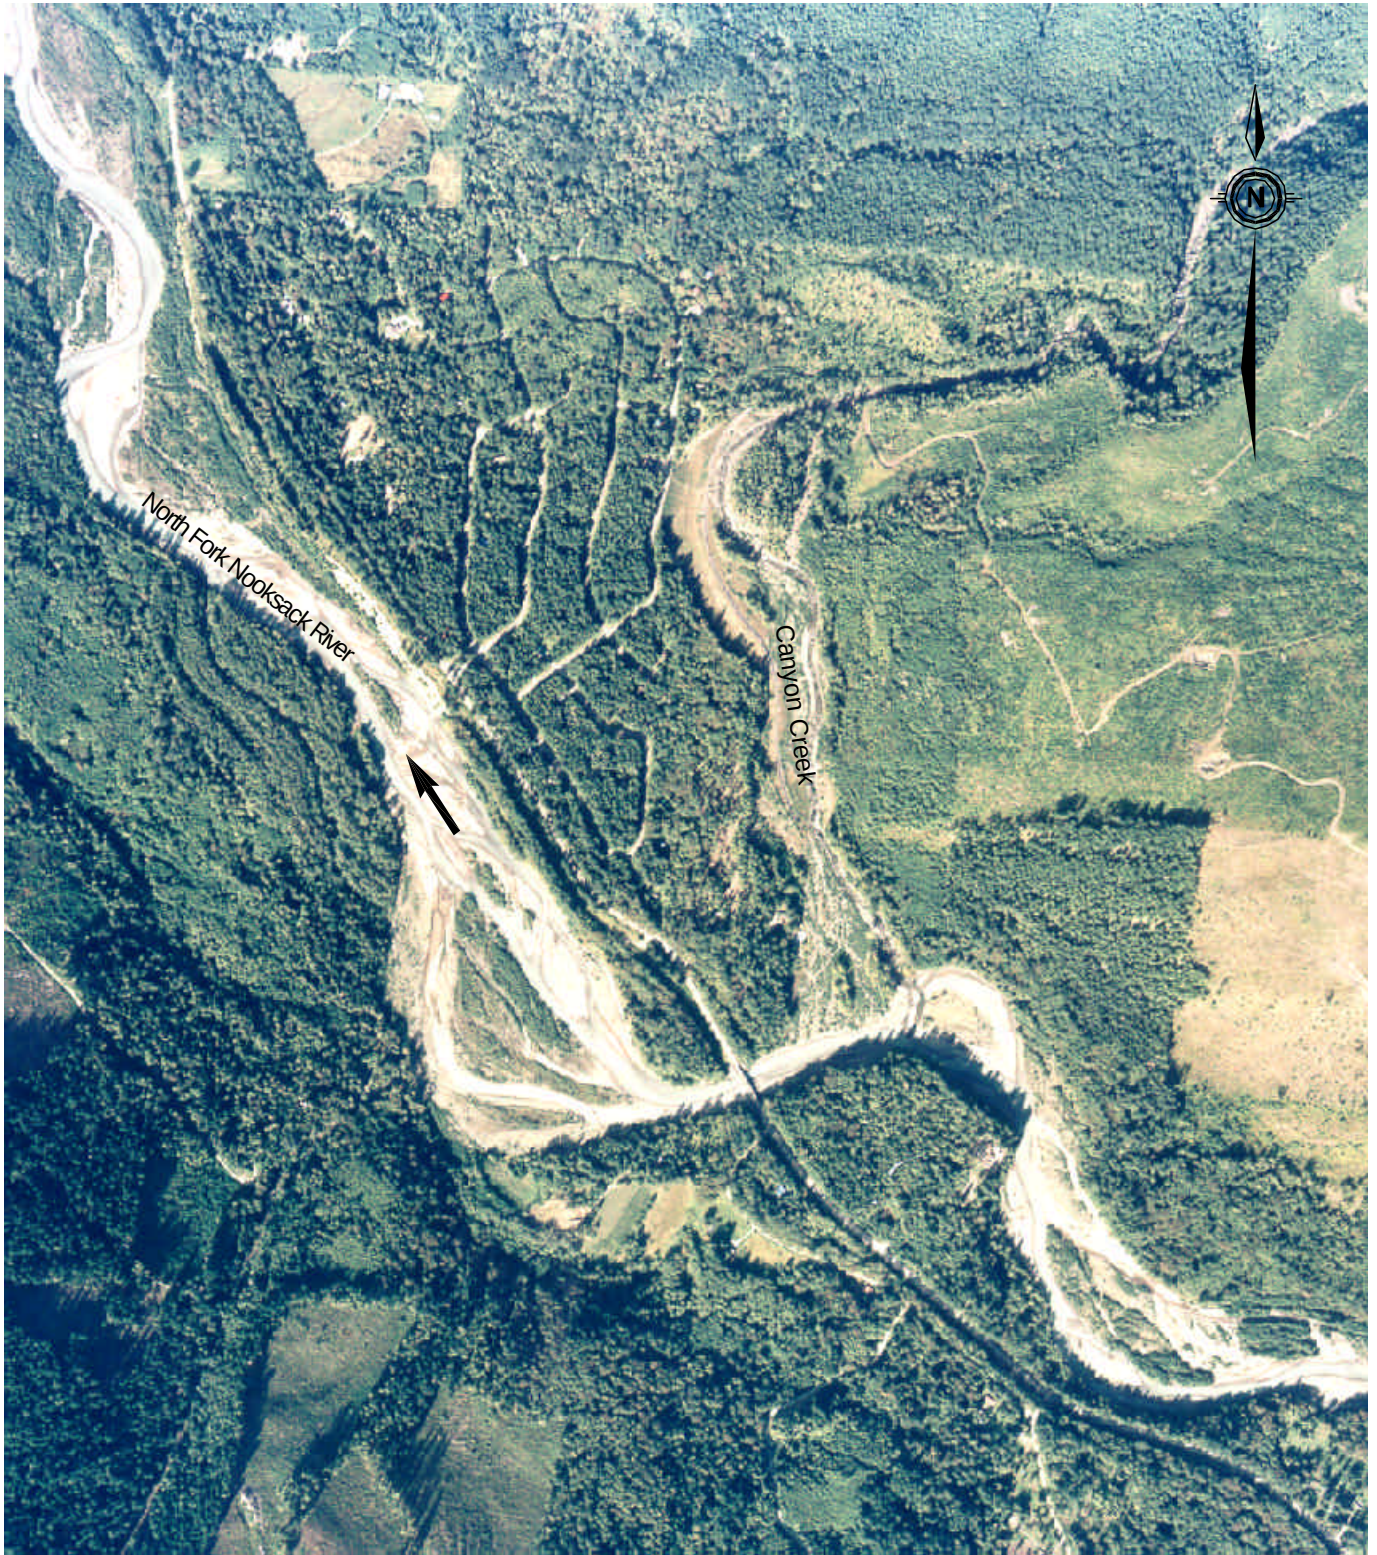
**Figure 2-2**

Baseplan Source: Washington State Department of Natural Resources. September 10, 2001. Project NW-C-0, Roll 73-58, Photo 217

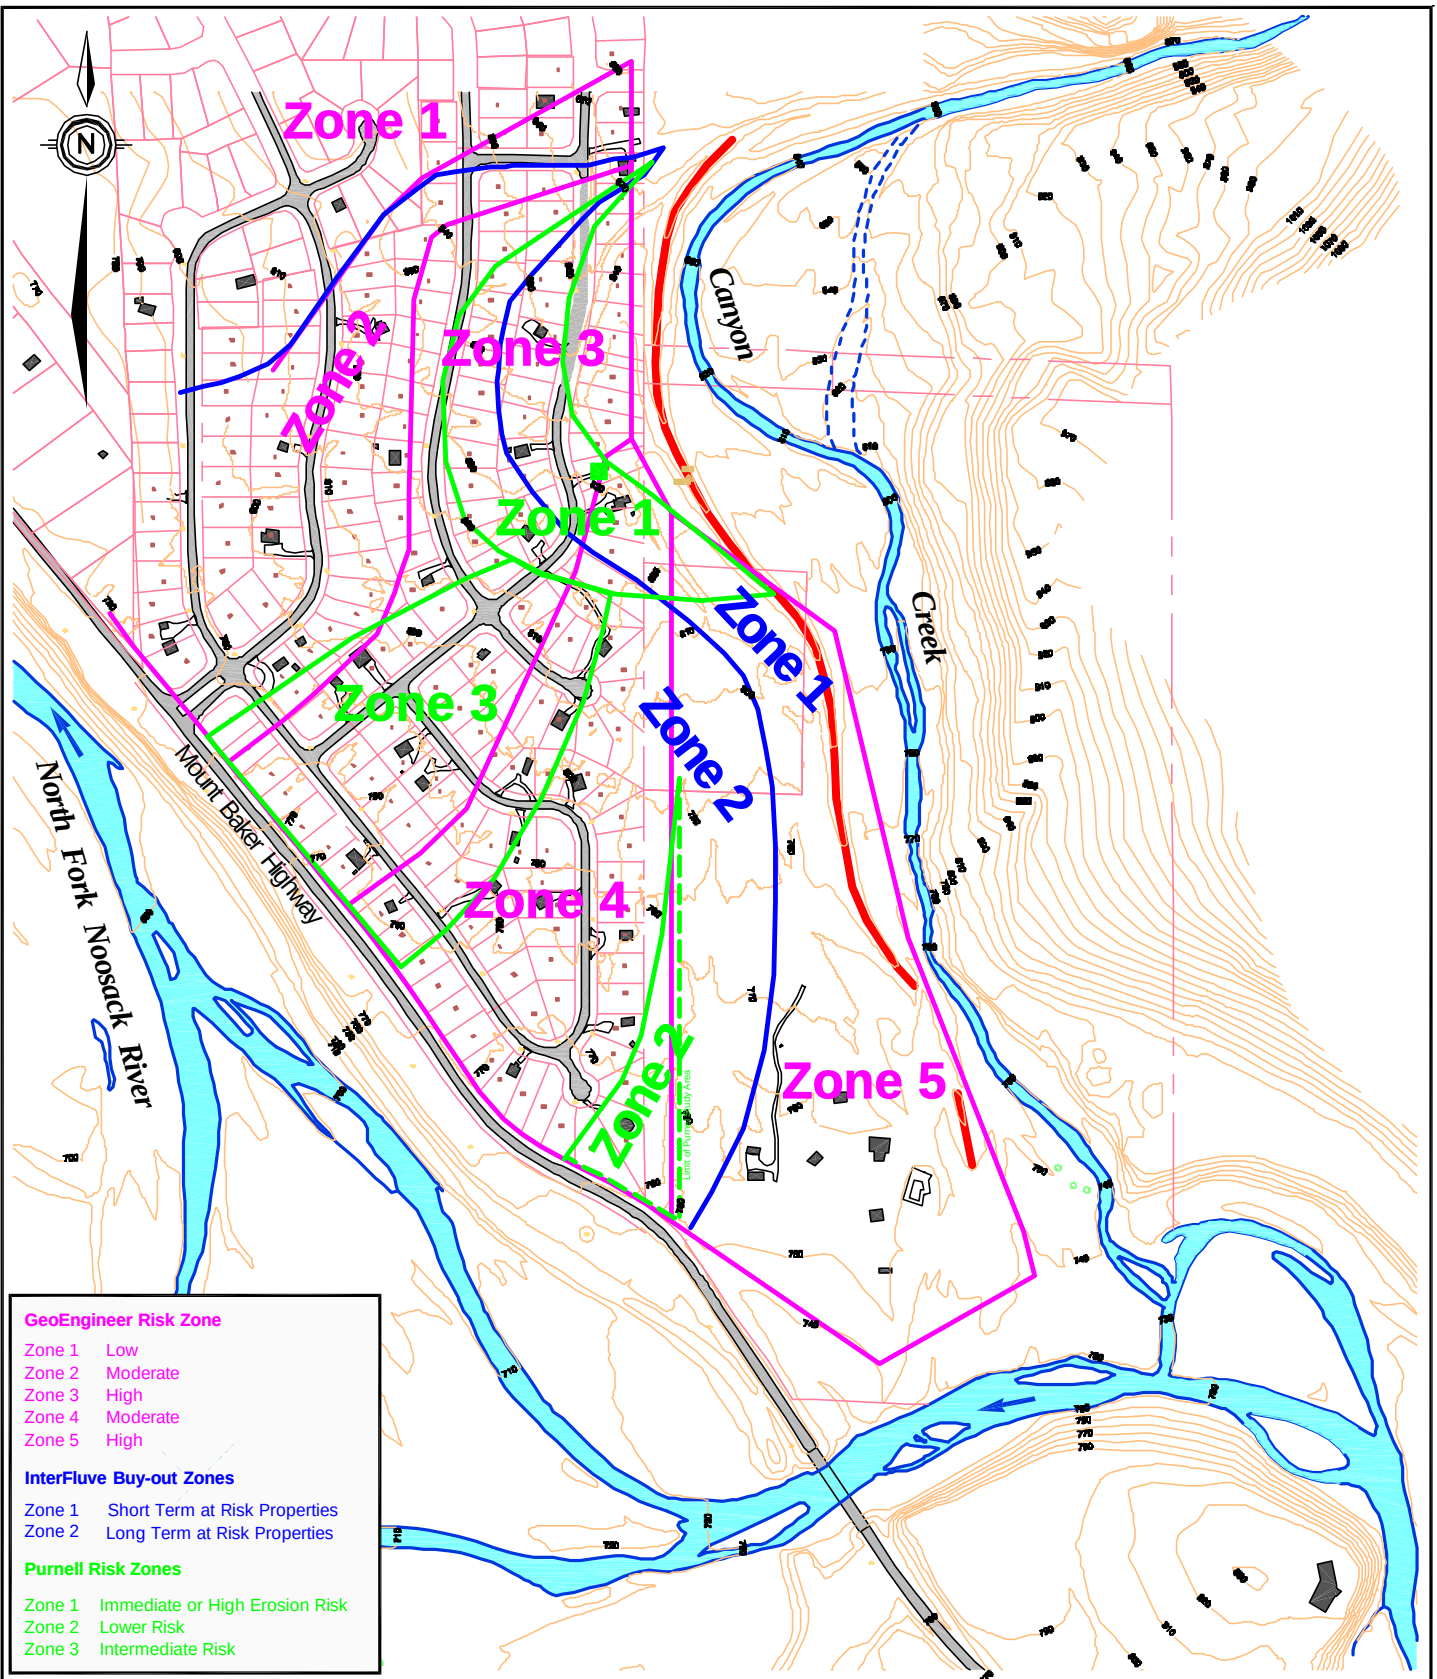
Figure 2-4

**GeoEngineer Risk Zone**

- Zone 1 Low
- Zone 2 Moderate
- Zone 3 High
- Zone 4 Moderate
- Zone 5 High

Purnell and Associates identified three hazard zones on the fan where future erosion could occur (Figure 2-4). Each of the hazard zones was assigned a level of risk and are defined as follows:

GeoEngineers (1992) divided the fan into five zones with three risk levels (Figure 2-4). The identified risk zones predate the berm design and construction (also true for Purnell). The zones are defined as follows:

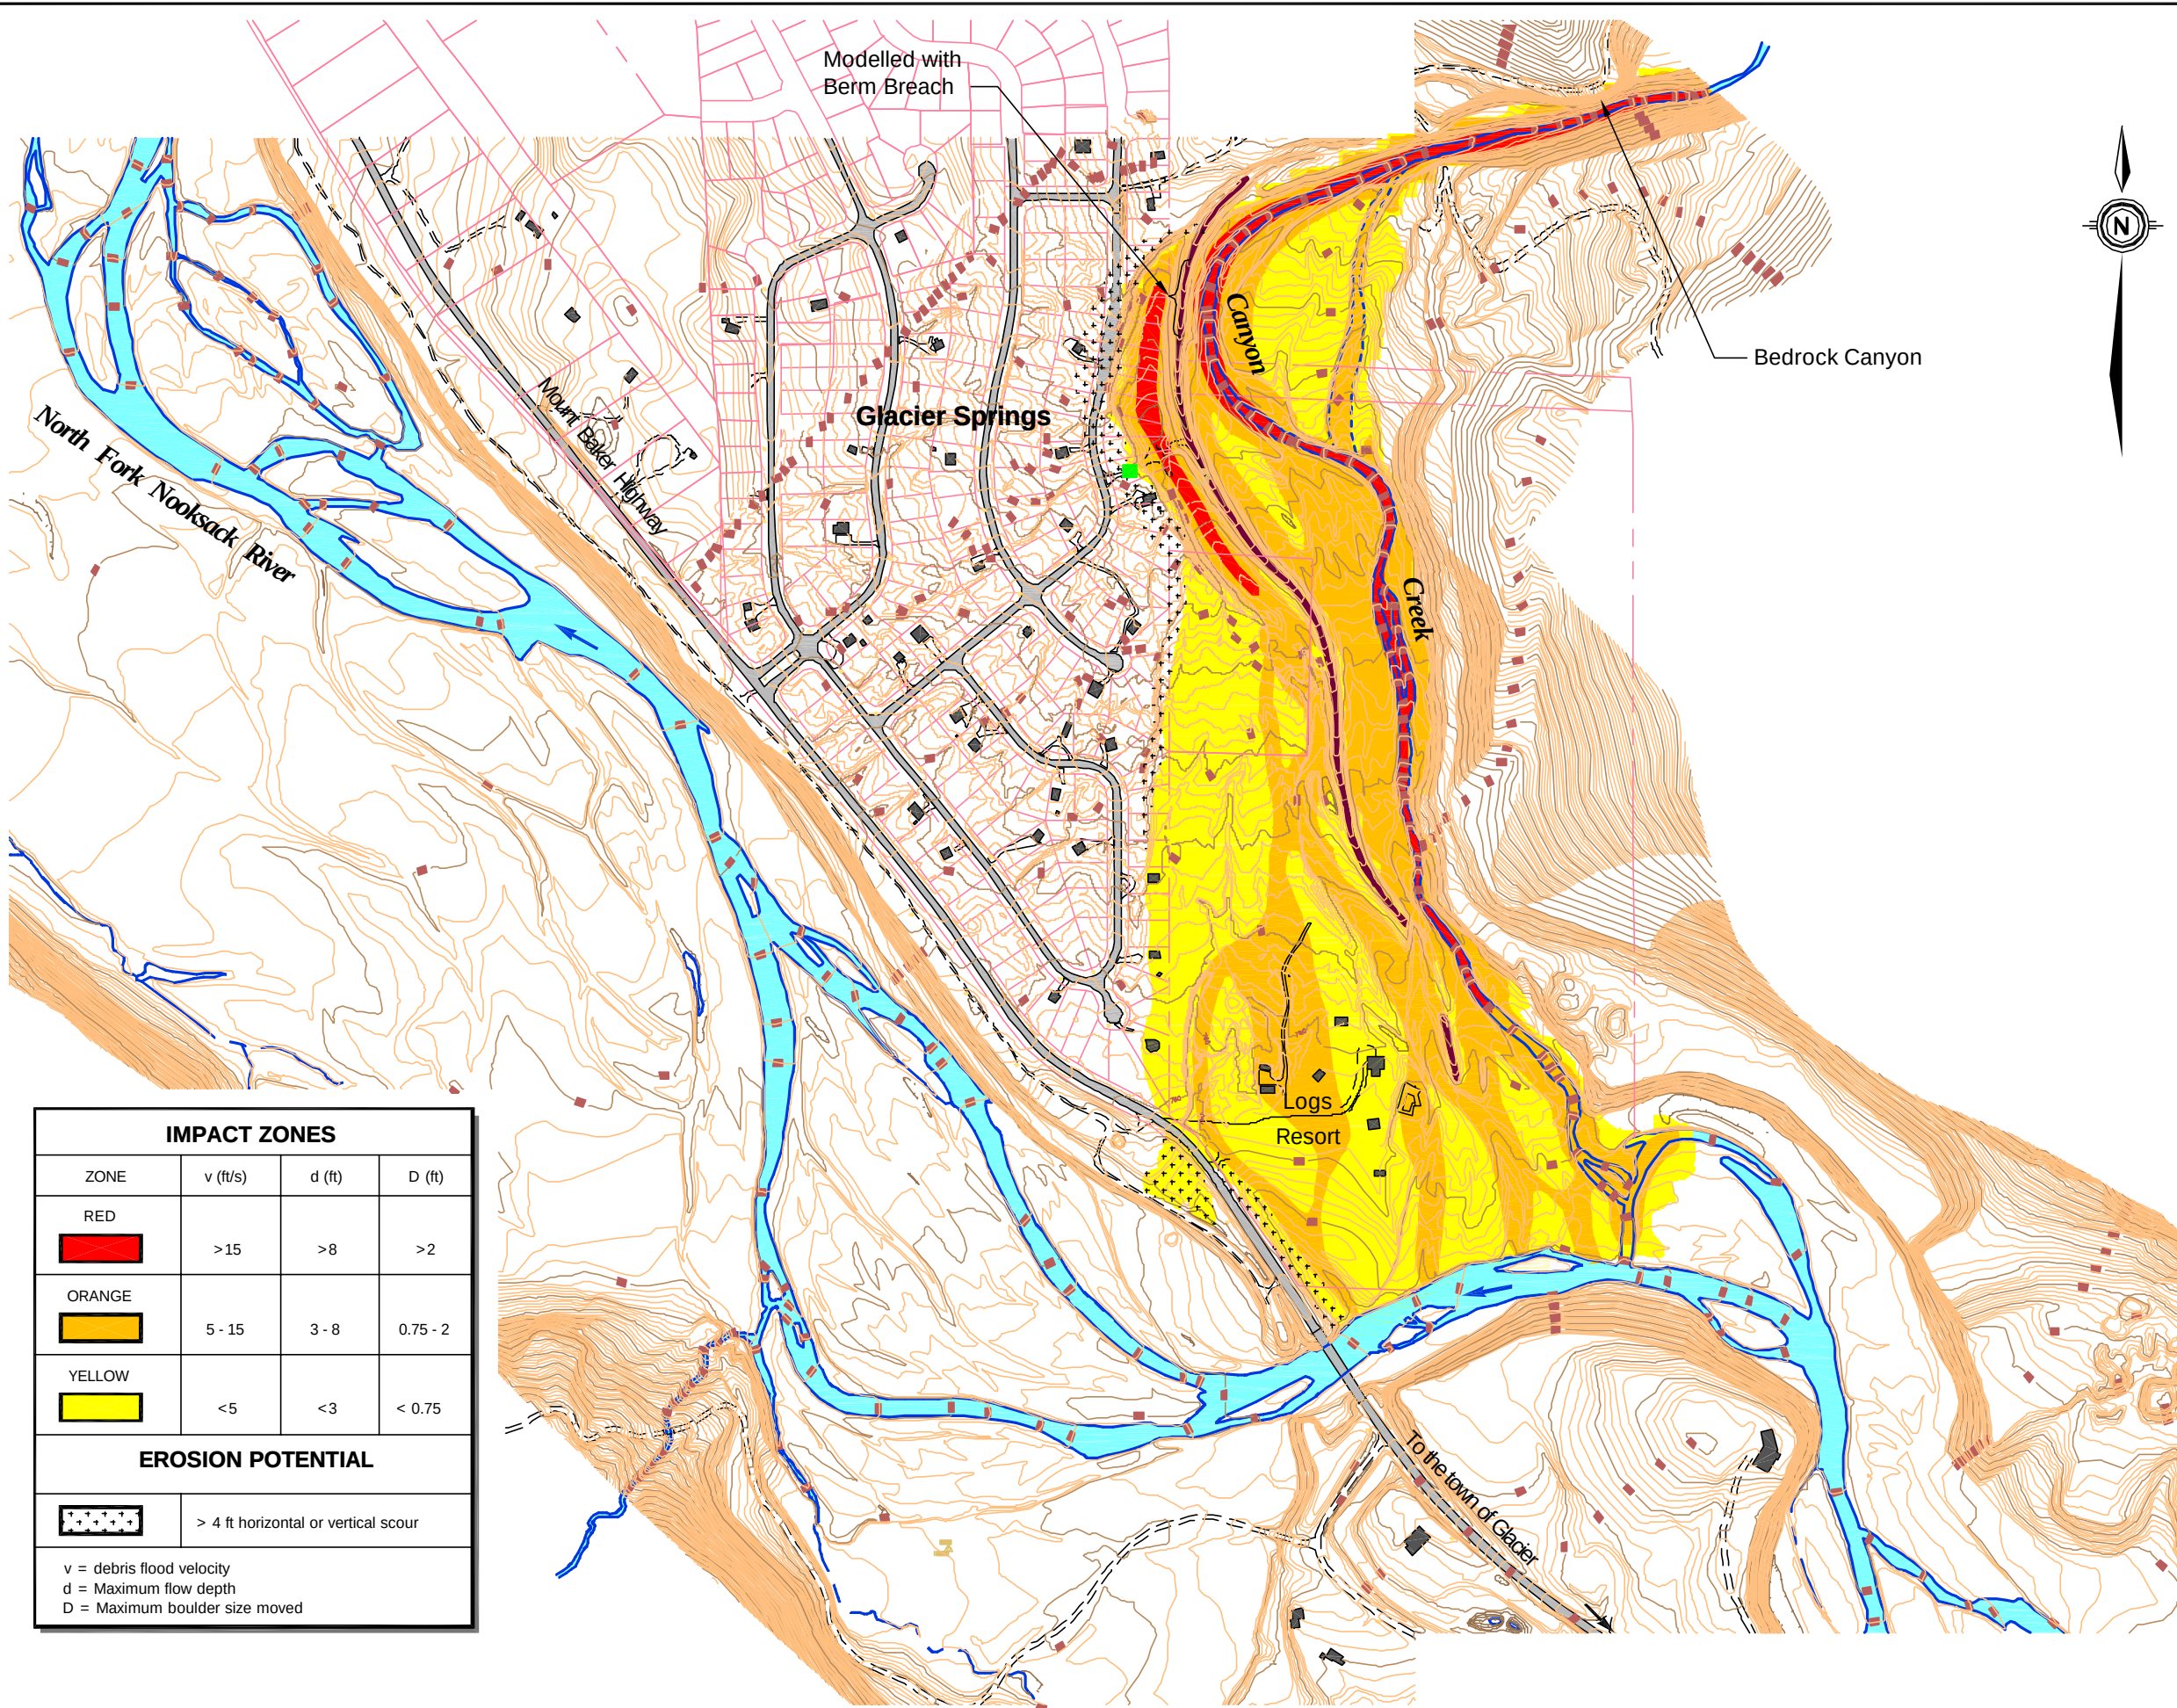
**Canyon Creek Debris Flood Modelling Results for Design Event**  
**Figure 3-1**

It is very important to understand that the zones delineated on Figure 3-1 reflect existing conditions. If a debris flood or large flood were to occur that caused significant channel changes or aggradation, the zones would have to be redefined on the basis of the future channel conditions. As an illustration of this point, despite its lower magnitude, the November 1990 debris flood at Canyon Creek caused more damage than the 1989 event because the 1989 event had significantly changed the channel alignment and aggraded the channel near the fan apex. Consequently, the zones identified on Figure 3-1 are valid only until the next major event on Canyon Creek at which time it would have to be updated.

It should also be recognized that there is a flood overflow/deposition hazard on the lower fan that is not specifically illustrated by the modelling results of Figure 3-1.

The modelling results for the design debris flood event (Figure 3-1) can be used to define hazard zones on the fan. Figure 3-2 presents a hazard map for the Canyon Creek fan. Three hazard zones are defined:
