# San Juan Islands Salmonid Limiting Factors & Recommended Actions

## Eight Basin report

San Juan County Public Works – Environmental Resources

June 27, 2019

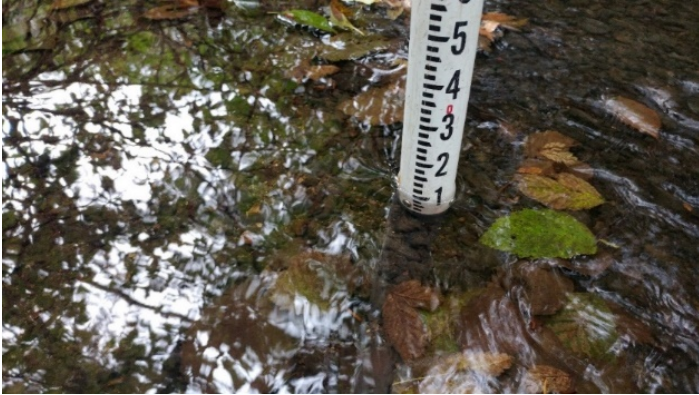
Figure 9. Less than 0.1 ft. depth in coho spawning, San Juan County Land Bank Coho Preserve, October 20, 2017. This flow is too low for coho spawning (photo by author).

The Rosario water right is one-second senior to the instream water right granted to WWT in 2012. Rosario uses Cascade Creek water mostly to run a microhydropower system where the outflow exits into Eastsound, west of the Cascade Creek watershed. The WWT instream flows are insufficient to maintain a viable salmonid population downstream of Doe Bay and Rosario outtakes in Cascade Creek. Water depth in Coho Preserve near the mouth was 0.1 ft. on Oct 20, 2017 (Figure 9). Flows in El Nino dry years can be very low in May and November-December.
