# City of Olympia

## West Bay Environmental Restoration Assessment

### Final Report

Prepared by:  
Coast & Harbor Engineering, a Division of Hatch Mott MacDonald

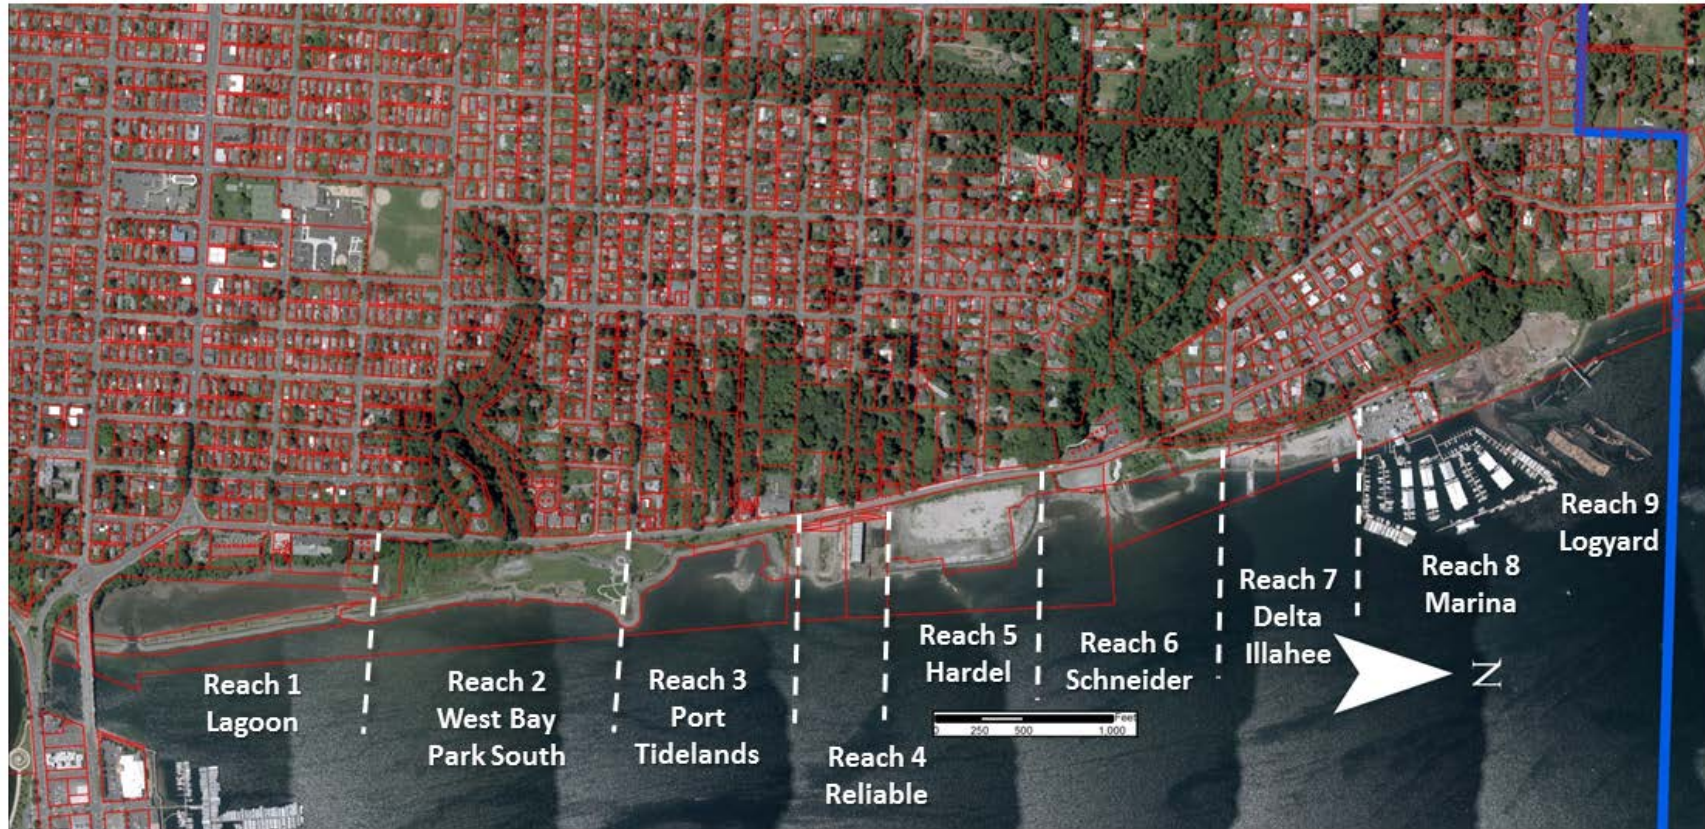
Figure 1. Project reaches, parcel boundaries, and aerial photograph from 2015.

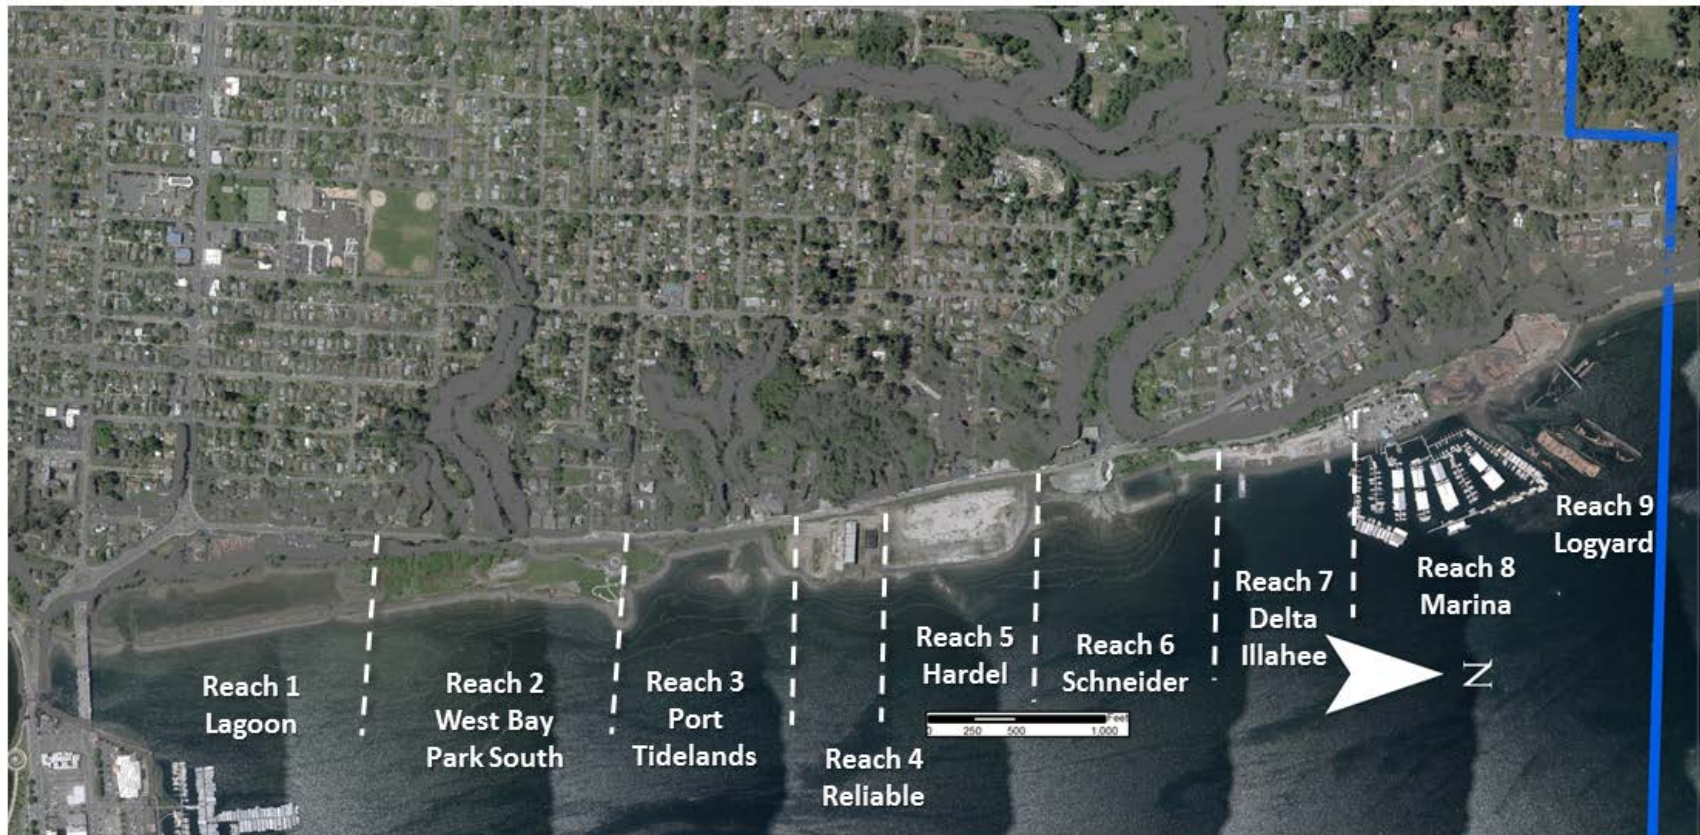
Figure 2. Project base map showing project reaches, 1-ft topographic contours, and aerial photograph from 2015.

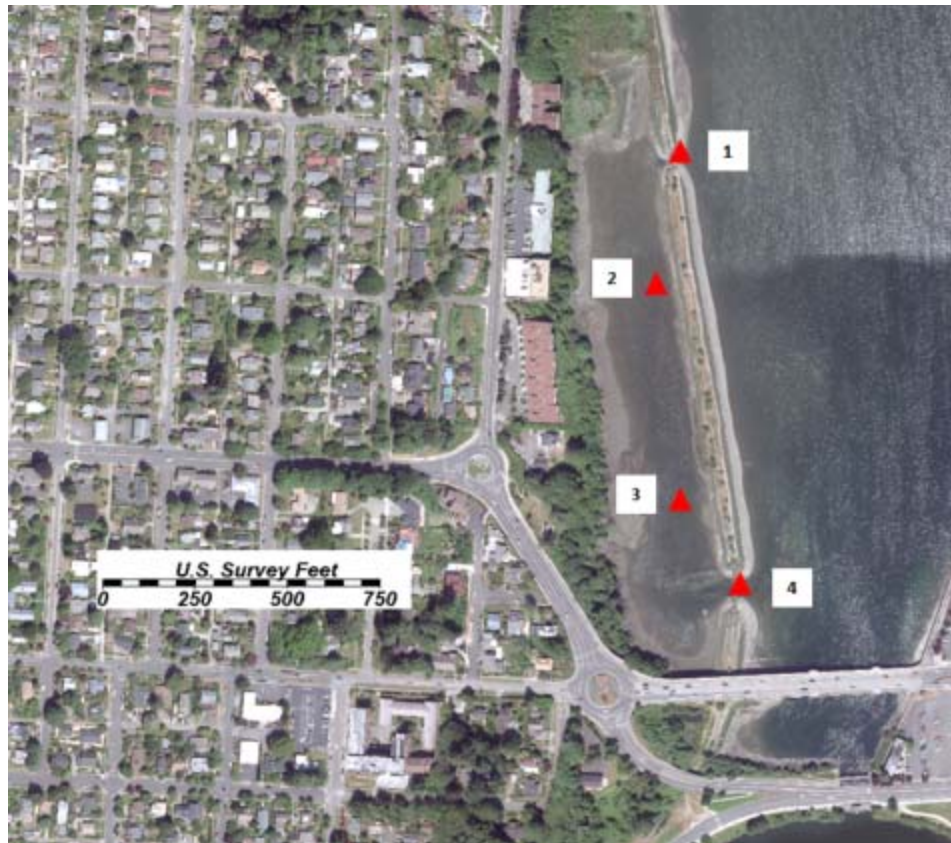
Figure 11. Location of model stations used for stationary analysis.

The output from local scale numerical model simulations included water surface elevations, depth-averaged flow velocities. Results were evaluated by analysis of changes in velocities throughout the lagoon and numerical dye tracer propagation in response to changes in the lagoon configuration. The flow velocity analysis included extraction and comparison analysis of modeling results at controlling stations. For all modeling scenarios, model stations were specified in the modeling domain at locations that are considered representative for analysis of potential changes and for evaluation of the conceptual design alternatives. The locations of the representative stations are shown and labeled in Figure .

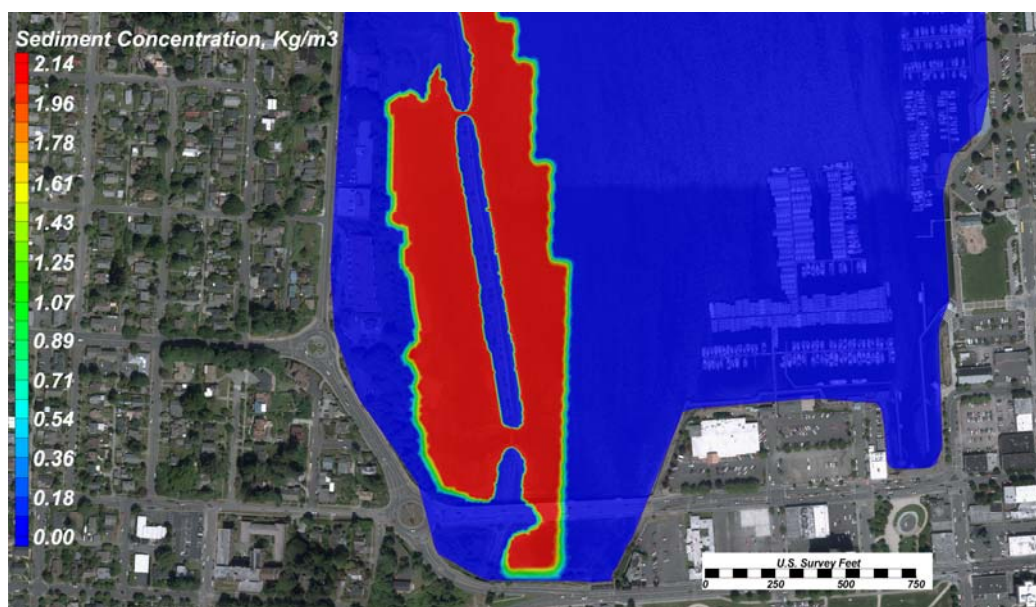
**Figure 14. Initial concentration around the lagoon for evaluation of residence time in the lagoon for existing conditions.**

Numerical dye as a concentration tracer modeling was conducted to determine the residence time for each of the alternative lagoon design options. Residence time was used as a proxy for circulation and flushing of each of the alternative designs. The residence time in a body of water is typically defined as the amount of time required for the concentration of some suspended material – non-settling dye in this case – to drop down to 37% of its initial concentration. The faster that it takes to decrease the initial concentration to the reference concentration, the more circulation is taking place in the body of water. A non-settling constituent (e.g. numerical dye) was integrated into the modeling grid around the alternative lagoon designs. Circulation models were run for existing conditions and each of the alternatives. The initial concentration conditions within the lagoon were set to  $2.14 \text{ kg/m}^3$  and residence time was determined when the average concentration in the lagoon reduced to  $0.79 \text{ kg/m}^3$ . Figure 14 shows the modeling grid for existing conditions with the initial concentration of the lagoon at  $2.14 \text{ kg/m}^3$ . As the models run, tidal flow through the lagoon and flow from the dam results in the dispersal of the initial concentration condition prior to dispersal.
